# Signal passed at danger by train 2552

Petrie, Queensland, 12 October 2017

**ATSB Transport Safety Report**  
Rail Occurrence Investigation  
RO-2017-015  
Final – 2 October 2018

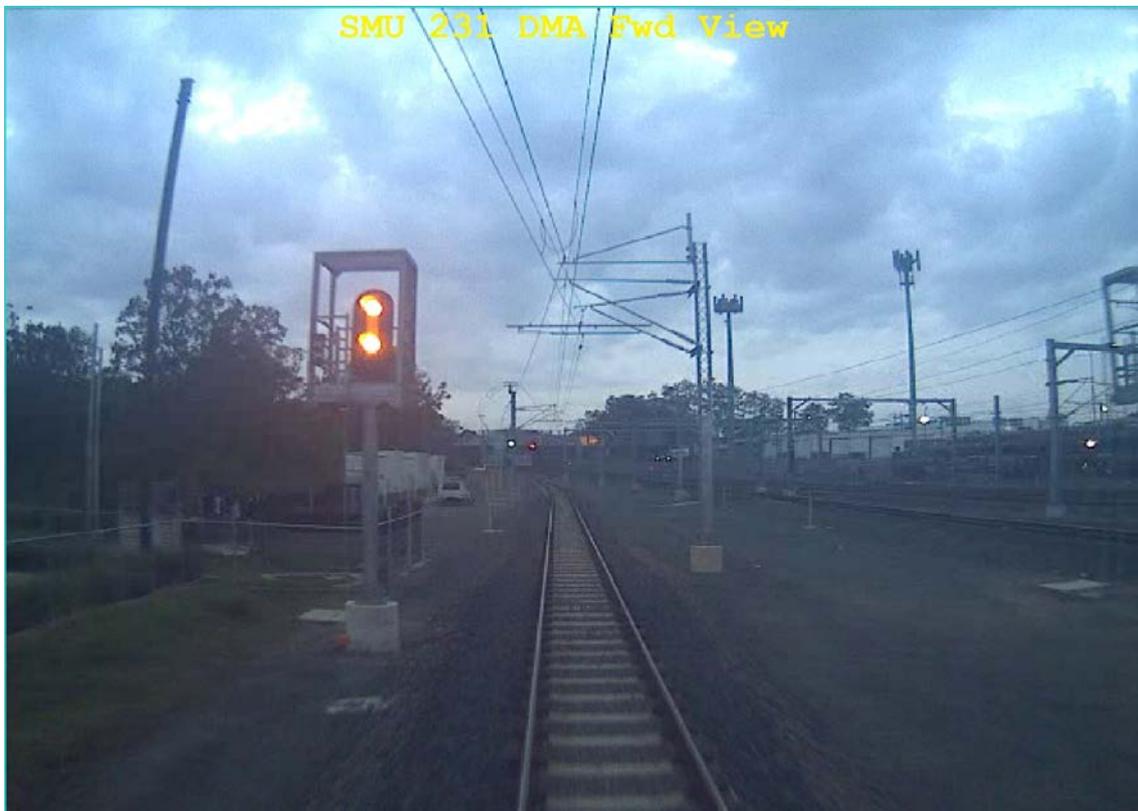
**Figure 1: Train 2552 passing signal PE54 at 1748:53, travelling at a speed of 41 km/h**

At about 1736 Eastern Standard Time<sup>1</sup> on 12 October 2017, Queensland Rail (QR) empty suburban passenger train 2552 departed Kippa-Ring Station towards Bowen Hills. The train ran on Proceed signal indications (green) until slowing for a sweeping curve into Petrie Station. The driver of train 2552 recalled slowing the train approaching Petrie platform then following yellow signals. The Automatic Warning System (AWS)<sup>2</sup> generated an in-cab alert to the driver of the restricted signal indication ahead on signal PE54 on the departure side of Petrie Station platform 5. The driver acknowledged the AWS, passed signal PE54 (which displayed a restricted indication double yellow aspect)<sup>3</sup> and continued towards the next signal PE38. The driver did not recall acknowledging the AWS associated with PE54.

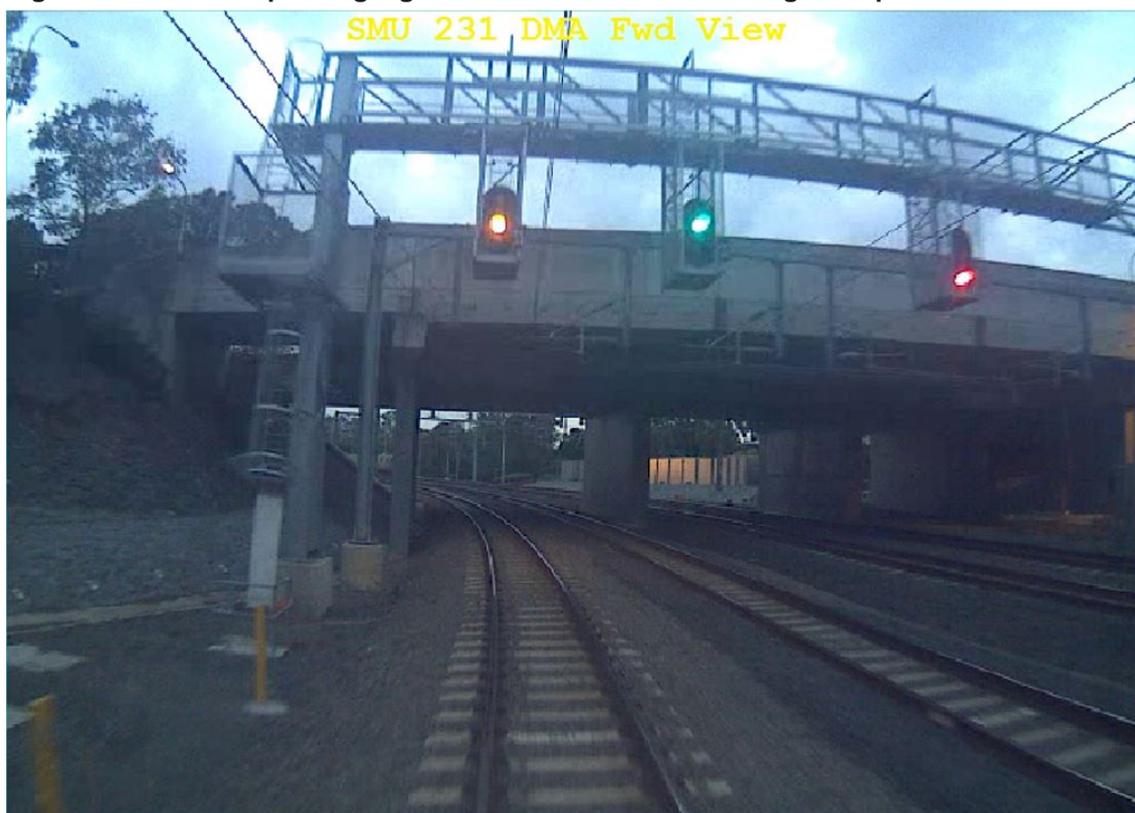
**Figure 2: Train 2552 passing signal PE38 at 17:49:12 travelling at a speed of 41 km/h**

Approaching signal PE38, the AWS activated again, indicating the next signal PE38 was also displaying a restricted indication (single yellow aspect). The driver acknowledged the AWS, passing signal PE38 at 41 km/h (Figure 2). Again, the driver could not recall acknowledging the AWS.

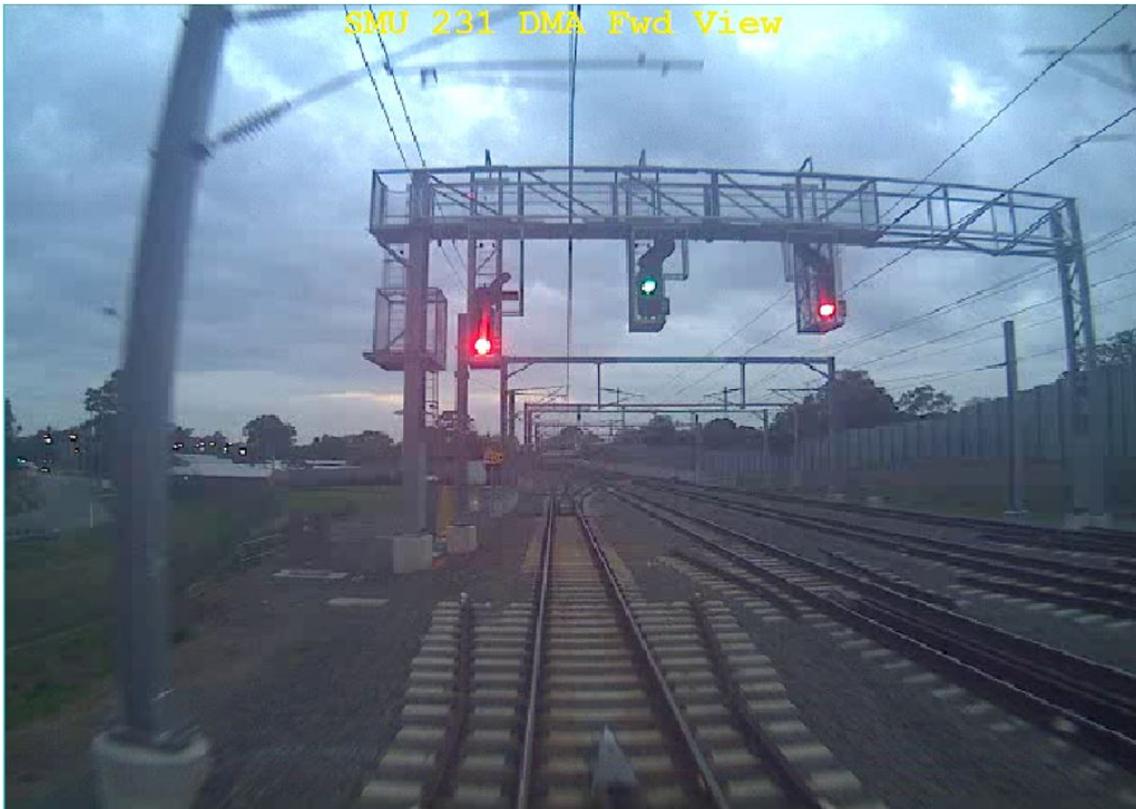
**Figure 3: Train 2552 passing signal PE28 1750:02 travelling at a speed of at 42 km/h**

At about 1750, train 2552 passed signal PE28 at STOP (Figure 3), and continued at a reduced cautious speed. The driver did not recall the red signal or acknowledging the associated AWS alarm. The driver commented that he was focussed on the preceding train and not the signal indication directly in front.

Adjacent signal PE26 cleared (green) for train TK74. Source: Queensland Rail

The driver of train 2552 unknowingly passed signal PE28 at STOP. The driver recalled he was planning the train handling with a focus on the movement of the train ahead, rather than the signalling system. He also reported feeling unwell. The extent to which the driver’s reported area of focus and his developing illness influenced the occurrence could not be determined. Both these elements however, had the potential to distract the driver’s attention from the light signals.

- The driver of train 2552 did not recall seeing a red light as they approached signal PE28 resulting in that signal being passed at STOP. The exceedance may have been influenced by a focus of attention on the preceding train and a developing respiratory illness.
- The network control officer responded to the SPAD by broadcasting an emergency message for train 2552 to stop. The driver did not respond to that call as they believed it was directed to another train, however the guard responded to the broadcast by activating the emergency brakes.

- Conducting a qualitative analysis of the SPAD scenarios at RS57 using a bowtie model.
- Presenting a health and wellbeing strategic plan to the Executive Leadership Team, which includes an organisational resilience and psychological wellbeing education and awareness program.

- Conducting a human factors review of driver response to AWS audible indications and reaction times for green and restricted signals.
- Facilitating the decrease in volume of the AWS audible indication at a Proceed signal (green) and increasing the volume of an AWS audible indication at a restricted signal (double yellow, yellow, and red).

- Seeking expressions of interest from market leaders to partner with Queensland Rail to implement European Train Control System (ETCS) on sections of the Queensland Rail network. ETCS incorporates automatic train protection that provides for monitoring of train speed and limits of authority to ensure trains stay within designated speed limits and authorised safeworking limits.

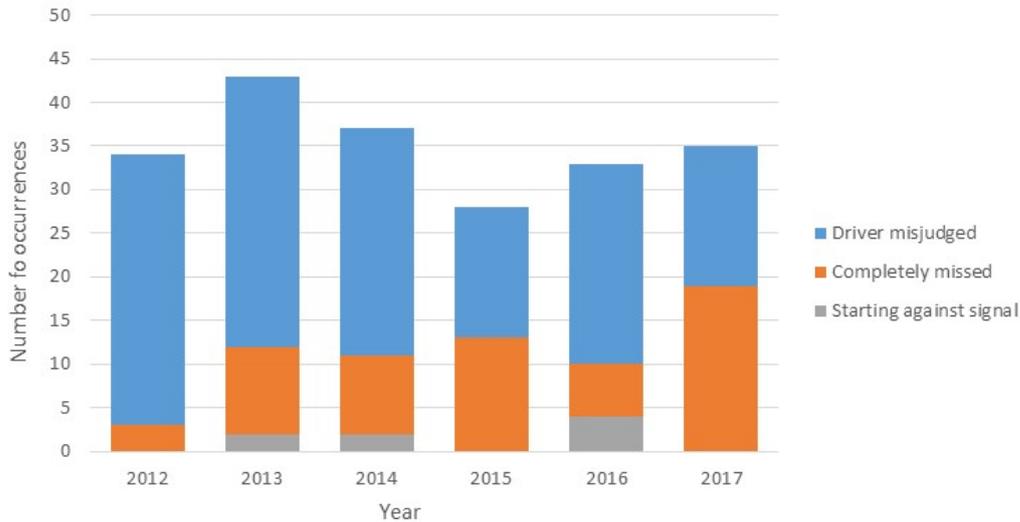
**Figure 4: Queensland train driver-related SPAD occurrences, 2012 – 2017**

The highest proportion of driver-related SPAD occurrences was ‘driver misjudged’, followed by ‘completely missed’, then ‘starting against signal’. The ‘completely missed’ SPAD occurrence is considered by QR to be a higher risk. As a proportion of all driver-related SPADs, the ‘completely missed’ SPADs represented 9% in 2012, 23% in 2013, 24% in 2014, 46% in 2015, 18% in 2016 and 54% in 2017. Based on the five-year average of completely missed SPADs (2012-2016), the data showed an increasing proportion of ‘completely missed’ SPADs in 2017.

Although the increase in 2017 was higher than previous years, there was insufficient data to conclude whether this was an anomaly or indicative of an increasing trend. Ongoing monitoring of this occurrence type will resolve this.
