Collision involving a Boeing B737, VH-VZZ and a catering vehicle

Sydney Airport, New South Wales, 14 October 2017

ATSB Transport Safety Report
Aviation Occurrence Investigation
AO-2017-099
Final – 14 November 2018

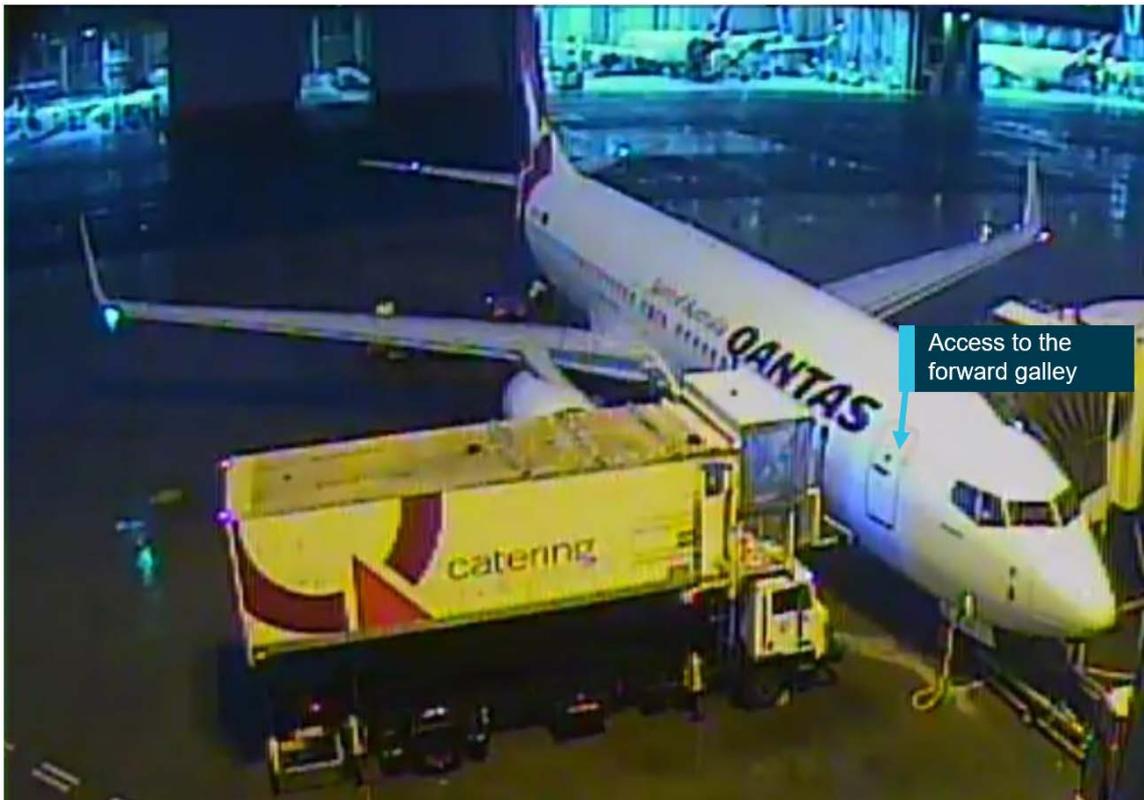
At about 1921, the engineer arrived at the aircraft, and received a handover from the other engineer who had been in attendance. The engineers discussed the aircraft status under the aerobridge as it had just started to rain. At this time, the catering vehicle (truck) was loading the forward galley through the right forward main entry door (Figure 1). The pushback vehicle's (tug) towbar was already connected to the aircraft.

Figure 1: Catering truck loading via the aircraft's right forward main entry door

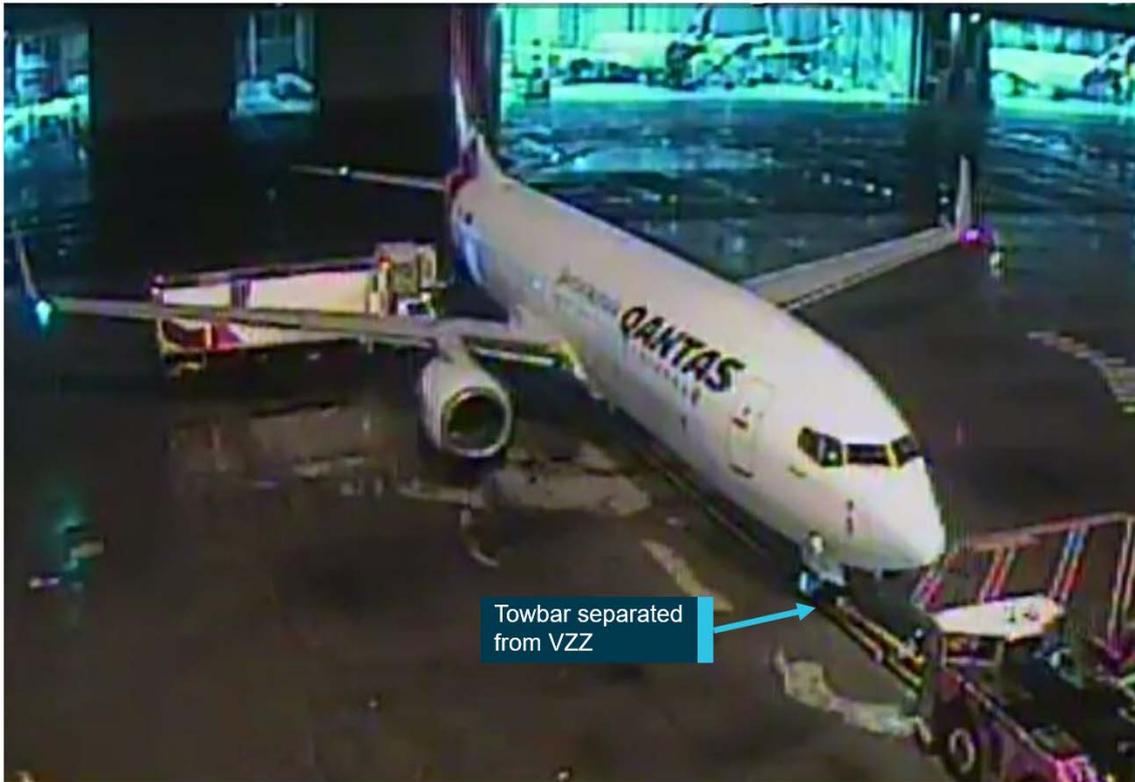
A few seconds later, the catering truck's marshaller identified that VZZ was moving and tried to alert the truck driver. At the same time, the engineer saw that the catering truck was not clear and 'yelled' at the tug driver to stop. The tug driver immediately applied the brakes. The tug stopped but the pins in the towbar sheared and it separated from VZZ (Figure 2).

Figure 2: The catering truck behind the aircraft's wing when the towbar separated

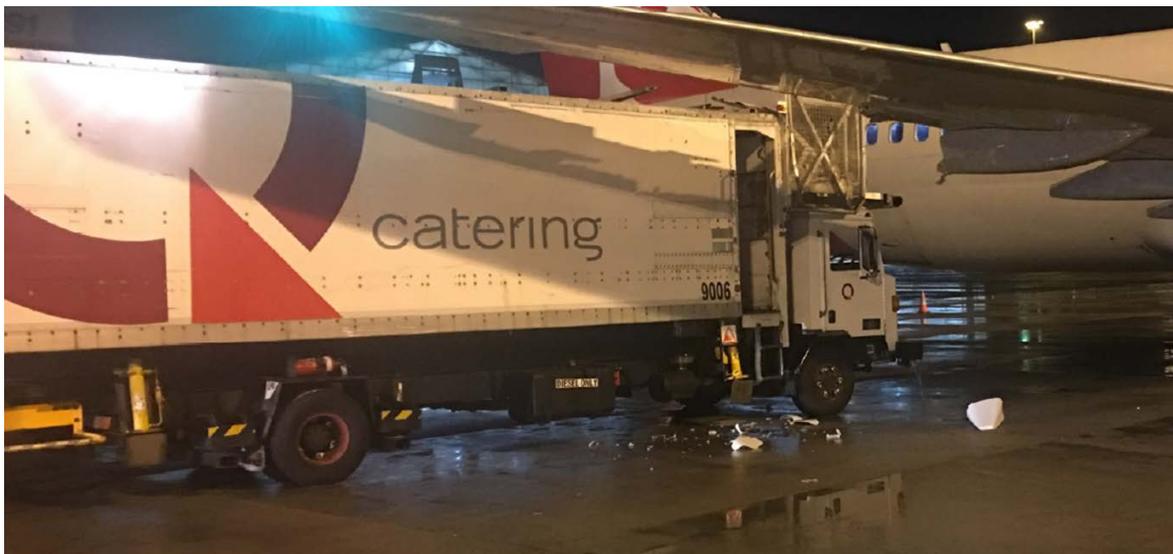
At 1932:53, the aircraft's right wing collided with the truck (Figure 3) before it came to a stop. The flight crew then engaged the aircraft's park brake and turned the right engine switch to OFF and the engine wound down as fuel had not been introduced.

Figure 3: Location of catering truck after the collision

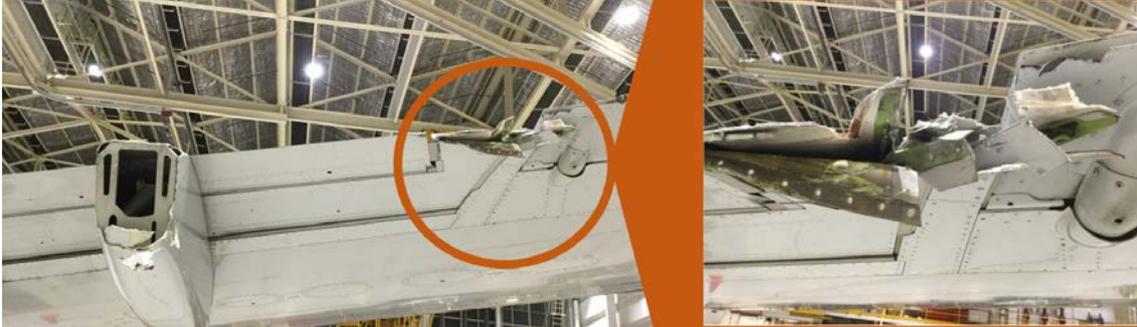
By 2012, a new towbar was connected to VZZ and it was towed back to the bay. No one was injured in the incident and the passengers disembarked. The aircraft was inspected and found to have substantial damage to its right outboard flaps, wing structure between the flaps and aileron, and the aileron (Figure 4).

Figure 4: Damage to the aircraft's right wing

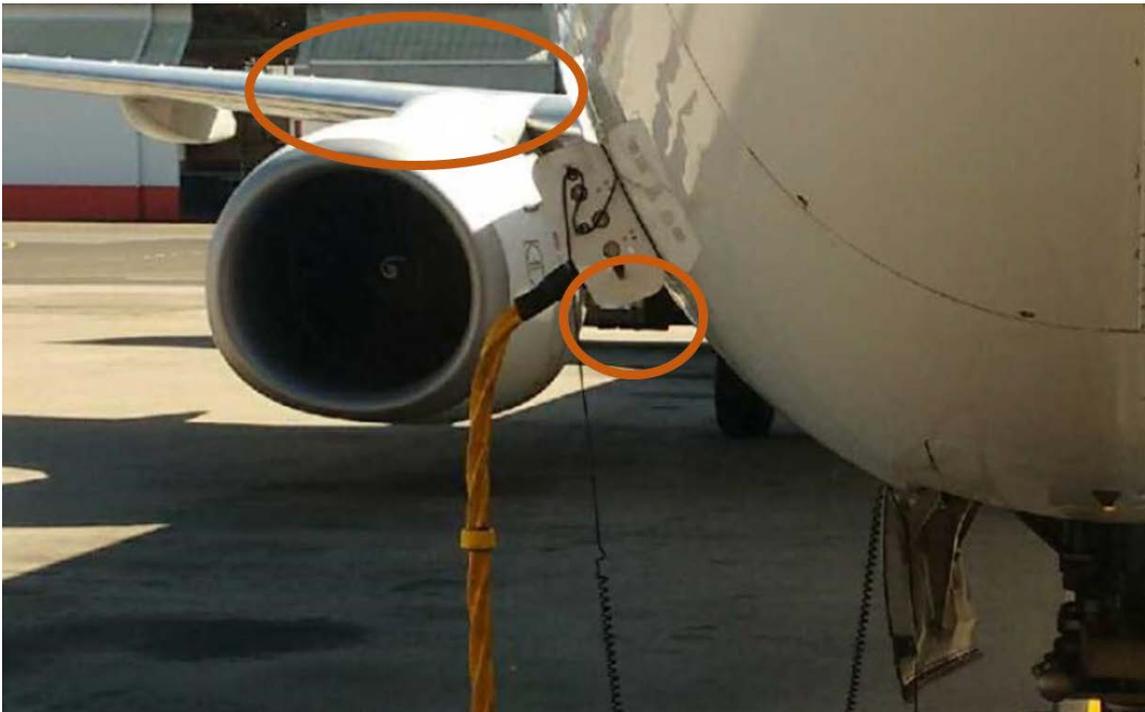
An investigation of this incident by Qantas included reconstructing the view of the catering truck from the tug's location (Figure 5).

Figure 5: View of the catering truck (circled) from the tug in daylight

There were a number of physical reasons why the engineer did not see the catering truck. He did not have his wet weather gear and, as it was raining, decided to sit in the tug's cabin for pushback. Seated in the tug, the engineer's view of the truck was largely obstructed by the aircraft's wing and a panel door (Figure 5). These obstructions were white, the same colour as the truck and blended with the small, unobstructed parts of the truck. Additionally, these parts blended into white hangars in the background. The trucks lighting and reflective strips were not in view. The dark and rainy conditions with lights reflecting off the wet tarmac also made it difficult to see the truck.

- Issued a safety information notice to all staff involved in aircraft dispatch activities highlighting the specific visual limitation issues associated with B737 aircraft pushback operations, and the importance of physically ensuring the pushback path is clear.
- Provided relevant training to the dispatch engineer involved in this occurrence.
- The engineering aircraft receipt and dispatch-training package will be revised to highlight the visual limitations and the risks which may be present during aircraft pushback operations.
- Lessons learned from aircraft pushback occurrences will be included in the human factors training program.
- Initiated a trial of cordless headsets to improve visibility during aircraft pushback.

- Conducted an assessment of the risk associated with the engineer sitting inside the tug during aircraft pushback.
