# Flight below minimum altitude involving Embraer ERJ135, VH-ZJG

near Essendon Airport, Victoria, 27 October 2017

**ATSB Transport Safety Report**  
Aviation Occurrence Investigation  
AO-2017-106  
Final – 19 December 2018

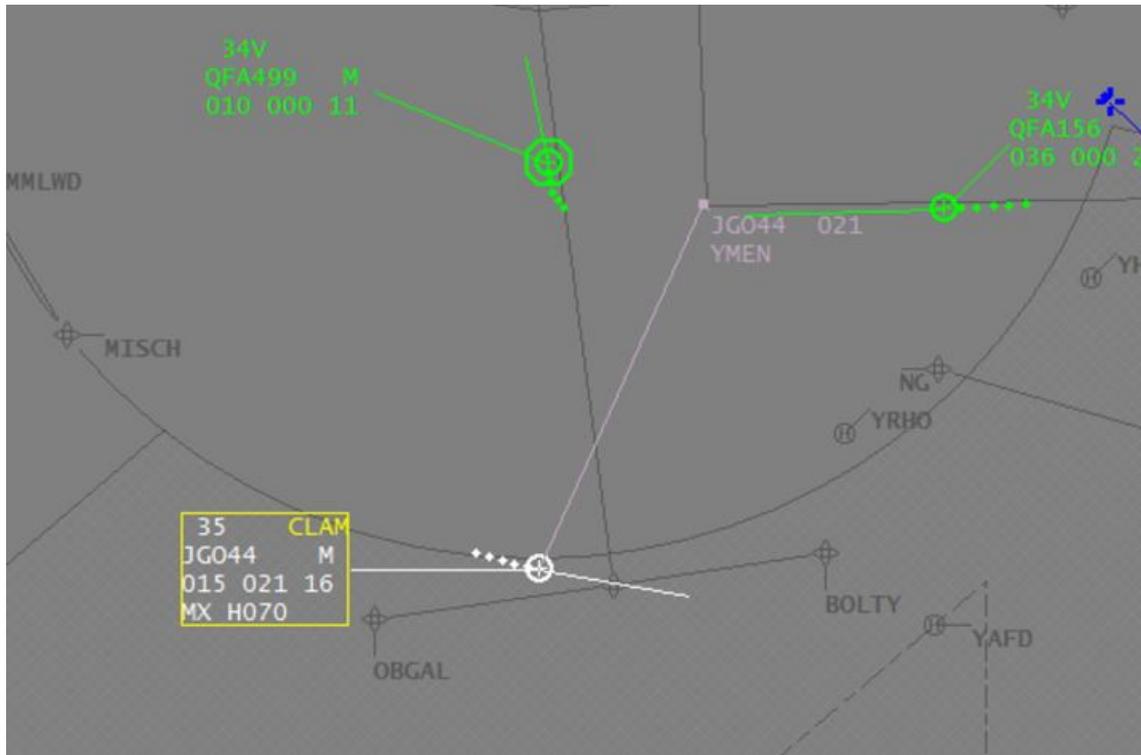
**Figure 1: Image of air traffic controller's monitoring screen showing CLAM alarm activation following the aircraft's descent below 2,100 ft**

At 2224:05, a cleared level adherence monitoring (CLAM) alarm<sup>5</sup> activated (Figure 1), further alerting ATC of a difference between the aircraft's assigned altitude and its actual altitude. ATC immediately issued a terrain safety alert, advising the flight crew that the lowest safe altitude was 2,100 ft.

Recorded radar data showed the aircraft's lowest altitude was about 1,500 ft during 2224:05 to 2224:10 (Figure 1).

Image shows the aircraft (JG044) with a current altitude of 1,500 ft ('015'), a cleared altitude of 2,100 ft ('021'), a radar vectored heading of 070° ('H070') and a groundspeed of 160 kt ('16'). Source: Airservices Australia
