Replacement of self-locking nuts on Robinson helicopters

On 2 August 2017, a Robinson R22 Beta helicopter impacted terrain about 7 km north-north-west of Cloncurry Airport, Queensland. The pilot, who was the only person on board, was fatally injured and the helicopter was destroyed. The accident flight was the first commercial flight post the helicopter's second 2,200-hour overhaul.

AO-2017-078-SAN-001:

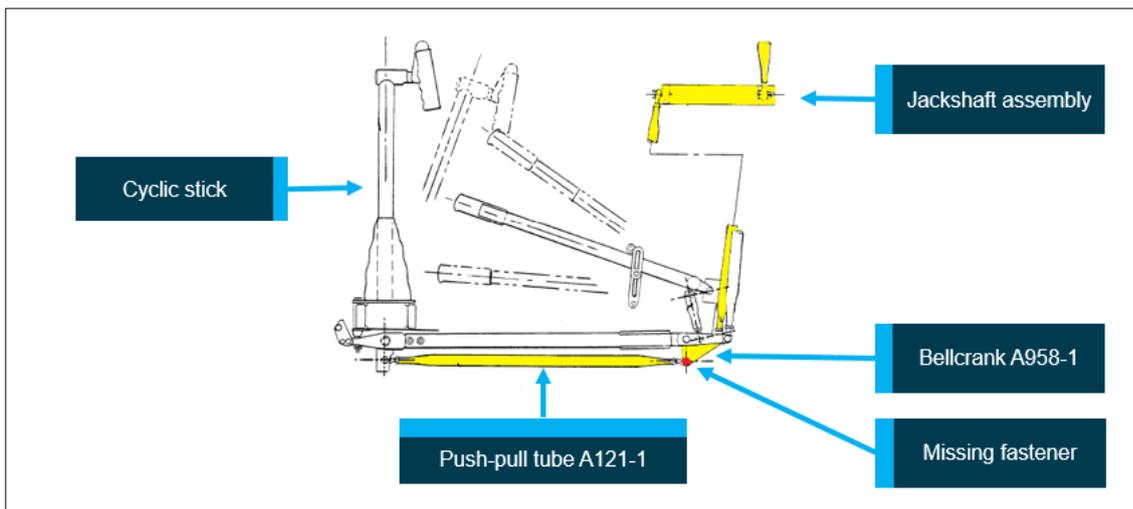
Figure 1: Robinson R22 helicopter cyclic control system

The missing fastener was part of the longitudinal cyclic pitch control system, which controls the fore-aft tilt of the main rotor disc (Figure 1).

Robinson R22 helicopter cyclic control system schematic: The horizontal push-pull tube, bellcrank, vertical push-pull tubes and jackshaft are highlighted in yellow. The location of the missing fastener is highlighted in red.

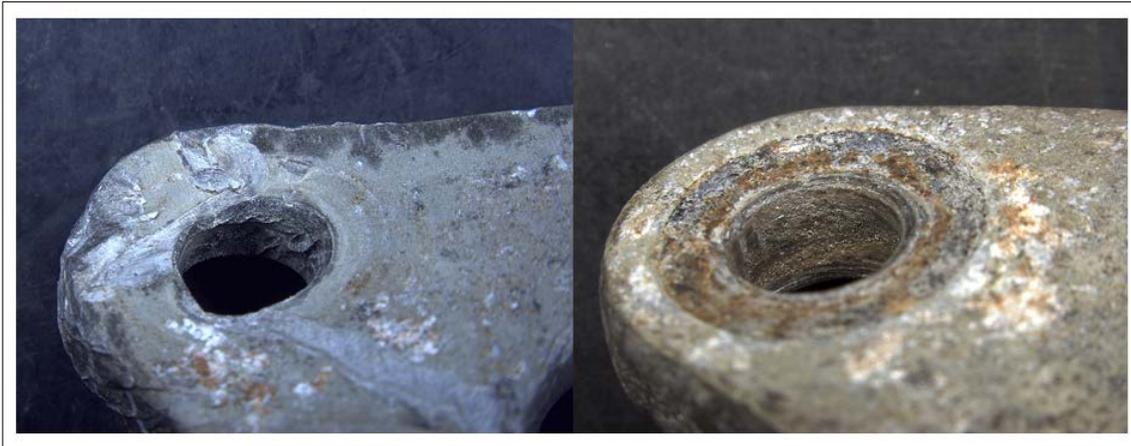
Figure 2: Comparison of the bellcrank bolt-holes

The examination of the bellcrank found that the bolt-holes for the missing fastener exhibited heat damage different to that of the bolt-holes for the remaining fasteners (Figure 2). In addition, the deformation of the bellcrank prevented the installation of a bolt where the fastener was missing, but did not prevent the removal of the remaining fasteners. This indicated that the bolt was not in-situ at the time of the post-impact fire.

Left: bolt-hole for the missing fastener. Right: bolt-hole for a removed fastener.
Source: ATSB

The Australian Transport Safety Bureau advises all maintenance personnel for Robinson helicopters to ensure that before re-using a self-locking nut, that the correct part number is fitted, and that the D210-series corrosion-resistant nuts are used for reassembly of critical fasteners in accordance with the Robinson Helicopter Company instructions for continued airworthiness.
