Collision with terrain involving Bell 206, VH-SDZ

75 km NE of Emerald Airport, Queensland, on 18 November 2017

ATSB Transport Safety Report
Aviation Occurrence Investigation
AO-2017-112
Final – 8 May 2019

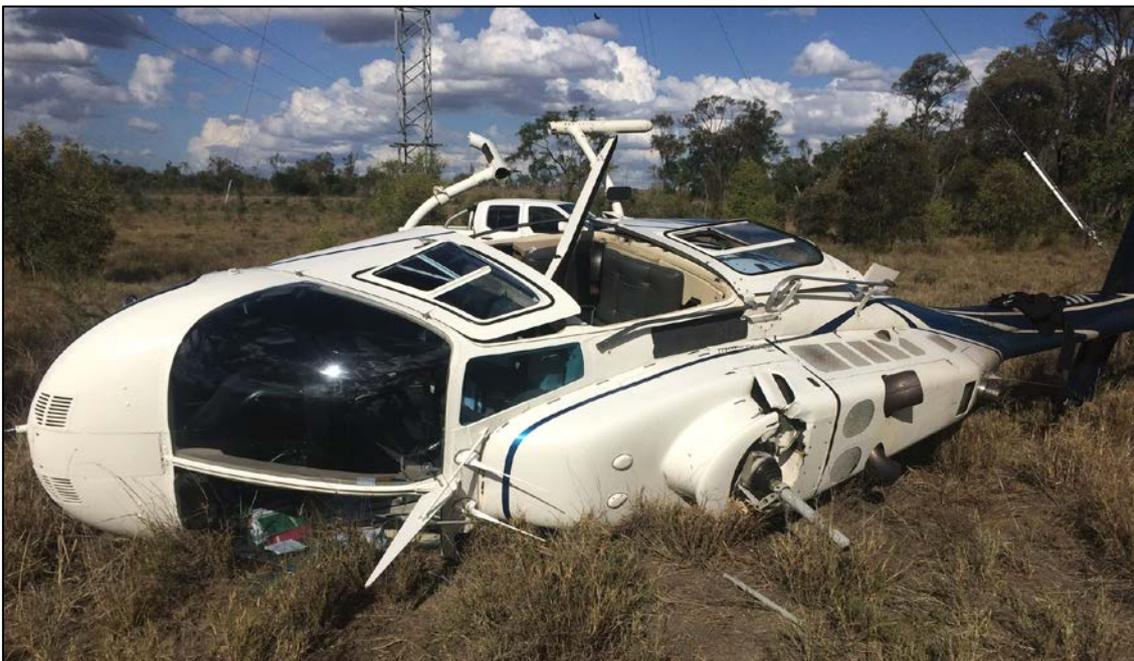
In response, the pilot immediately lowered the collective, intending to land in a clear area below the helicopter, but it did not respond to collective or cyclic control inputs. Instead, the helicopter began to pitch upward and drift backwards. The helicopter then yawed to the right, most likely due to contact with trees behind. The yaw could not be controlled with the tail rotor pedals so the pilot moved the throttle to the idle position. Despite attempts to level the aircraft, the left skid contacted the ground first and the helicopter rolled over.

Figure 1: VH-SDZ following collision with terrain

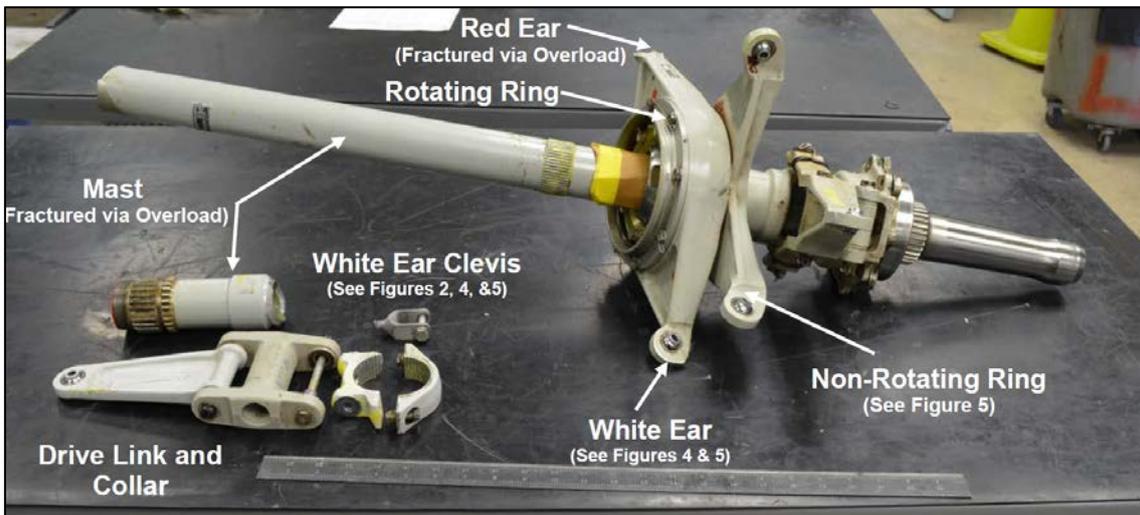
Examination of the helicopter following the occurrence identified that the mast, both pitch links, and the swashplate were fractured. The mast collar set was also fractured and not engaged with the mast². The operator initially suspected that the mast collar set had disengaged in flight.

Figure 2: Components examined at Bell Helicopter's Engineering Laboratories

The hypothesis of mast collar separation was considered by Bell Engineering Laboratories. It was determined that an in-flight separation would likely have resulted in rotational damage on the mast and mast collar splines, which was not observed. The damage observed in the pitch links was also not consistent with a separated mast collar.

Bell Helicopter concluded that all of the fractures, including that resulting in the mast collar separation, were a result of overstress. No pre-existing defect was found and all damage observed was secondary to the occurrence. Seized or damaged trunnion bearings were also considered for inhibited movement of the pitch links, which could result in abnormal bending loads. However, the condition of the trunnion bearings was found to be typical for bearings removed from service.
