Signal passed at danger of passenger train NP43

Gunnedah, New South Wales on 10 June 2019

ATSB Transport Safety Report

RO-2019-012

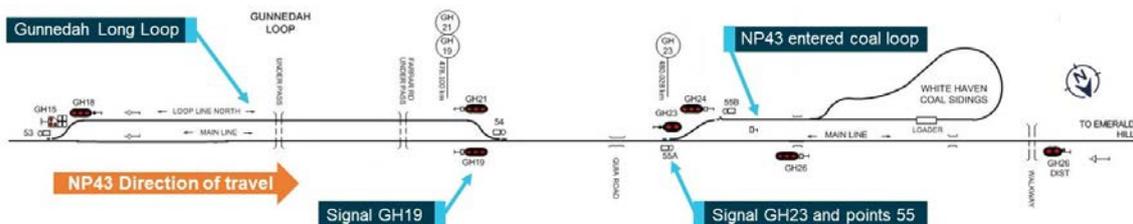
Figure 1: Gunnedah signal location

At 16:46:28 NP43 passed signal GH23 at Stop, located at 480.028km and entered the Whitehaven Coal Loop siding at approximately 110km/hr. The train stopped approximately 400m into the coal loop (see Figure 1 for incident location). The driver stated when he did see signal GH23 at Stop, he initiated an emergency brake application, but was unable to stop prior to points 55.

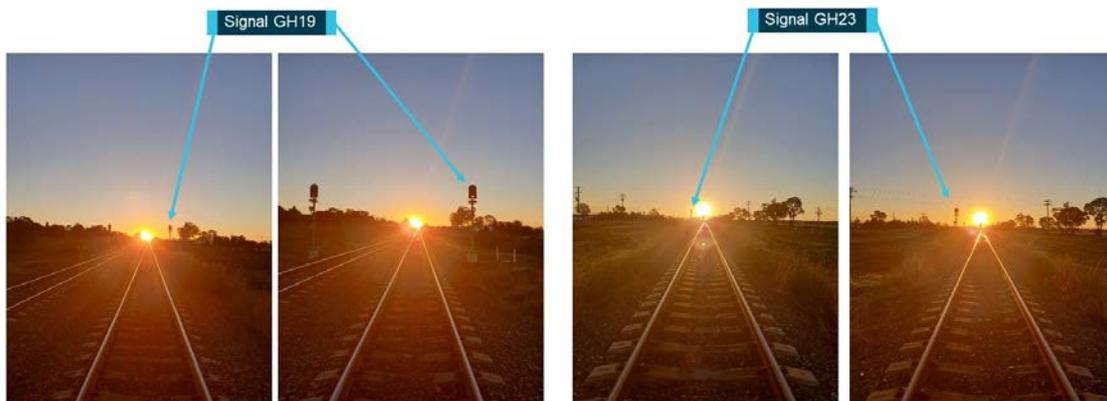
Figure 2: Signal sighting at approximately 100m and 30m to GH19 and GH23

The position of the sun aligned directly with the path of NP43, likely reducing the safe sighting distance to within 100m of signals GH19 and GH23. The driver reported that the sun was reflecting from the stainless steel coal wagons parked in the Gunnedah long loop. This may have distracted the driver from sighting signal GH19. The driver reported wearing sunglasses and utilising the cab blind in an effort to block the sun, but reported his visibility was still affected.

A site inspection completed the following day confirmed the position of the sun would have affected the driver's visibility of the signal aspects for GH19 and GH23 (see Figure 2). This inspection was completed at the same time in similar weather conditions to the previous day.

- The driver's vision of the signals GH19 and GH23 was likely impaired due to the position of the sun. The sun reflecting off the side of the coal wagons prior to signal GH19 possibly further impaired the driver's vision. Under these conditions the driver did not suitably adjust the speed of the train to allow for safe sighting of the signal.

Drivers are reminded of the importance of operating to the current conditions, but also with consideration to potential future conditions. If safe sighting distance is reduced due to environmental factors, it is important to reduce speed and be prepared to stop.
