Ground collision with airport infrastructure involving British Aerospace AVRO 146-RJ85, VH-NJW

Perth Airport, Western Australia | 30 July 2019

ATSB Transport Safety Report
Aviation Occurrence Investigation
AO-2019-038
Final – 30 January 2020

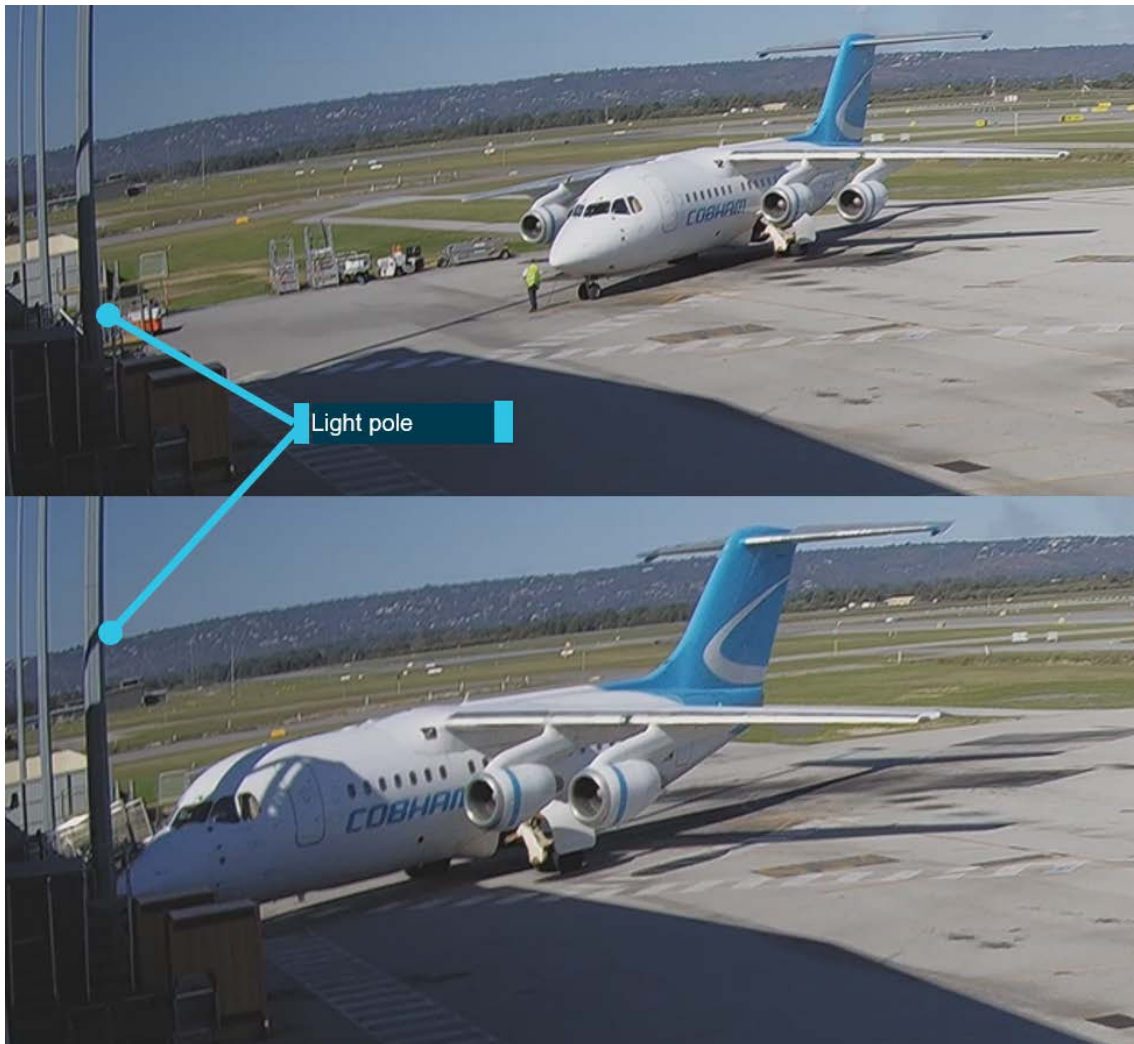
About 18 seconds after the start of the roll-forward, NJW collided with movable aircraft stairs, which were in front of the Cobham terminal. The stairs struck the front of the aircraft, beneath the right pilot seat. Shortly after, NJW collided with a bollard in front of a light pole, then with the light pole itself. The roll-forward and collision with airport infrastructure was captured on Cobham CCTV (images shown in Figure 1).

Figure 1: CCTV showing start of roll-forward (top) and collision with infrastructure (bottom)

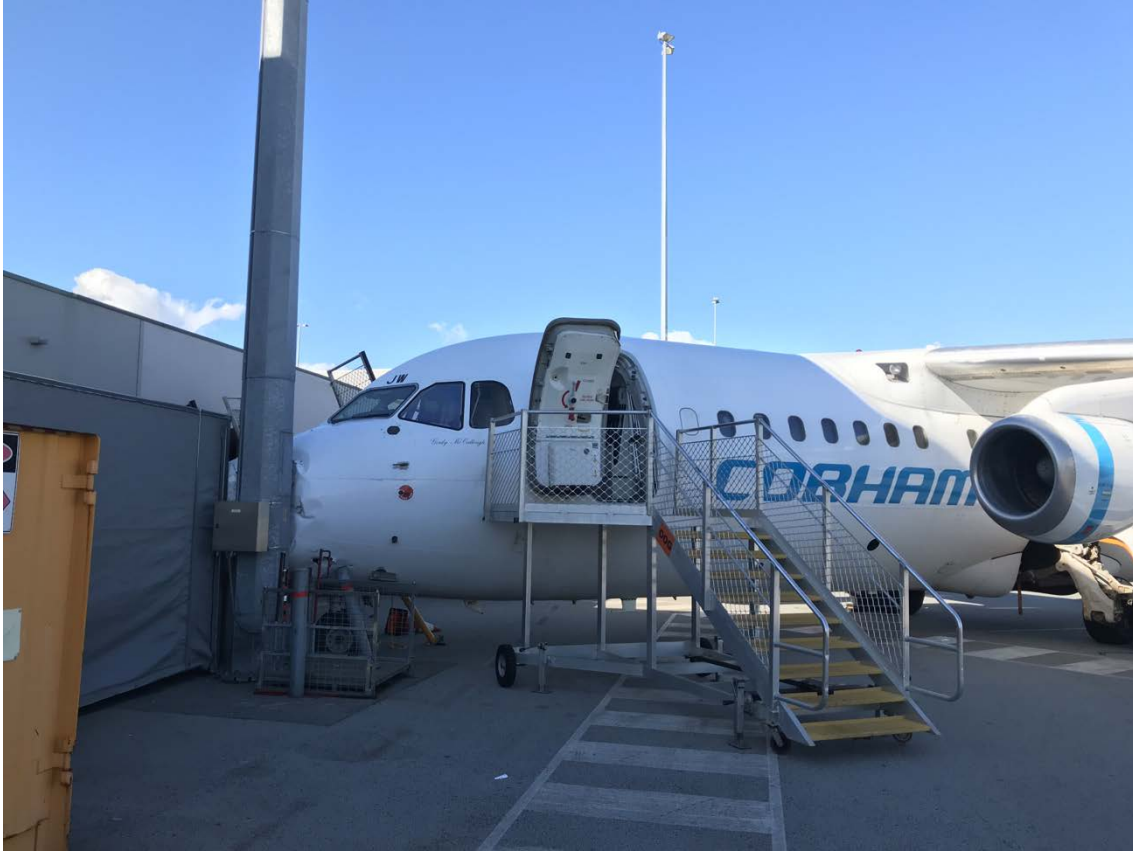
The aircraft was substantially damaged by the accident (see Figure 2). One cabin crew member was thrown from a standing position into a door handle during the collision with the light pole, but was not injured. There were no injuries to the other crew or the passengers.

Figure 2: VH-NJW following collision with airport infrastructure
