Fractured bogie frame on coal train TM78A

Kooragang, New South Wales, on 12 December 2017

ATSB Transport Safety Report

RO-2017-018

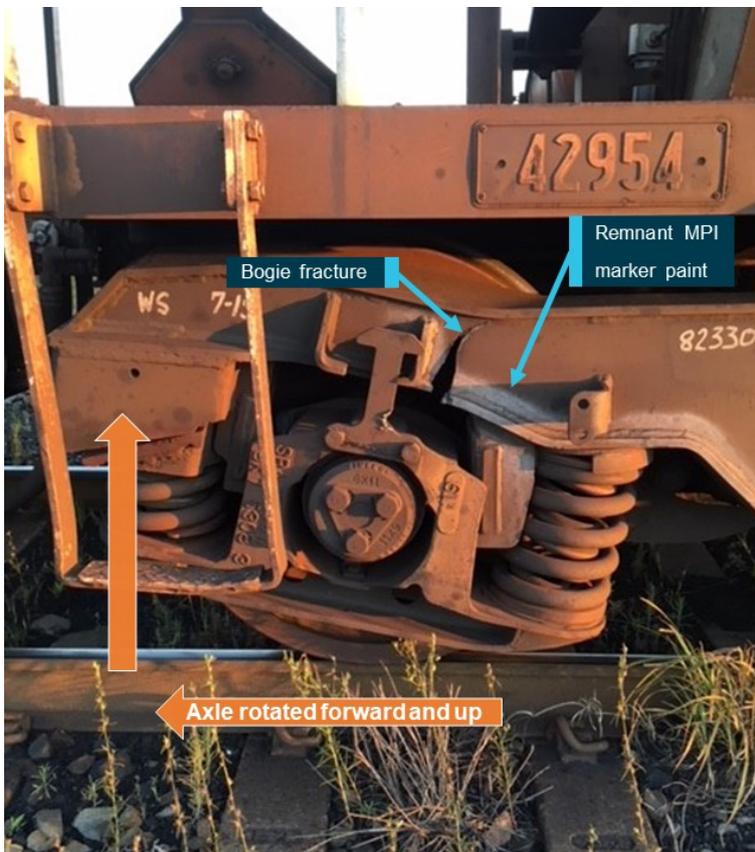
Figure 2: Fractured bogie frame NDCA 1199

The roll-by inspection completed on 12 December was completed by a single worker, with the worker positioned on the same side as the fractured bogie and the defect was identified. The axle showed signs of rotating forward and up relative to the frame as the fracture opened under the weight of the wagon (Figure 2). As the fracture opened the effective axle spacing changed, lengthening the wheelbase on the side of the cracked frame. PN maintenance standards permit roll-by inspections being completed by a single worker. The defect was detected during a roll-by inspection, however could have been missed if the worker was positioned on the opposite side.

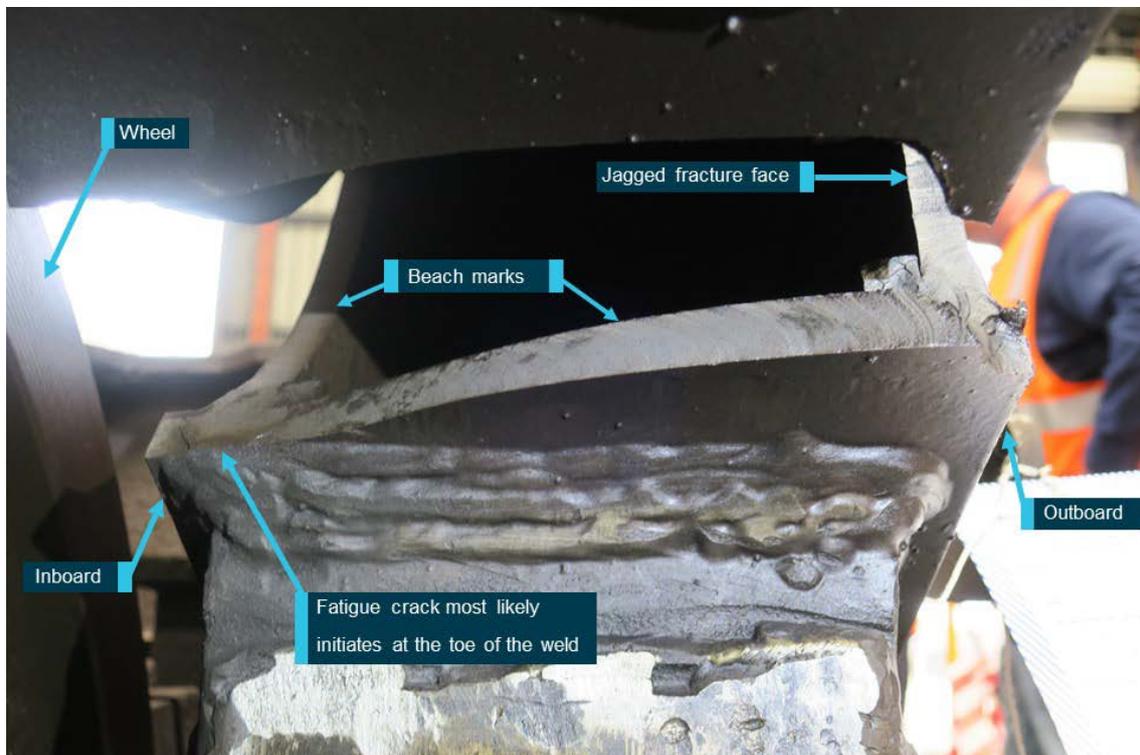
Figure 3: NDCA 1199 fracture analysis

Post-occurrence inspection of the bogie NDCA1199 showed a fatigue crack most likely initiated at the toe of the weld on the inboard corner of the bogie side frame before progressing across the lower plate and inboard vertical plate (Figure 3). The inboard fracture face was smooth and displayed beach marks (slow progression), while the outboard face was jagged in appearance indicative of rapid progression.

The image shows the bogie fracture from the underside of the bogie to show the three fracture faces.
Source: OTSI

- A fatigue crack likely originated at the toe of a weld on the inboard lower plate of the bogie frame that was not identified during the preventative maintenance activities, prior to the structural failure of the frame. The fatigue cracking most likely progressed across the full face of the lower plate and inboard side plate before rapidly progressing across the outboard side plate.

Pacific National revised maintenance standard *WMM 11-08_06 One Piece Bogie Inspection* to increase the area subjected to NDT testing during schedule overhauls. The entire side frame is now tested on the inboard and outboard plates as well as the underside of the bogie frame through the horn cheek area.
