# Derailment of XPT ST23

Wallan, Victoria on 20 February 2020

**ATSB Transport Safety Report**  
Rail Occurrence Investigation  
RO-2020-002  
Preliminary – 3 April 2020

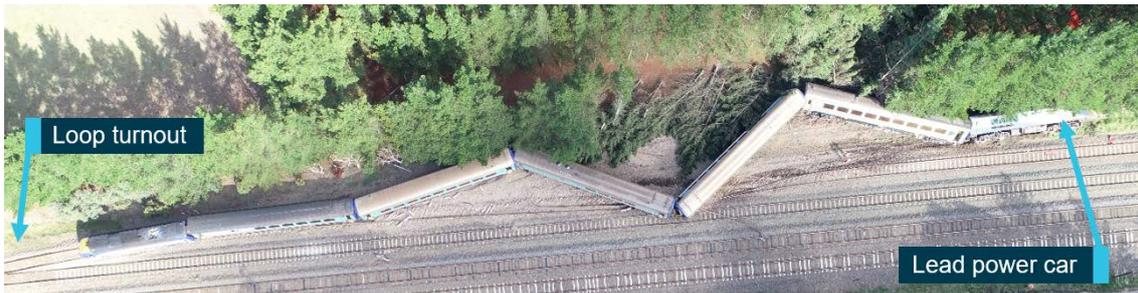
**Figure 3: Aerial photograph of derailment site**

At about 1943, XPT ST23 was approaching the northern end of Wallan Loop at about the track's line speed. Recordings from the train indicate an Emergency brake application a short distance before the points. This slowed the train a small amount before it entered the turnout travelling at a speed in excess of 100 km/h. The train was not able to negotiate the turnout to the loop track at this speed and derailed. All vehicles derailed excepting the rear power car (Figure 3).

During the derailment sequence, the leading power car rolled onto its left side and the XPT driver and the AQW sustained fatal injuries. Three passengers were seriously injured and 36 received minor injuries.<sup>16</sup> Five train crew that were in the passenger cars also sustained injuries.

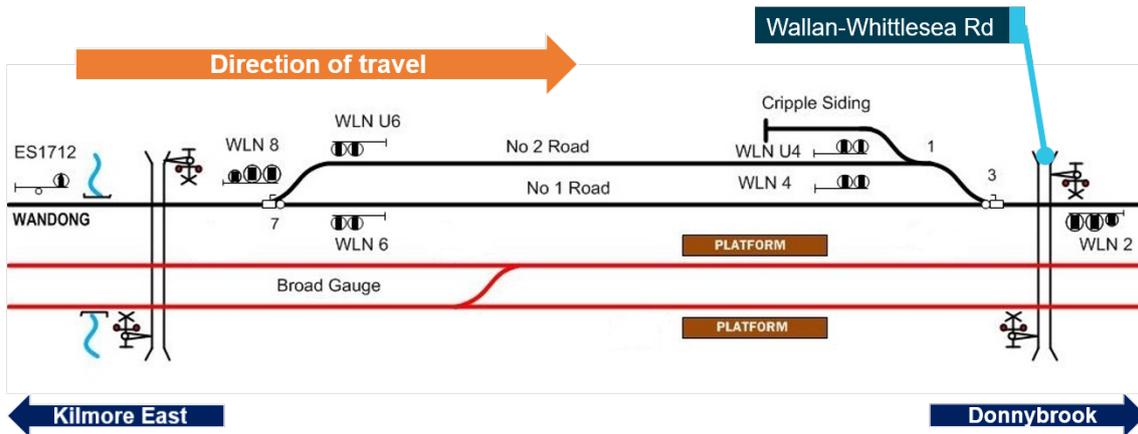
**Figure 4: Wallan Loop (standard-gauge track shown in black, with signals)**

The standard-gauge track between Kilmore East and Donnybrook was a single, bi-directional line that serviced the XPT, V/Line passenger services and rail freight. There were passing lanes at Kilmore East and Donnybrook and a 1,550 m crossing loop at Wallan. The northern entry to this loop was located about 1.8 km north of Wallan–Whittlesea Road (Figure 4).
