Australian Transport Safety Bureau

# Safety Advisory Notice

Number: AO-2020-013-SAN-001

## Rescue hoist cable failure

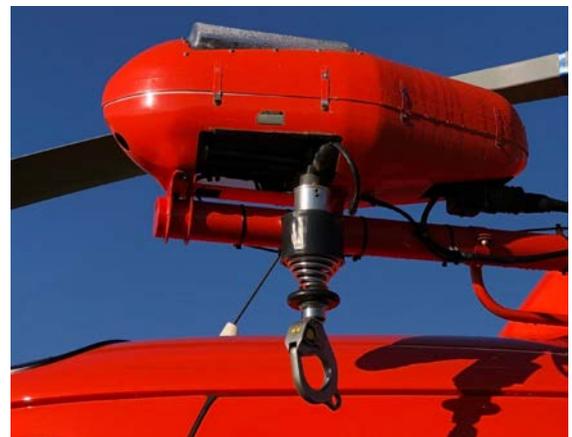
Rescue hoist and hook assembly  
(Source: NSW Parks and Wildlife Service)

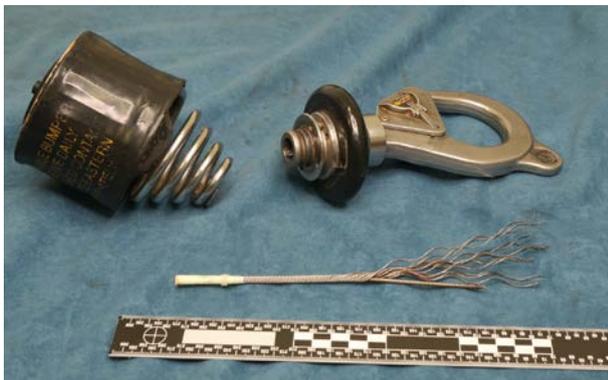
Although the investigation is ongoing, the ATSB's examination of the helicopter winch system identified that the wire rope cable failed near to the swaged ball-end that terminated into the hook assembly (see images below). Detailed technical examination identified that significant wear had occurred to the individual stainless steel wires comprising the cable, leading to reduced cross-section and an associated gross loss of tensile strength. The cable had accrued just 617 cycles of its 1,500 cycle life-limit. Examination of another rescue hoist from the operator identified similar wear damage had also occurred to that cable.

The ATSB identified that the wear associated with the cable failure probably occurred due to improper stowage of the hook assembly following hoisting operations. A hook that is not firmly seated or with the bump stop spring not sufficiently compressed can move during exposure to airframe vibrations and rotor downwash buffeting during normal helicopter operations. That movement can lead to accelerated wear of the hoist cable close to the ball-end fitting where it enters the hook assembly.

Failed cable and hook assembly from VH-UAH  
(Source: ATSB)

**AO-2020-013-SAN-001:** The ATSB advises all helicopter operators and flight crew involved in rescue hoist operations to review their current operational practices to ensure hoist operation and hook stowage are in accordance with the hoist manufacturers' published procedures.

In addition, the ATSB advises those operators, flight crew and maintainers to closely review the pre- and post-flight inspection requirements of the hook and cable assembly, along with any recurring scheduled maintenance of the hoist system, to ensure that they are completed in accordance with the manufacturers' instructions.

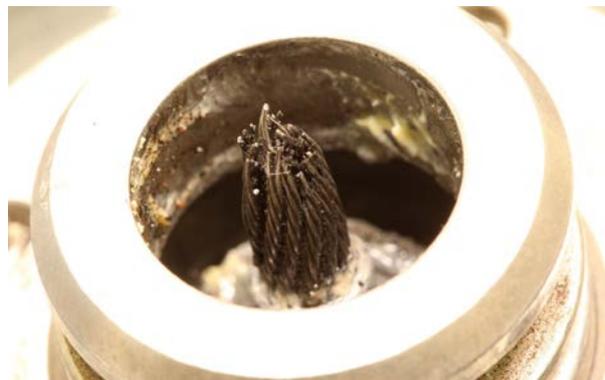
Close view of the failed cable from within hook assembly  
(Source: ATSB)

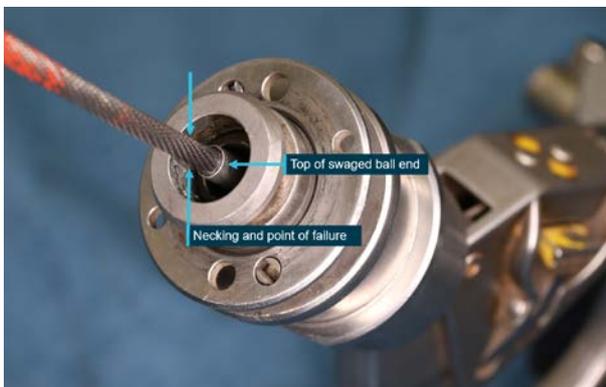
Exemplar hook assembly noting the failure location (Source: ATSB)

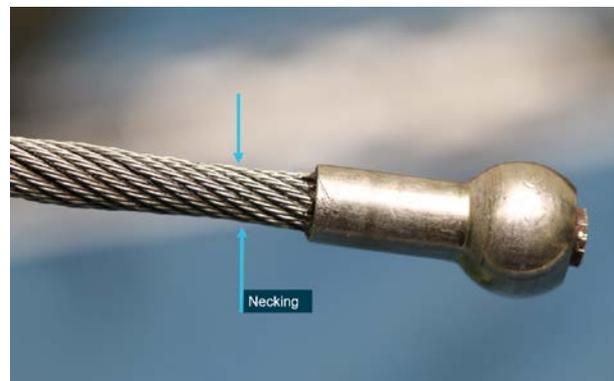
Damaged cable with necking due to wear  
(Source: ATSB)

A rescue hoist cable that exhibits ongoing loosening of the outer strands, may have accrued damage from incorrect stowage following hoist operations. If the hook assembly is not firmly seated or is noted to be incorrectly stowed, during the required post-flight inspection particular attention should be paid to the ball-end of the cable for evidence of localised thinning or necking-down, broken wires or deformed strands. Such defects can reduce the cable integrity and compromise the safety of the rescue hoist system.
