Wheels-up landing involving Beech Aircraft Corporation B200, VH-ODI

Mount Gambier Airport, South Australia, on 8 December 2018

ATSB Transport Safety Report
Aviation Occurrence Investigation
AO-2018-080
Final – 20 May 2020

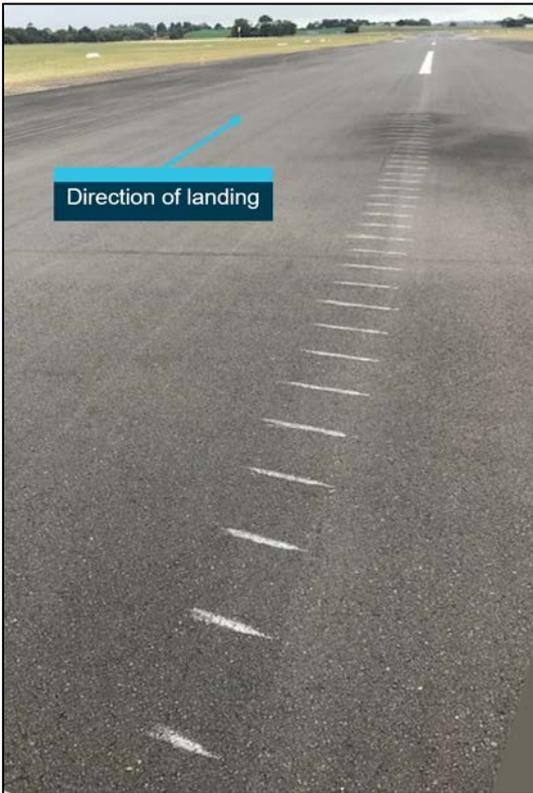
Figure 2: Left propeller strike marks

At 1222, the aircraft briefly touched down on the propellers and bounced (Figure 2). Two seconds later, the propellers again contacted the runway. The pilot, believing the landing gear was down and the aircraft had landed on the runway, twice attempted unsuccessfully to engage reverse thrust.

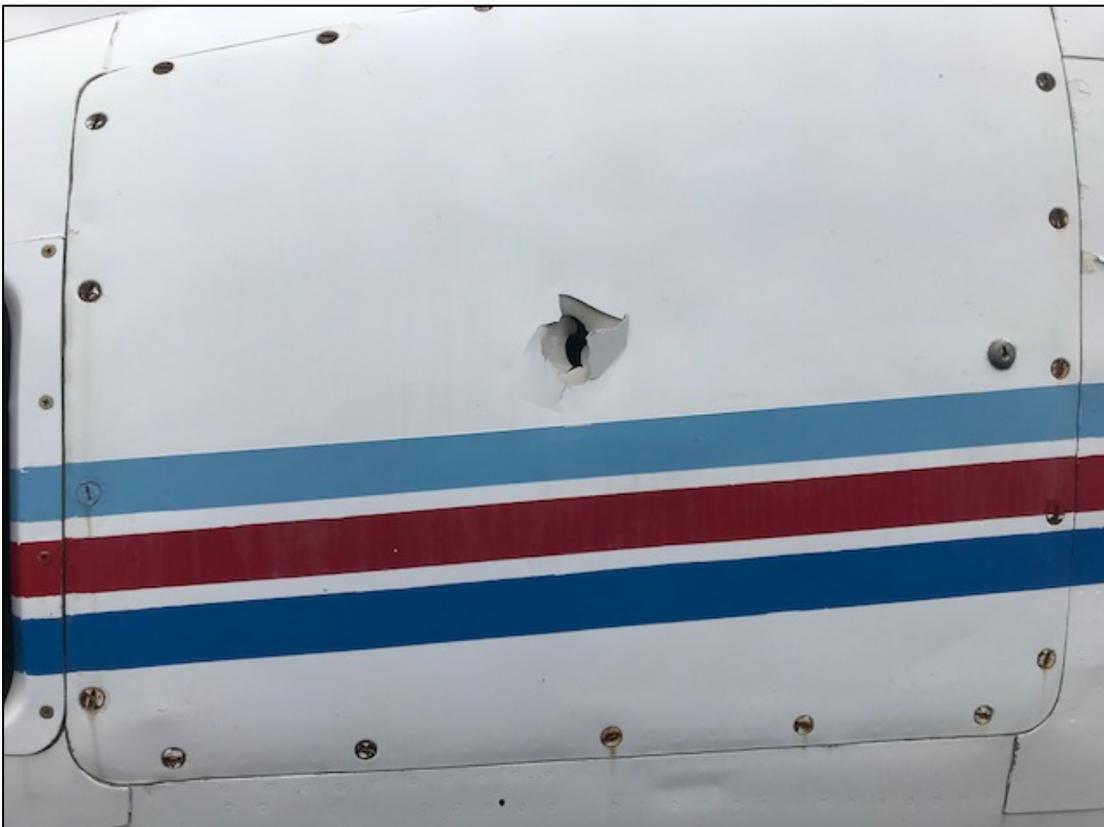
Figure 6: Forward fuselage damage

The aircraft sustained damage to both propellers, the left engine and the fuselage (Figure 6). The damage resulted in fragments of the left propeller penetrating the left side of the fuselage and a significant oil leak from the left propeller shaft (Figure 7). The damage to the left engine led to the failure of that engine upon the application of power for the go-around.

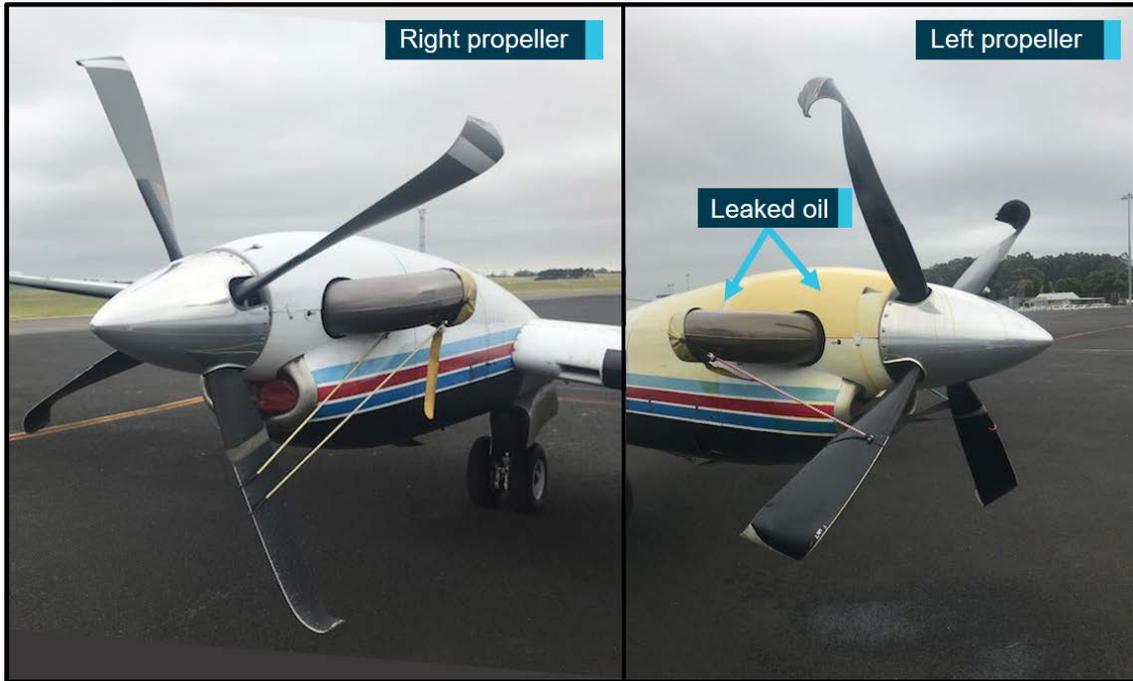
Figure 7: Propeller and engine damage

The right propeller sustained less severe damage. The pilot and observer did not detect any deterioration in performance from the right engine and were not aware of the damage to this propeller until after landing.

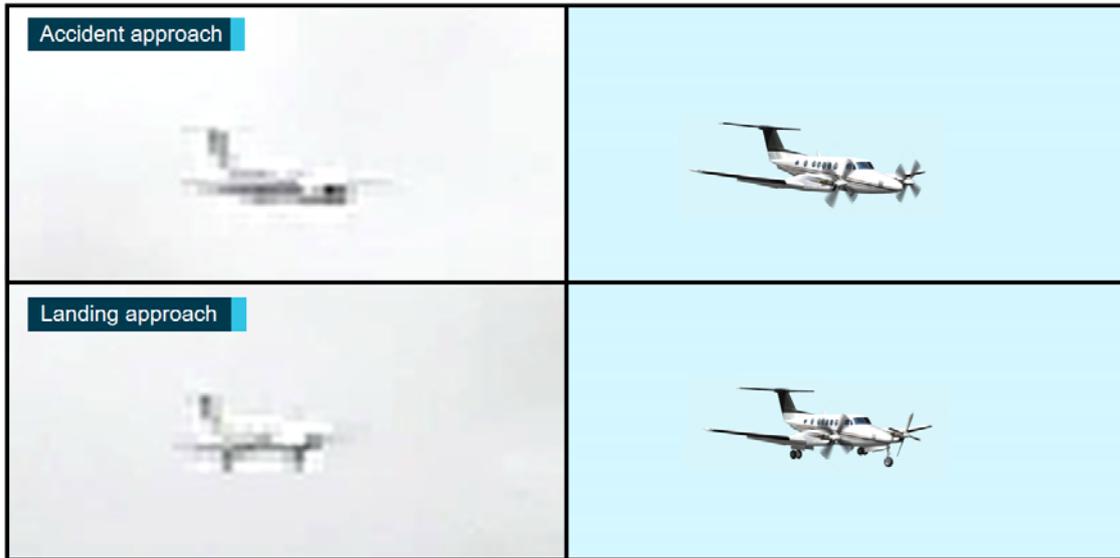
Figure 8: Mount Gambier Airport CCTV captures of ODI and representative images of a B200

The magnification of the footage led to a reduction in image quality. However, the footage showed the landing gear as dark objects beneath the aircraft during the landing approach. The dark objects were absent in the footage of the occurrence approach, consistent with the retracted landing gear.
