Loss of control and collision with terrain involving EC130 helicopter, VH-YHS

19 km south-south-east of Mansfield, Victoria, on 19 January 2019

ATSB Transport Safety Report
Aviation Occurrence Investigation
AO-2019-005
Final – 29 May 2020

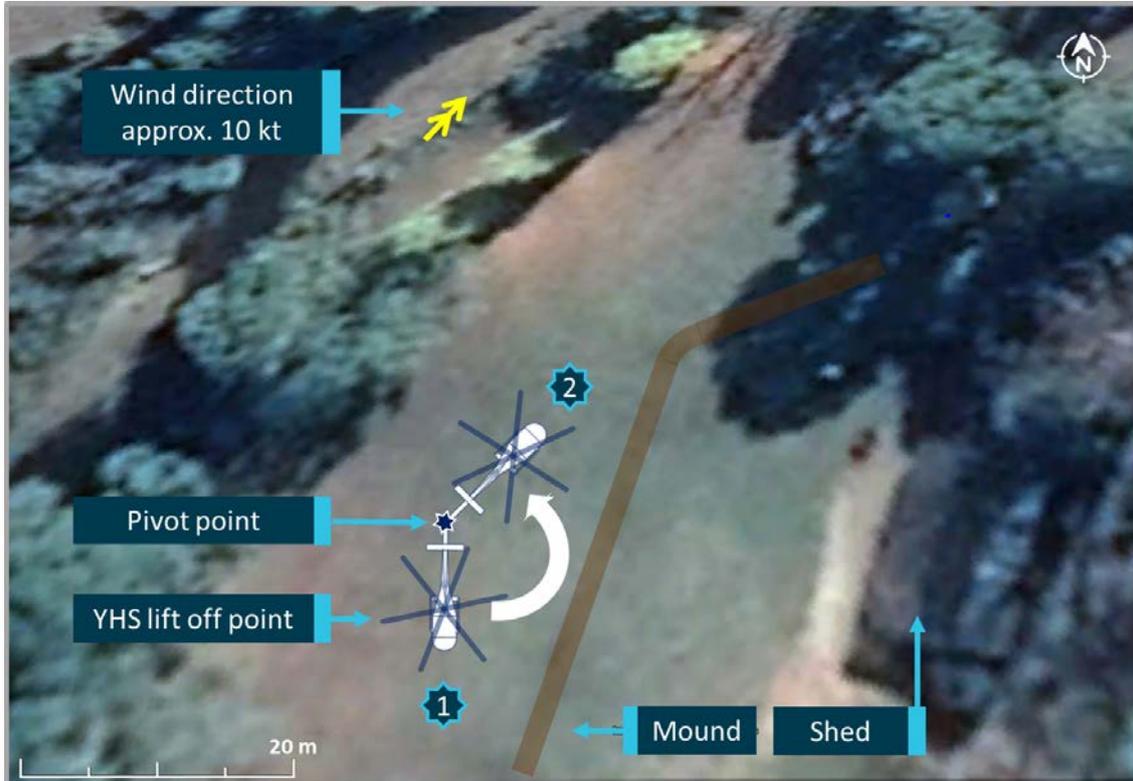
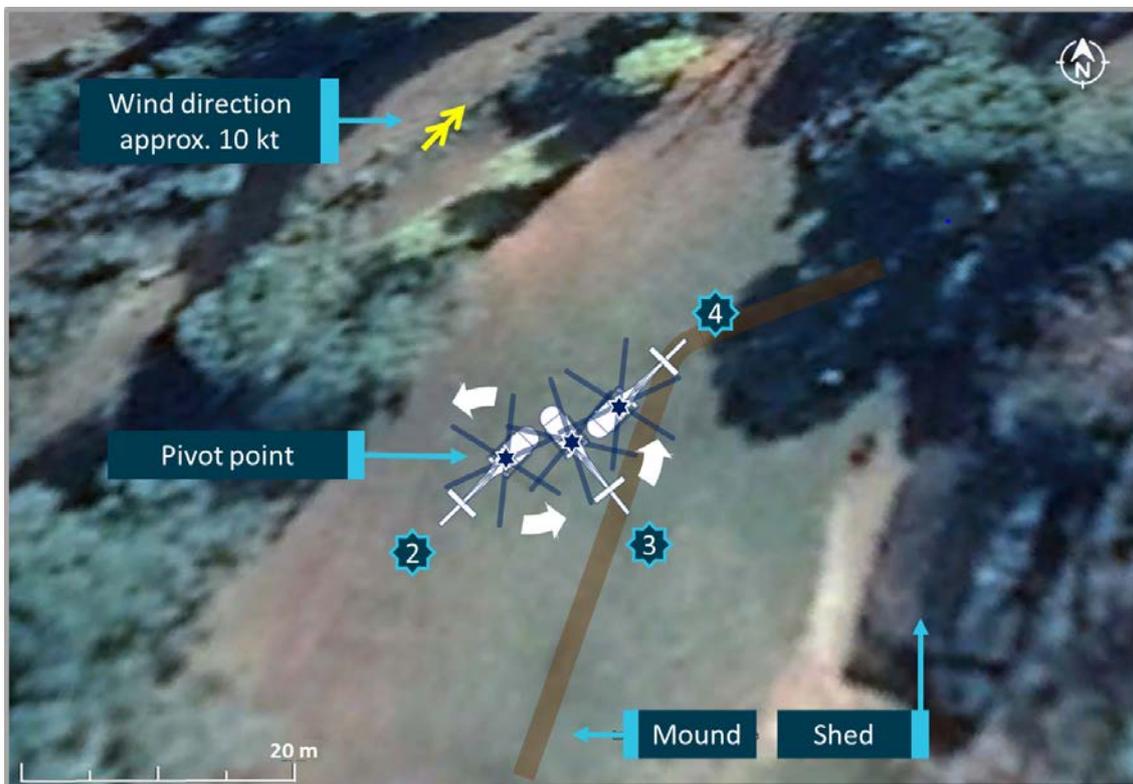
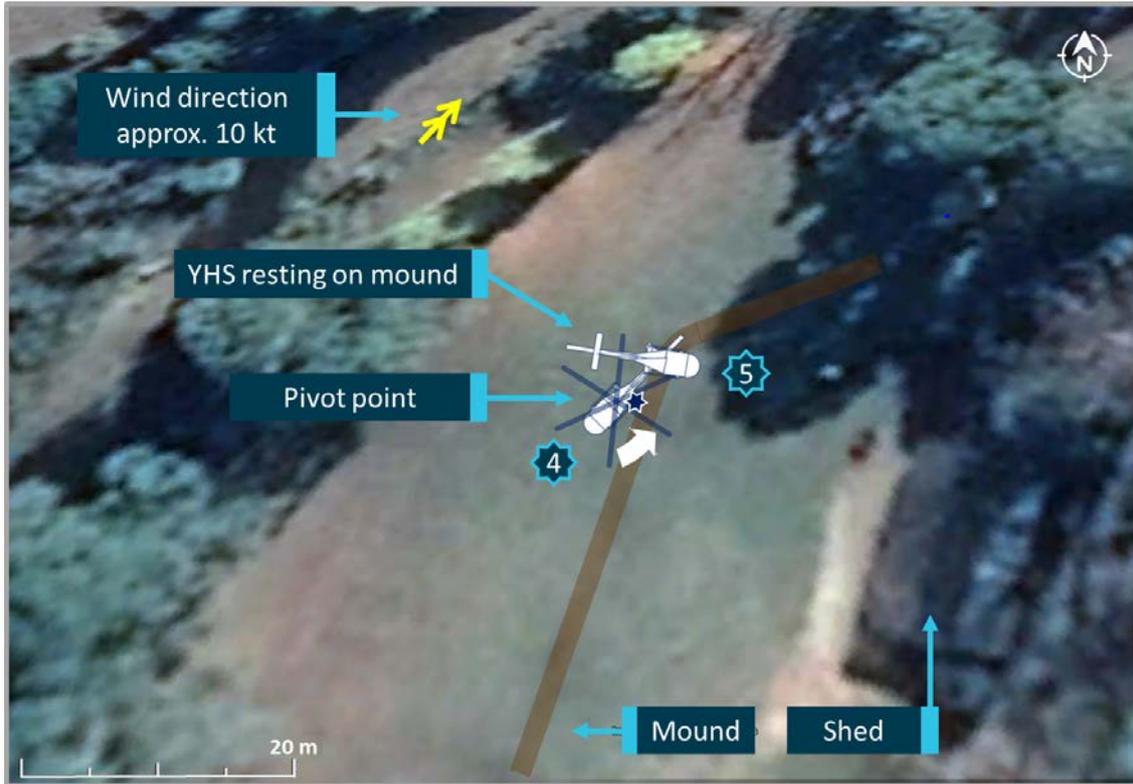
Figure 1: Accident sequence

Shortly after 1500, the pilot was again ready to take-off. He raised the helicopter off the ground, more rapidly than he normally did without getting the usual 'fine balance'⁵. At a height of about 3 m above the ground, the helicopter began to yaw to the left (turning counter-clockwise), seemingly pivoting about the tail and its attitude became progressively unstable (Figure 1, Top).

The pilot applied inputs, mainly cyclic, to control the helicopter's movement but the yaw increased. The aircraft now seemed to be pivoting about the main rotor, moving closer to the trees and shed (Figure 1, Middle). The pilot recalled that the helicopter felt 'unstable' and moved the cyclic but did not get the response he expected. In seconds, the helicopter had turned through 360° (Figure 1, Bottom). Unable to control the helicopter, the pilot decided to land and lowered the collective.

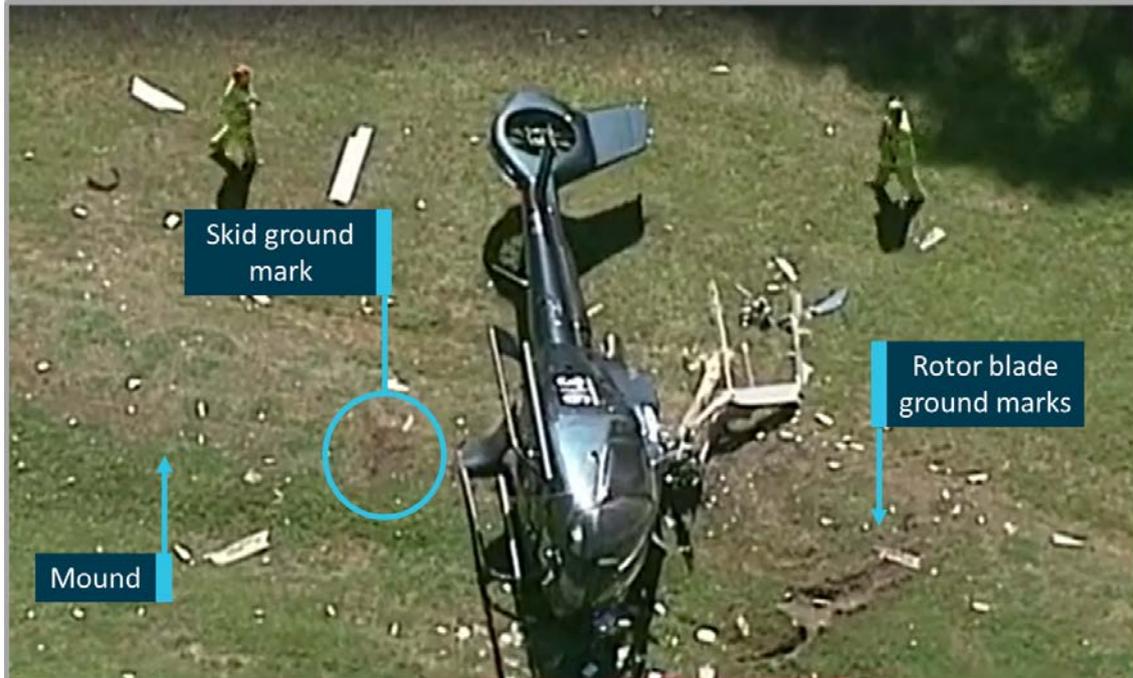
Figure 2: Accident site

As the helicopter descended, its left skid contacted the mound, resulting in the helicopter pivoting around that skid and the main rotor blades striking the ground. The helicopter came to rest on its left side, facing the shed (Figure 2). The sequence, from lift-off to ground contact, occurred over about 5 seconds.
