Signalling irregularity involving train DP41

Eagle Junction, Queensland, on 23 September 2018

ATSB Transport Safety Report

RO-2018-020

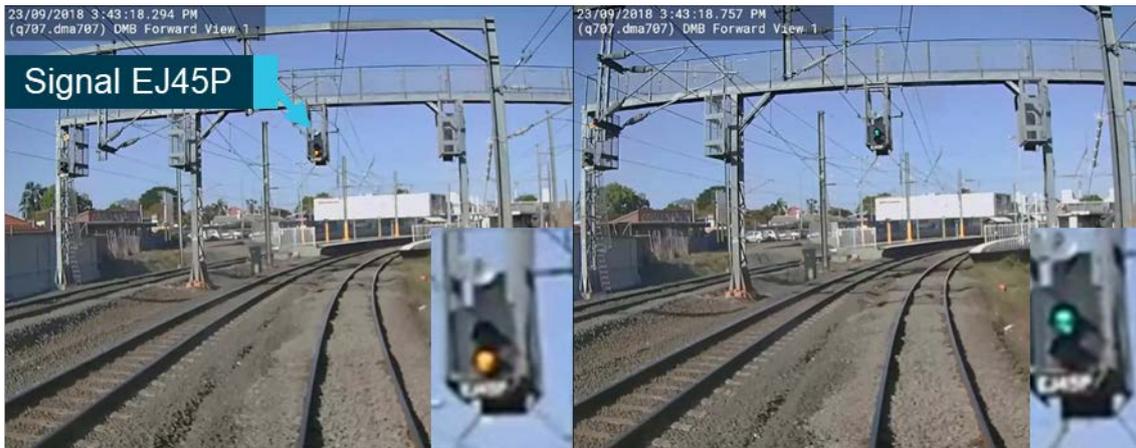
Figure 2: Train DP41 approaching Eagle Junction station with signal EJ45P

At 1543:18, train DP41 approached Eagle Junction station from the city, heading towards the airport. At that time, the train's forward facing video camera showed signal EJ45P (before the station) changing from a single yellow (proceed with caution) to green (proceed at authorised speed) (Figure 2).

Note: Signal EJ45P changing indication from yellow to green as DP41 approaches.
 Source: Queensland Rail, annotated by the ATSB

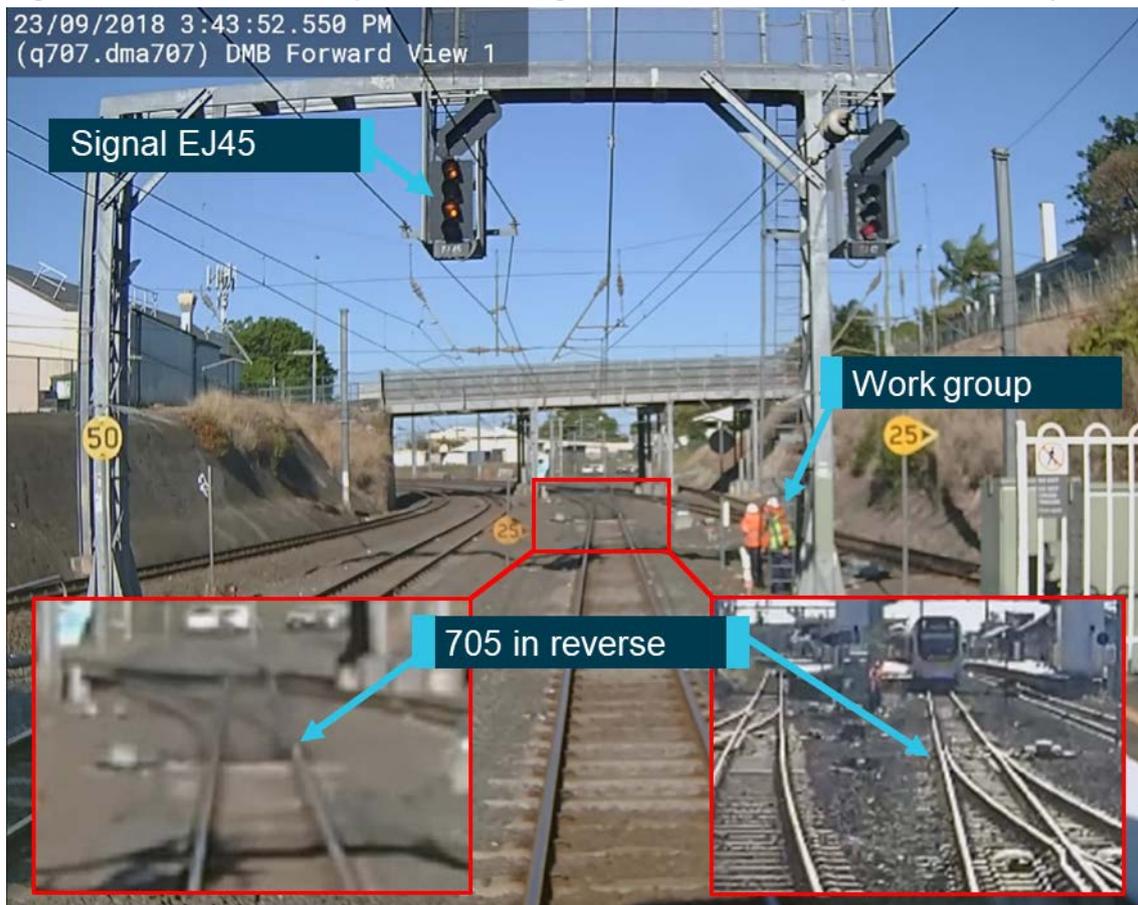
Figure 3: Train DP41 at the platform with signal EJ45 and the 705 points incorrectly set

Note: Signal EJ45 indicating double-yellow. Route indicator not illuminated indicating points are set towards the Airport Line. Signal electrician E1 with the protection officer visible on the right. The gaps between the rails show that the points are in the reverse position. Source: Queensland Rail, annotated by the ATSB

At around the same time, the signal electrician (E1) at the end of the platform noticed the irregularity between EJ45 and the 705 points set. The signal electrician visually indicated to the driver of train DP41 not to proceed. The driver contacted the NCO via radio to report the issue. The NCO directed the driver not to proceed until further instruction. The signal electrician also called for the detection to be broken at the 705C points. Train DP41 remained at the platform.

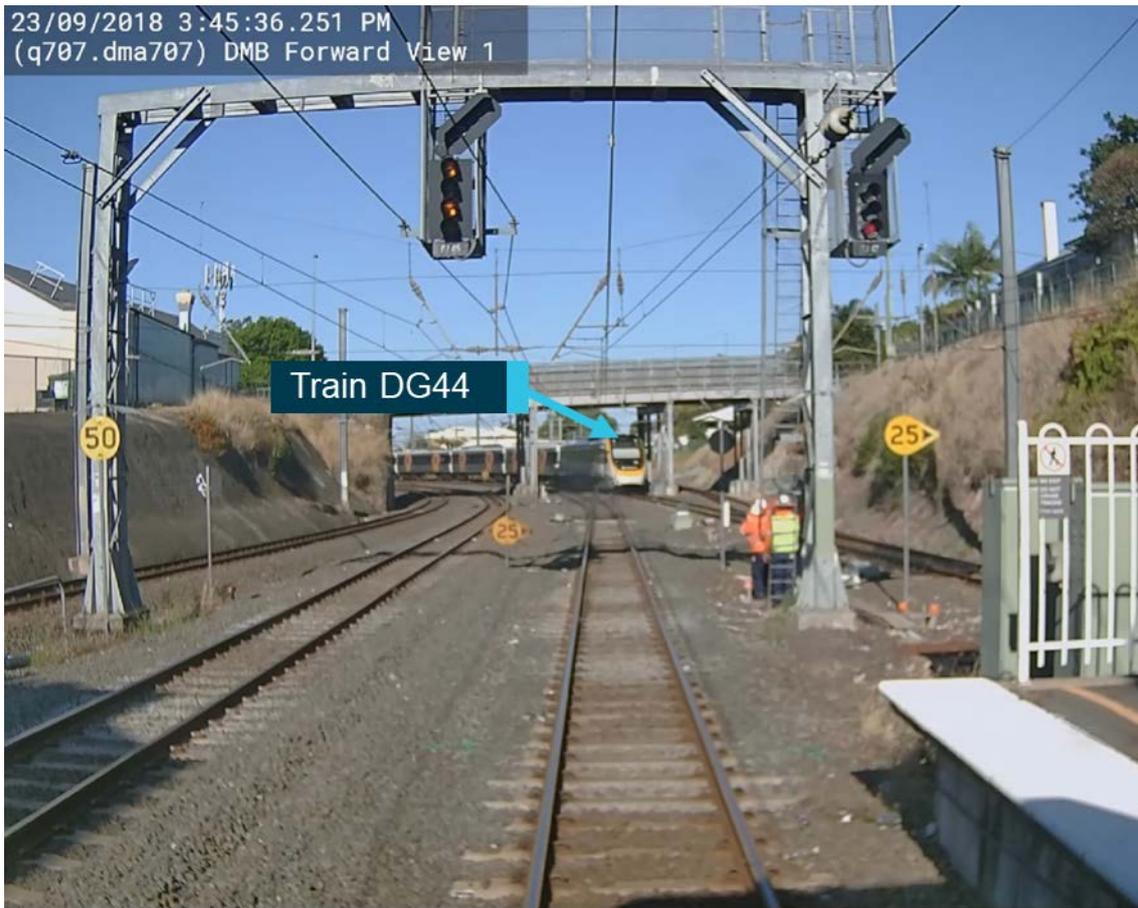
Figure 4: Train DG44 crossing the conflicting route

About 100 seconds after, train DG44 from the airport rounded the curve and approached Eagle Junction, across the conflicting route (Figure 4). The driver of DG44 overheard the conversation on the radio between the driver of DP41 and the NCO, and cautiously approached Eagle Junction platform for a scheduled stop.

As train DG44 was arriving at the platform, the signal electrician (E3) at the 705C points interrupted the detection electrical circuit, causing the 705 points set to motor to the normal position, as set by the NCO on the UTC system prior to the arrival of DP41 and DG44. As the points moved, signal EJ45 displayed a stop indication until the points were in the normal position and detected. Signal EJ45 then displayed a double yellow proceed indication, the correct indication for the configuration of the 705 points.

Note: Approaching train DG44 crossing the conflicting route.
 Source: Queensland Rail, annotated by the ATSB

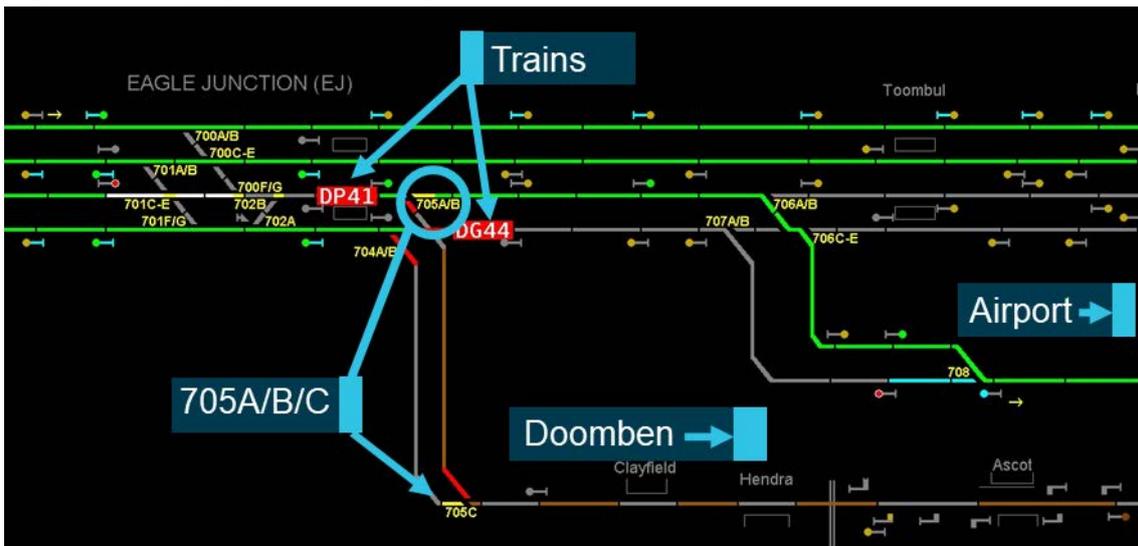
Figure 5: UTC playback of the Eagle Junction area at 1545:05

The wayside¹⁰ signalling infrastructure at Eagle Junction was remotely operated by a network control officer (NCO) located in the Mayne Control Centre at Bowen Hills. The NCO used the Queensland Rail universal train control (UTC) system to set the routes required, and place blocks on sections of the track for maintenance and other purposes, enabling the safe passage of trains throughout the NCO's assigned control area. The UTC showed a green line to represent the route set, a red line for an occupation/lock, and a yellow line when the section of track was not detected/error. Figure 5 shows a representation of what the UTC displayed when train DP41 was at the Eagle Junction platform.

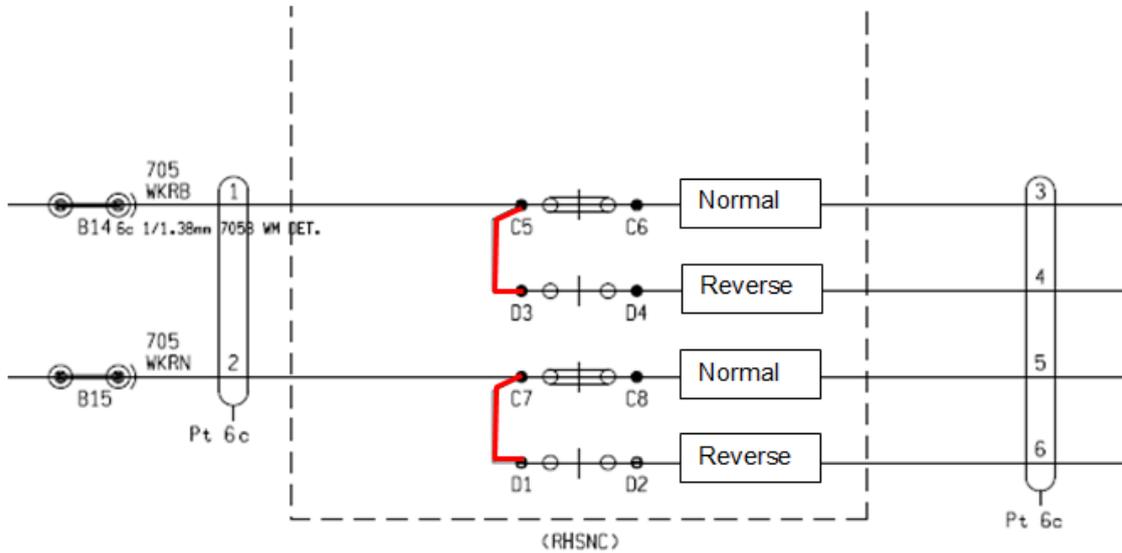
Figure 7: 705C points machine master circuit diagram

The Queensland Rail master circuit diagram (#3225) for the 705C points machine was first issued in 1999. In-line with their procedures, any changes made affecting the points was to be reflected on the circuit diagram and approved by an engineer. At the time of the incident, version four of the circuit diagram was current, dated June 2014. Variations made since initial issue were annotated on the diagram, none of which mentioned changes specifically relating to the 705C points machine. However, Queensland Rail noted that their documents only had to be retained for a period of 10 years, which meant that the reasoning behind any changes made beyond this could not be traced.

The master circuit diagram was used by the team leader to pre-wire the new 705C points machine prior to the day of installation. Figure 7 shows the way in which the new point machine was wired (in red).

Queensland Rail required the master circuit diagram to be updated and approved when changes were made to the signalling equipment. However, post-incident fault-finding established that the diagram did not reflect the existing wiring configuration of the removed 705C points machine.

While minor changes over the years were noted on the diagram, there was no reference to the wiring configuration having been altered. Therefore, as the removed machine had been functioning correctly until replacement, it was likely that, when the points were upgraded to accommodate the Airport Line, changes were made to the machine but the master circuit diagram was not updated to reflect these modifications. Since that time, maintenance had been routinely performed on the machine, however, it was likely that this did not involve comparing the in-field wiring with the master circuit diagram.

Consequently, the new 705C points machine was wired in accordance with the master circuit diagram, and a wiring error was inadvertently introduced. This resulted in the Universal Train Control and signal interlocking systems indicating the 705 points set were in the normal position, irrespective of whether they were physically in normal or reverse.

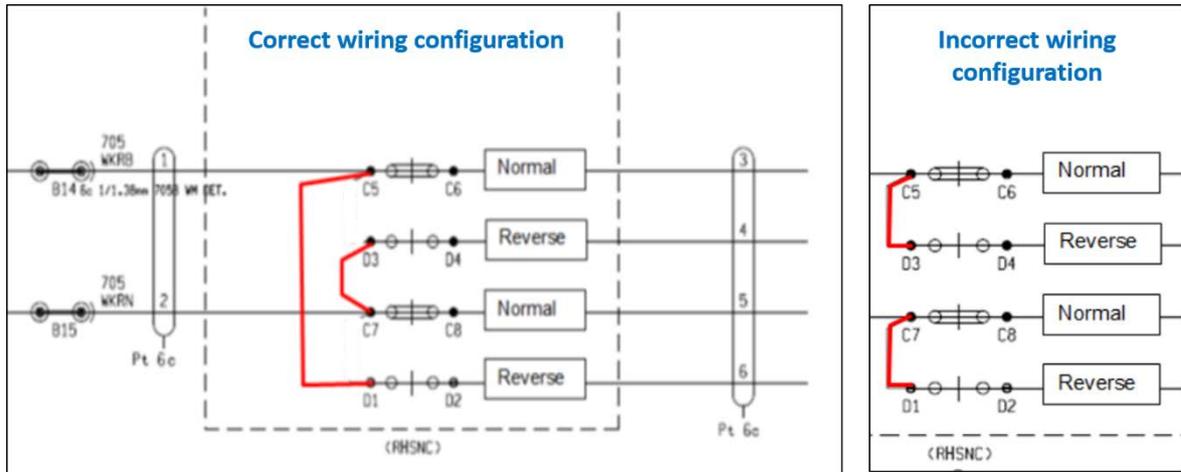
Figure 8: Comparison of the in-field equipment wiring (left) with the 705C points machine circuit diagram (right)

The signal interlocking system relies on polarity signals from in-field equipment to determine the binary condition of equipment. For example, a positive voltage would register in the signal interlocking system as a normal points position, and a negative voltage indicated a reverse points position. This information is then utilised by the system to logically determine if a proposed movement is allowed or not. However, Queensland Rail reported that the master circuit diagram for the 705C points machine was drawn in a way in which the ‘configuration essentially sets the system to understand the points are in normal whether the points are in normal or reverse’. They also concluded that, although the diagram was incorrect, the removed points machine had been correctly configured and had worked as expected without fault.

Figure 8 (left) represents what the in-field wiring (in red) would have looked like before the 705C point machine was removed. This circuit also represents the change that was later approved following the incident. For comparison, the incorrect wiring configuration from the master circuit diagram is shown on the right.

Queensland Rail indicated that, the configurations shown above (Figure 8) were both correct ways for wiring a points machine. However, only one of these was applicable to the set-up at Eagle Junction. Hence, the error in the master wiring diagram may not have been obvious to the signal electricians by visual inspection.

After identifying the error with the diagram, all further work was suspended. The NCO arranged for 705A/B points to be clipped and locked, and electrically blocked, until an independent signalling engineer could approve the necessary changes to the master circuit diagram, which occurred later that night.
