# Runway overrun involving Gippsland Aeronautics GA8, VH-BNX

Cornwell's ALA, Fraser Island, Queensland, on 2 January 2020

**ATSB Transport Safety Report**  
Aviation Occurrence Investigation  
AO-2020-001  
Final – 22 June 2020

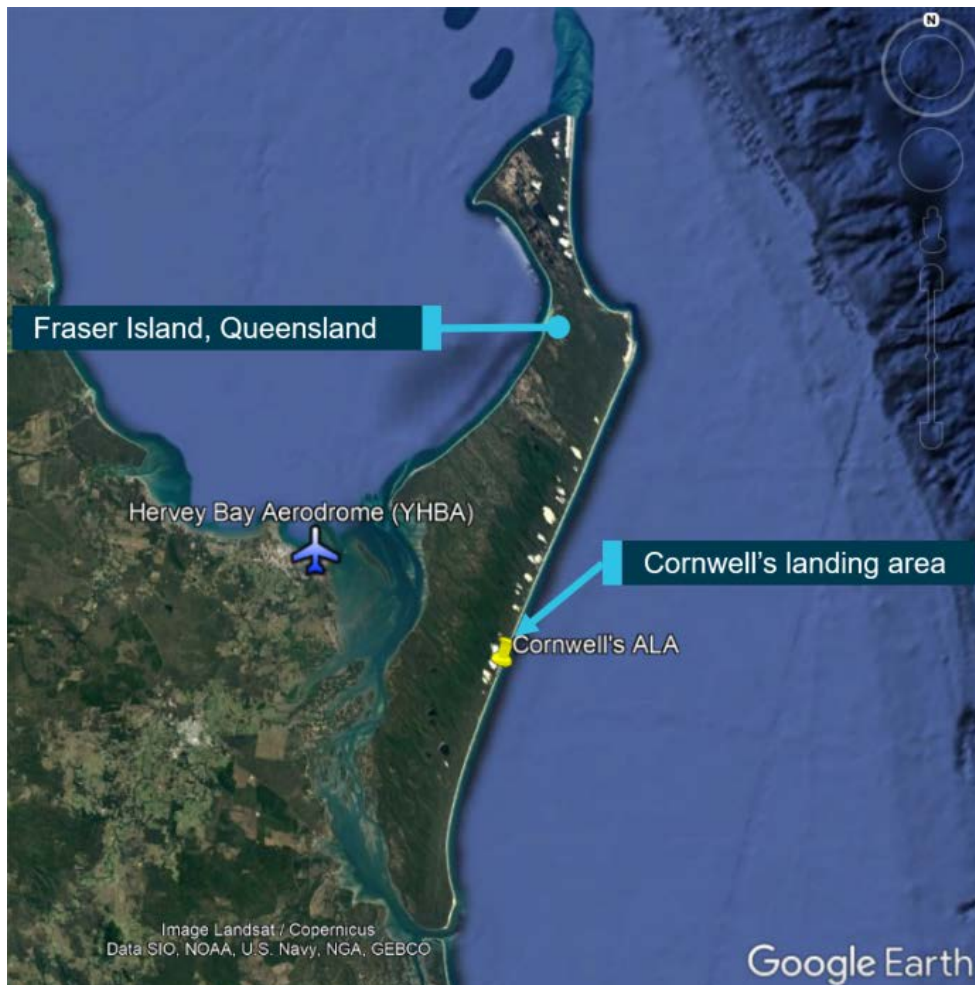
**Figure 1: Fraser Island and Cornwell's aeroplane landing area**

Cornwell's ALA was located on the east coast of Fraser Island (Figure 1). The runway, which was on the beach, was 500 m long and marked with traffic cones. The wind was 5-10 kt from the east-north-east and the beach was busy, with vehicles on the beach and campers in the sand dunes. There were also vehicles parked on the edge of the clearway, which extended 100 m either end of the runway.

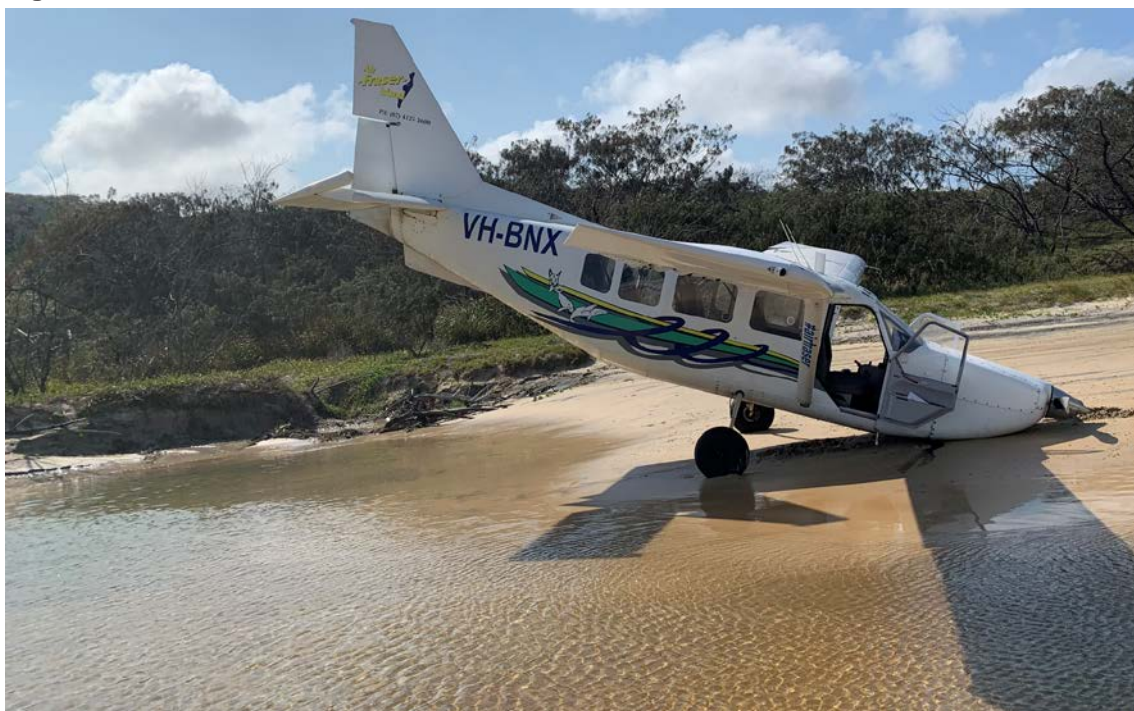
**Figure 2: VH-BNX at the accident site**

The aircraft was still at speed as it approached the end of the runway. As the aircraft overran the runway, the pilot raised the nose to get the aircraft over a washout, concerned that it would flip if the nose wheel struck the water. Immediately beyond the washout, the aircraft pitched forwards heavily onto the nose landing gear, which collapsed. The propeller struck the sand and the aircraft came to a halt (Figure 2). The video footage showed that less than 5 seconds elapsed between the landing and when the aircraft stopped.

The aircraft sustained substantial damage. There were no injuries to the pilot or passengers. The pilot and front passenger were wearing four-point harnesses and rear passengers wore over-shoulder harnesses with lap sash seatbelt. The pilot reported he had verified that everyone was wearing their seatbelts and had headsets on so he could communicate with them before commencing engine start.
