Loss of separation involving Boeing 777, registered N2333U and ATR 72, registered VH-FVQ

About 4 km north of Sydney Airport, NSW on 22 January 2020

ATSB Transport Safety Report
Aviation Occurrence Investigation
AO-2020-005
Final – 28 July 2020

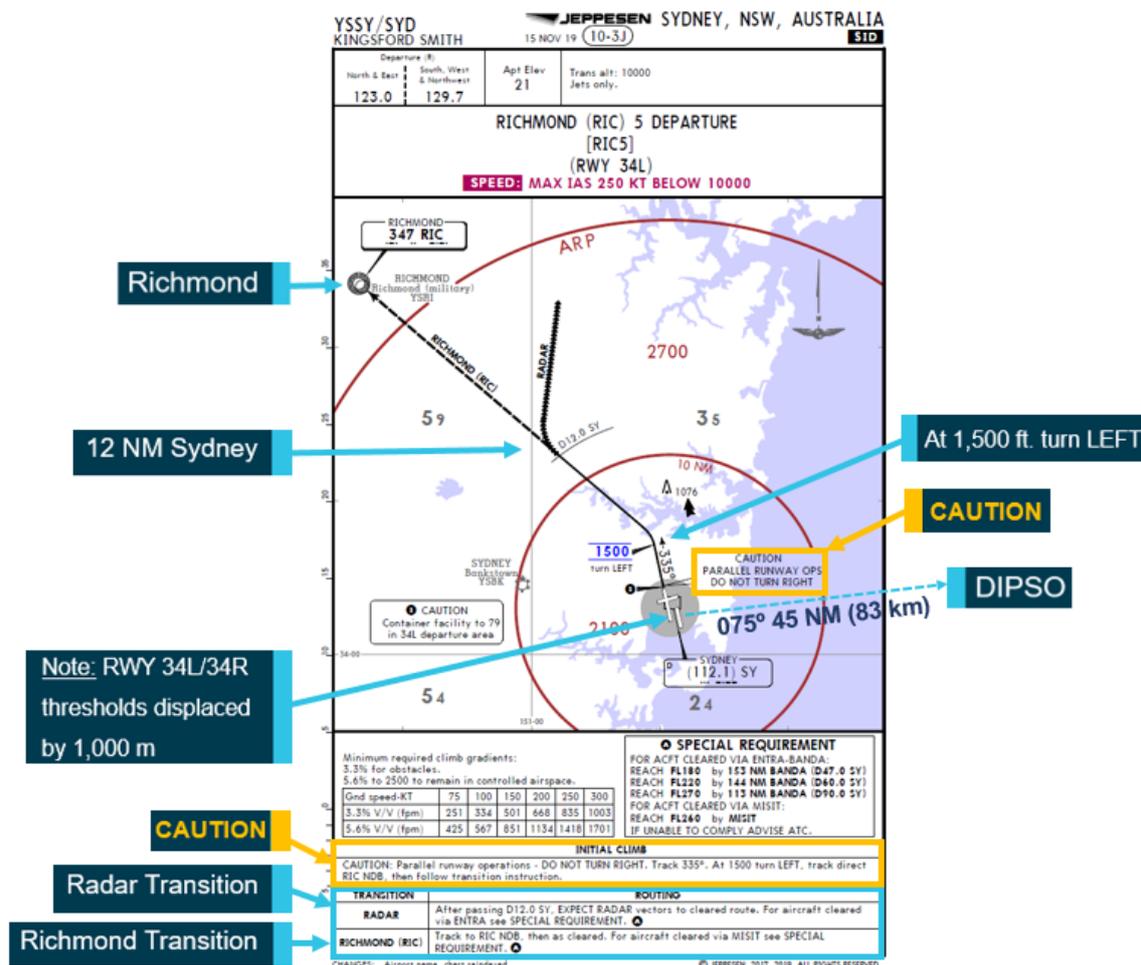
Figure 1: RICHMOND 5 Standard Instrument Departure (SID) from runway 34L

The UA870 crew reviewed the RICHMOND FIVE (RIC5) SID chart (Figure 1). That chart included two distinct caution notes about the initial climb. The more detailed caution stated:

Parallel runway operations - DO NOT TURN RIGHT. Track 335°. At 1500 [ft] turn LEFT, track direct RIC NDB [Richmond], then follow transition instruction.

The radar transition option in the FMC included a deliberate discontinuity⁹ (gap) in the waypoint¹⁰ sequence (coding). The discontinuity represented the point where air traffic control would provide radar vectors to facilitate a re-join to the oceanic track (to San Francisco) after the aircraft passed 12 NM from Sydney (see Figure 1).

At 1422:29, VOZ1153 departed runway 34R. About 35 seconds later, as VOZ1153 was climbing through 1,500 ft, UA870 departed runway 34L. (The runway 34L threshold is about 1,000 m north [ahead] of the runway 34R threshold [see Figure 1].)

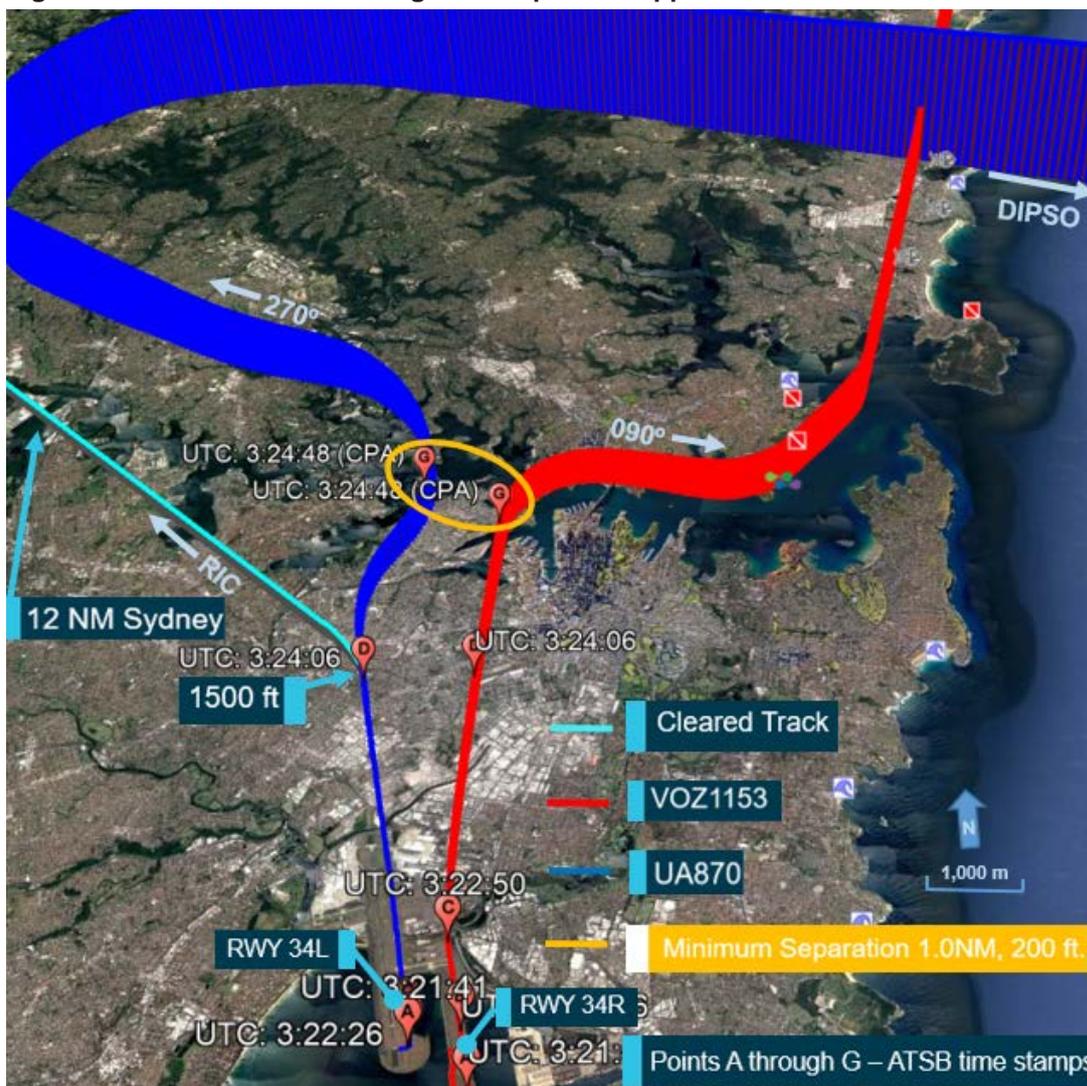
Figure 2: Aircraft tracks showing closest point of approach

Recorded flight data showed that the UA870 autopilot was disengaged about 3 seconds after the interventional instruction to UA870 was received, at an altitude of 2,160 ft. Due to the momentum of the 777, the aircraft continued turning right through a further 5 degrees to heading 018°, prior to the PF manually reversing the turn back to the left. The minimum distance between the two aircraft was 1.0 NM laterally and 200 ft vertically (Figure 2).

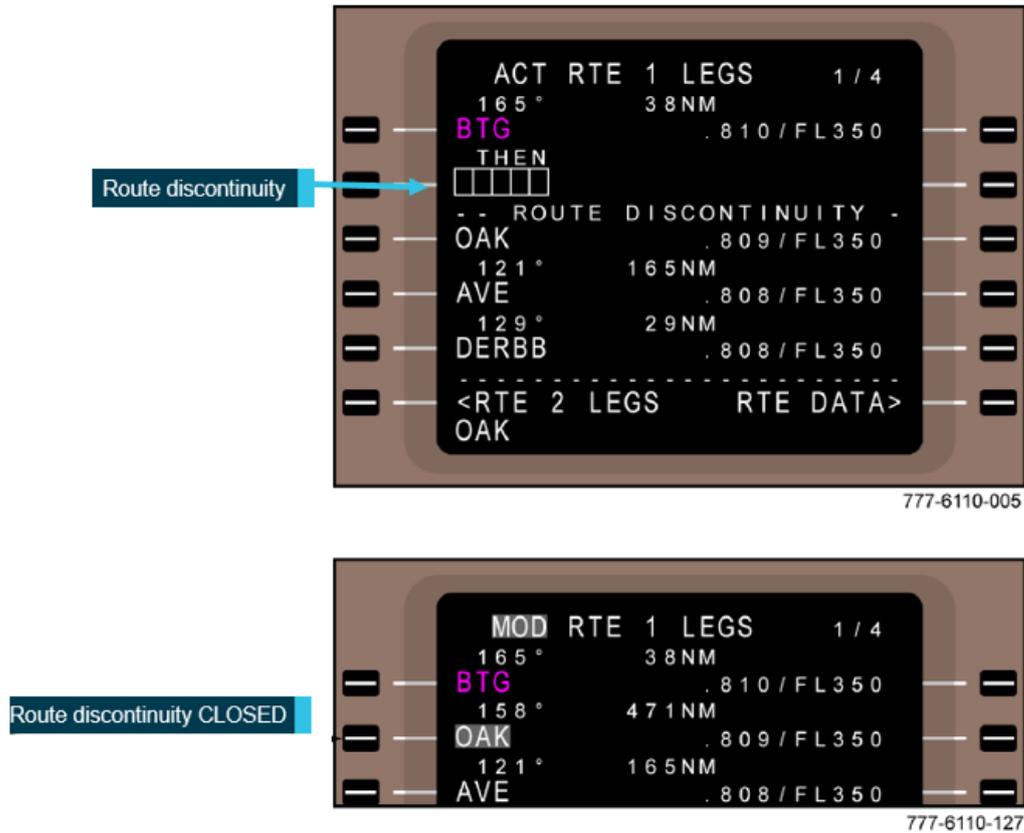
Figure 3: Example of a route discontinuity displayed via the B777 FMC LEGS page

The PF uploaded the flight plan to the FMC via satellite datalink. Procedurally, the crew (usually the PF), then manually entered the SID based on the departure clearance provided, which is contained within the FMC memory.¹⁵ The majority of procedural SIDs could then be joined to the uploaded route by removing the discontinuity created between the end waypoint defining the departure procedure and the first waypoint of the main route to their destination. This was the normal process dictated by the operator's procedures, where it was emphasised that for most departures the remaining FMC discontinuities should be rectified (removed) using the FMC legs (LEGS) page (Figure 3).

A discontinuity can be viewed by either the FMC LEGS page or route (RTE) page. The RTE page is a summary page generated displaying significant waypoints and airways (routes) that, in sequence, define the coded route the aircraft is programmed to fly via either the autopilot, if engaged or the flight director, if flying manually. The RTE page does not contain the same level of detail contained via the FMC LEGS page (Figure 3).

Do not use the RTE page to repair discontinuities resulting from SID entries. Critical changes in departure ground track may result.
