Propeller blade collar failure involving de Havilland DHC-8, VH-ZZA

Near Darwin, Northern Territory, on 3 December 2019

ATSB Transport Safety Report
Aviation Occurrence Investigation
AO-2019-074
Final – 3 September 2020

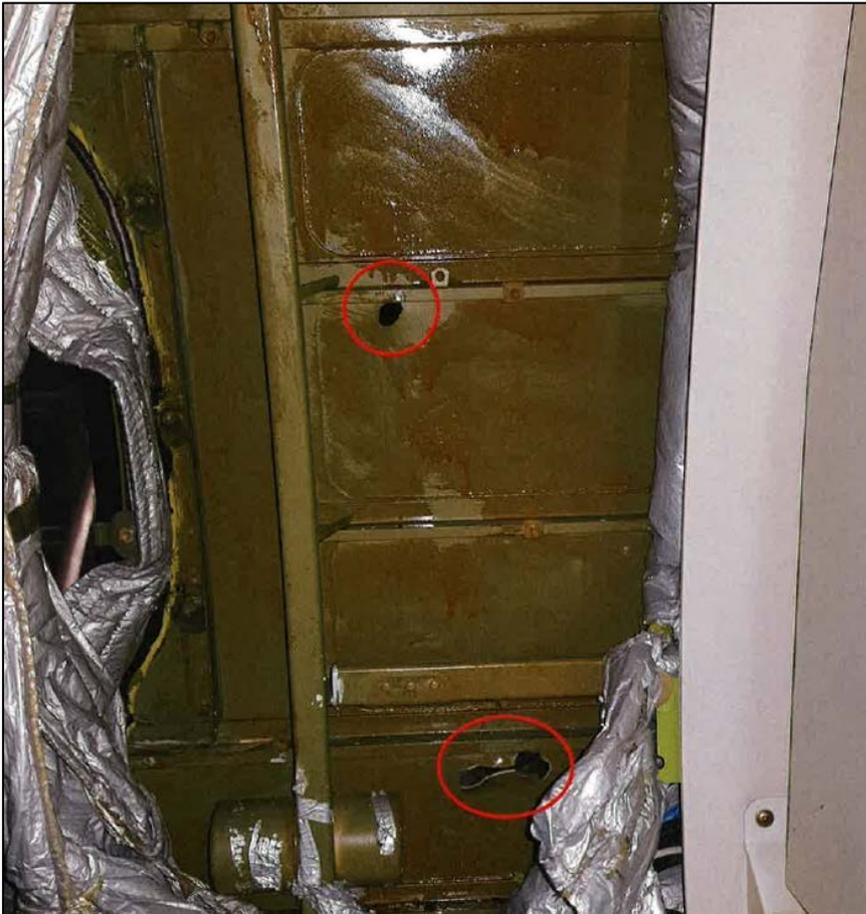
The aircraft landed without further incident, but an engineering inspection subsequently found damage to the right propeller and to the ice shield on the right side of the fuselage. Subsequent removal of the ice shield revealed that the fuselage had been penetrated in two places (Figure 1).

Figure 1: Fuselage penetration

The number 2 blade collar was the only component found missing from the aircraft during the post-flight inspection. Given that the number 1 blade was also damaged, it follows that the number 1 blade accelerated the detached collar fragments into the fuselage with sufficient force to penetrate it. This appears to be consistent with a previous occurrence, where it was determined that fragments of blade collar likely struck a propeller blade, accelerating them into the fuselage.

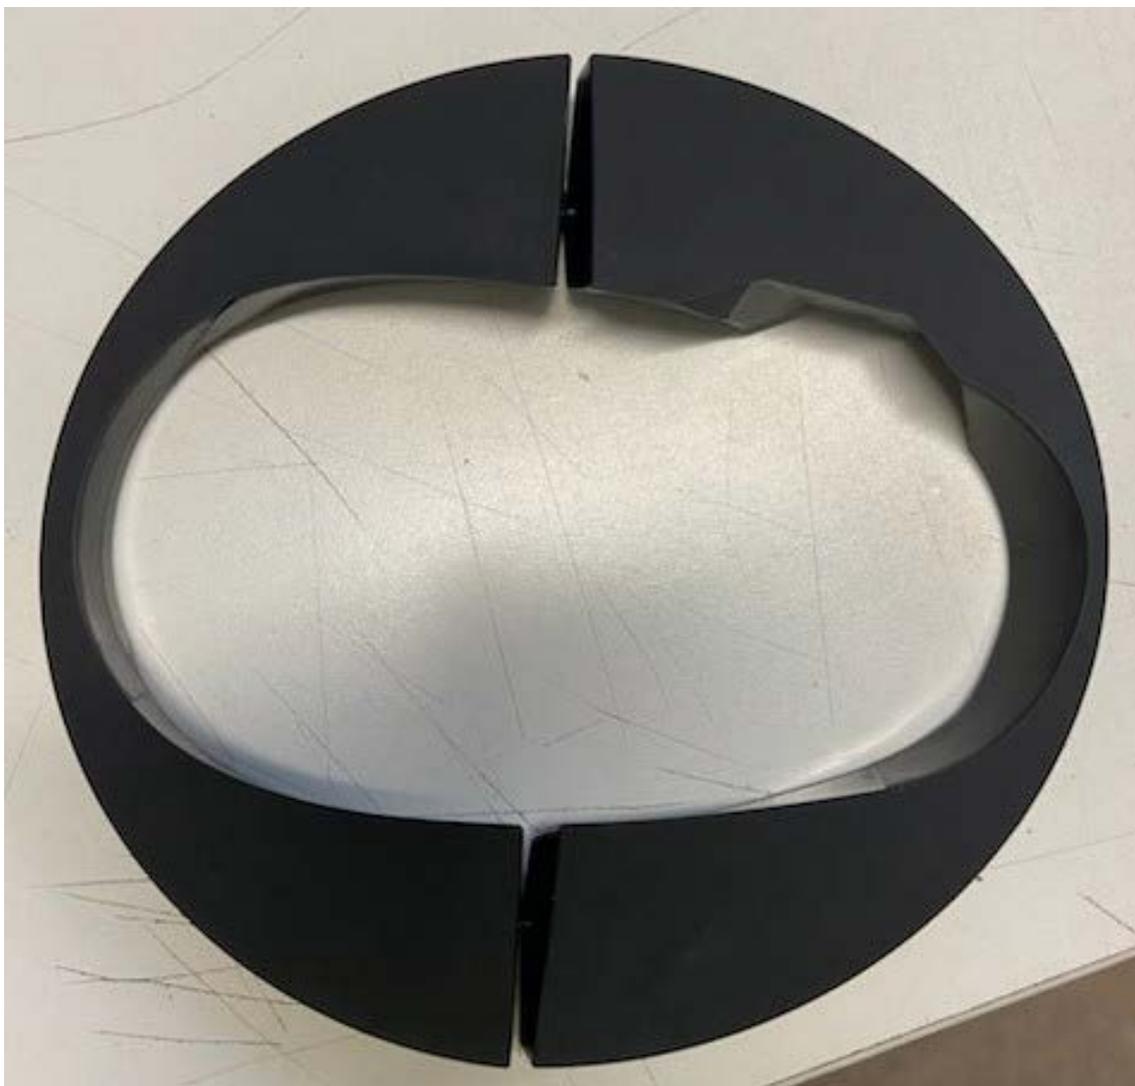
The blade collar was a plastic component fixed to each propeller blade to improve aerodynamic performance. The two halves of the collar, such as those shown in Figure 2, were screwed together and secured to the blade shank by an adhesive. The two approved adhesives for installation were RTV157 and PR-1826 Class B.

Figure 2: Blade collar halves

In 2015, the blade manufacturer, Collins Aerospace, released an updated design for the blade collar as the original design was not dimensionally stable, which prevented consistent bonding with the blade. This in turn caused a number of collars to separate from the blade shank during service. The new design was only to be installed using RTV157 adhesive.

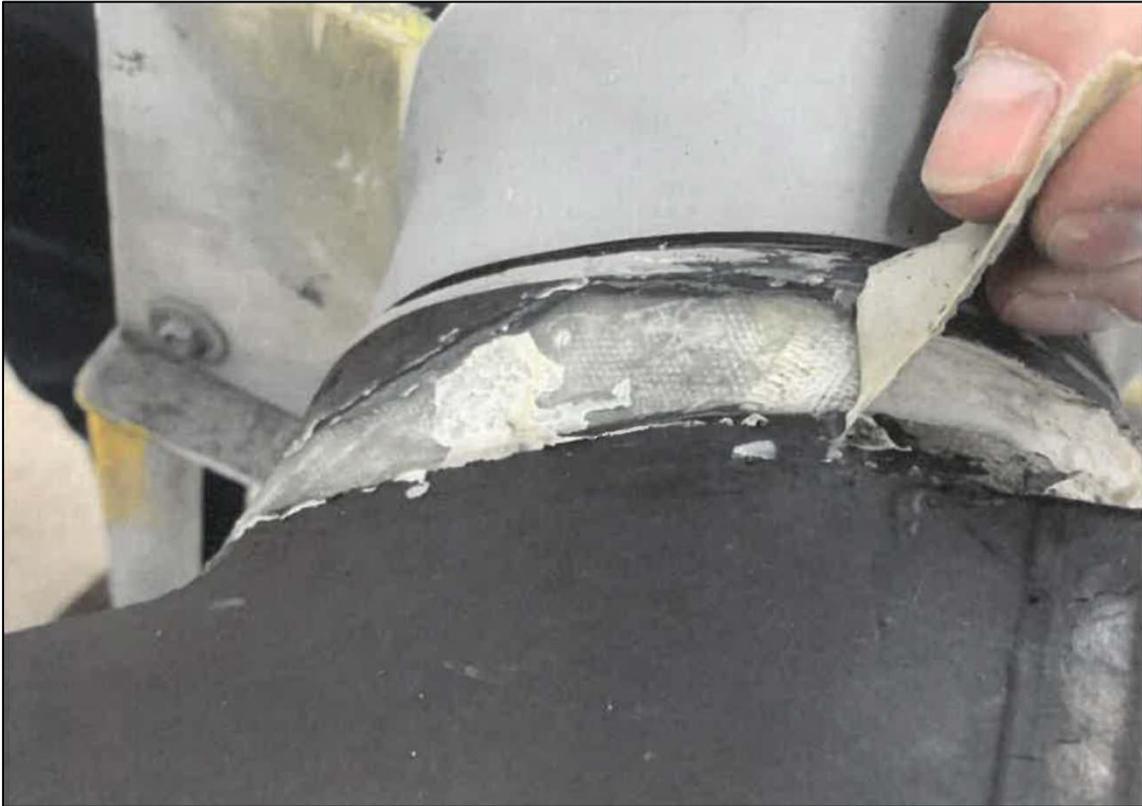
The remaining adhesive was easily peeled from the blade shank, indicating poor adhesion.

The vendor determined that this was most likely due to insufficient surface preparation/cleaning prior to adhesion. Figure 3 shows the adhesive being peeled off the number 2 blade shank where the separated collar was previously attached.

Figure 3: RTV157 adhesive being peeled off the number 2 blade shank

The adhesive remaining on the number 2 blade was not well bonded to the blade shank, likely due to problems with the preparation/cleaning of the bonding surfaces prior to adhesion. The lack of adhesion between the collar and blade shank resulted in the collar becoming loose and separating in flight. Similar problems were observed on the number 3 blade, where adhesive from a previous field repair prevented adequate bonding between the blade and collar.

As a result of this occurrence, Cobham released an engineering notice in March 2020 requiring the entire blade assembly to be replaced in the event of a loose or cracked blade collar. If a serviceable blade assembly was not available, Cobham required collars to be replaced in

consultation with the relevant Technical Services Engineer, and emphasised that all preparation instructions from the component maintenance manual were to be observed during the repair.
