Level crossing irregularity involving passenger train 3MA8

North Geelong, Victoria, on 8 January 2019

Rail Occurrence Investigation

RO-2019-002

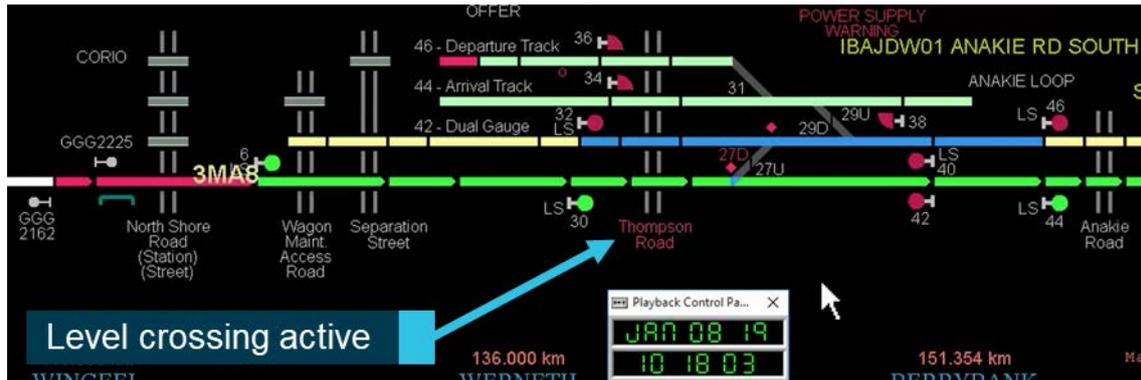
Figure 1: Phoenix replay of the Thompson Road level crossing alarm

At about 1048, after applying the jumper cables, the tester verified that the level crossing was functioning by activating the local push-button.⁸ Upon verification, the team left and made their way to the next crossing at Anakie Road. The test triggered an alarm on the Phoenix control system⁹ display in the ARTC train control centre in Adelaide, South Australia. The NCO received a level crossing fault alarm, and the 'Thompson Road' text changed colour to red to indicate it had been activated (Figure 1). The NCO immediately contacted the operations coordinator¹⁰ and asked if the crossing was okay, and not affected, and would operate as normal. The operations coordinator advised the NCO that the crossing should operate as normal.

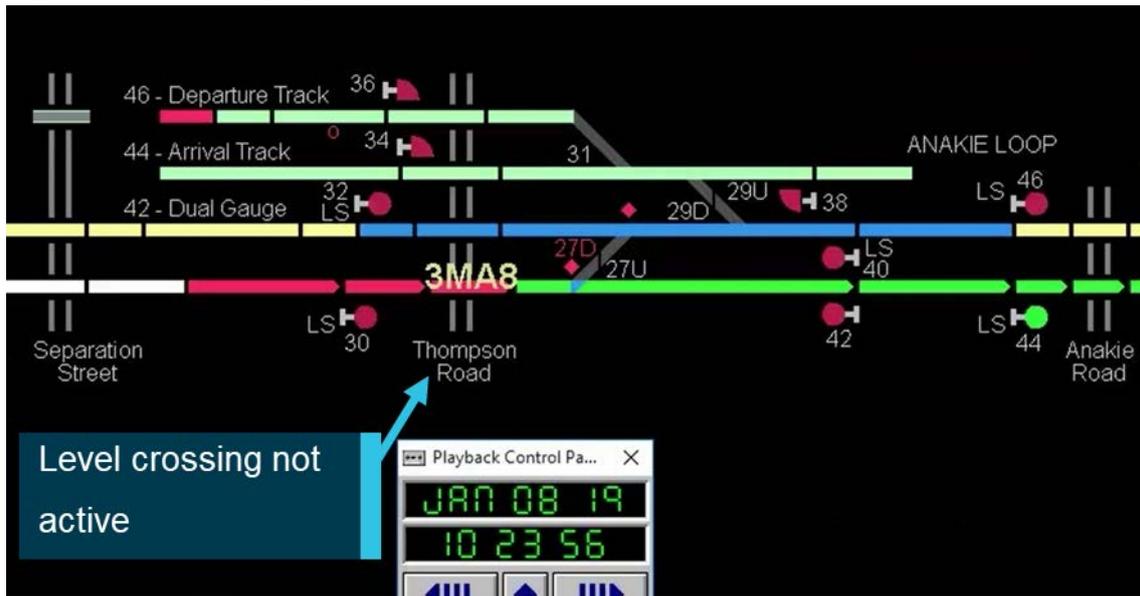
Figure 2: Phoenix replay of the occurrence

Soon after, The Overland passenger train 3MA8 was nearing the Thompson Road level crossing, operating on the ARTC standard-gauge track. The train crew had been previously made aware by the NCO that track workers were operating at the North Geelong 'C' signal box. As the train approached, the crew noticed that the level crossing lights had not activated and the boom gates had not lowered. In response, they commenced braking, reduced the throttle, and sounded the horn to alert approaching road traffic. At about 1054, the train passed through Thompson Road at a reported speed of about 50 km/h, with the level crossing protections inactive. Although there was road traffic in the vicinity of the crossing, no vehicles were in the danger zone¹¹ at the time the train passed through. The Phoenix replay (Figure 2) showed the 'Thompson Road' text white, indicating the crossing was not active as 3MA8 passed (represented by the red line).

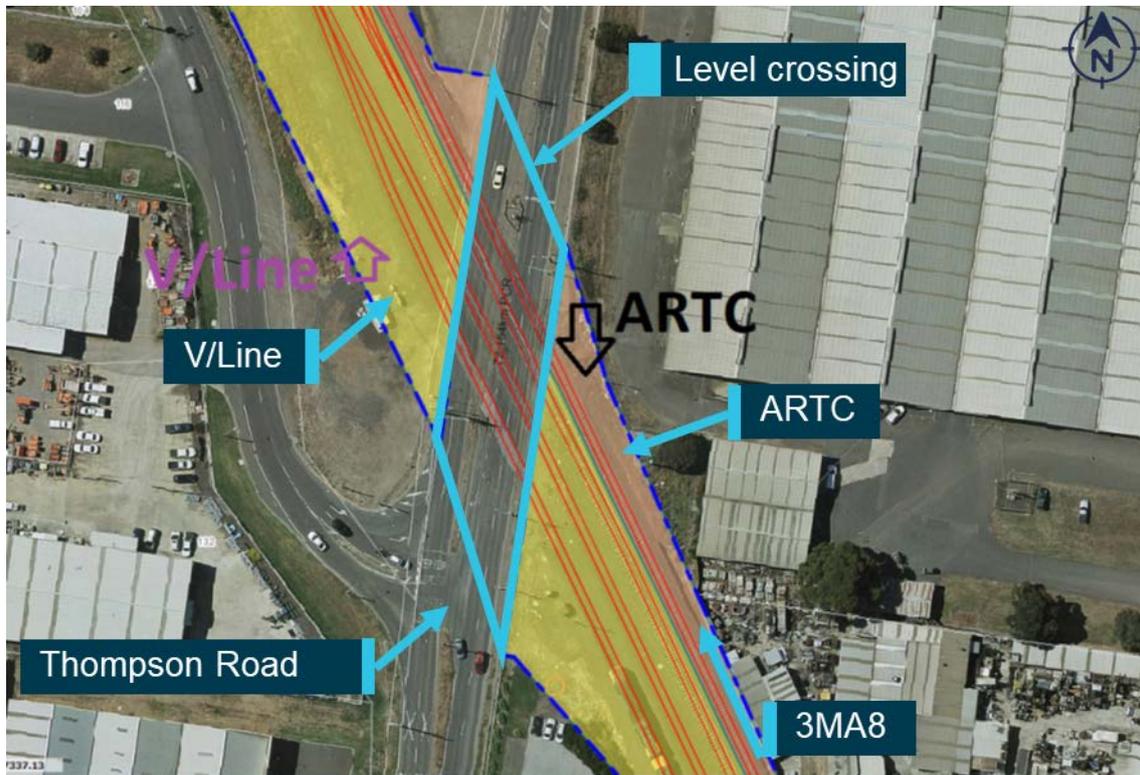
Figure 3: Aerial view of ARTC and V/Line responsibility boundaries

V/Line managed both the broad-gauge and single dual-gauge tracks (yellow shading in Figure 3), and Australian Rail Track Corporation (ARTC) managed the single standard-gauge track (red shading in Figure 3). ARTC had primary maintenance responsibility for the level crossing infrastructure.

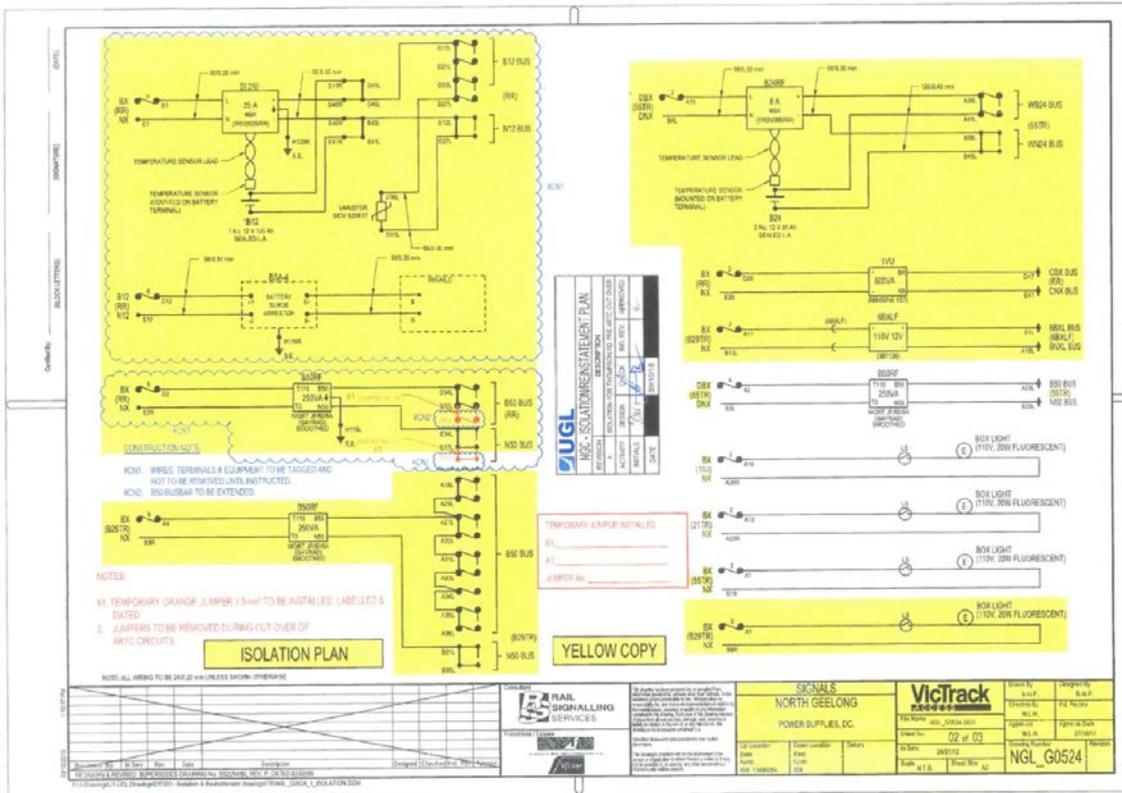
Figure 4: One of the isolation plans for the North Geelong works stage 1

The isolation plan for each location was designed by UGL, then reviewed, and approved by all stakeholders¹² before the work commenced. The plans (Figure 4) contained critical information on what circuits were to be isolated, and identified each isolation jumper cable for each circuit. While each plan was associated with a certain stage of the project (see *Planned work* above), there was no supporting instructions provided in the package specifically detailing the scope of work to be conducted at each stage, nor were the plans marked to clearly identify at which stage that plan applied to.
