Runaway of freight train wagons

Bordertown, South Australia, on 23 November 2019

ATSB Transport Safety Report

RO-2019-020

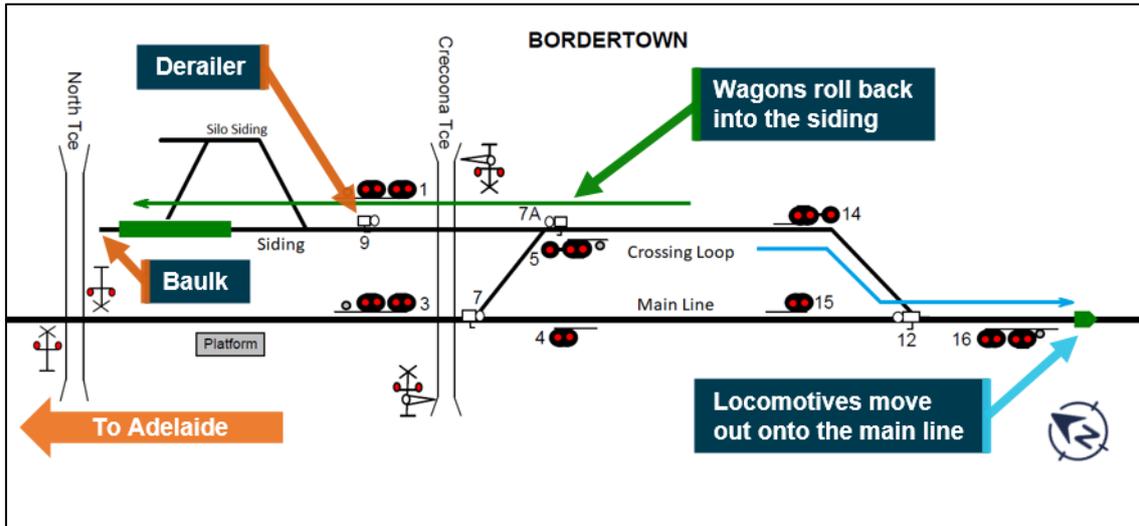
Figure 2: Unattended wagons roll back into the siding

Terrace level crossing (which operated automatically as designed). The ATSB calculated the runaway speed as having increased from about 12 km/h to about 18 km/h as the lead wagon traversed the track circuits between Signal 5 and Signal 1 (Figure 2), a distance of about 257 m (refer to Appendix A). The wagons then bounced over the derailer² and continued back into the Bordertown siding (Figure 2, green arrow). Note: Derailers are usually directional. That is, they are designed to protect the main line by derailing a runaway vehicle exiting a siding. In this case, the wagons were moving away from the main line, so were travelling in the opposite direction for which the derailer was designed and was therefore ineffective at derailing the wagons.

The locomotives start the run-around movement by moving out onto the main line (blue arrow). The unattended wagons roll back, pass over the level crossing, bounce over the derailer and continue back into the siding (green arrow). Source: ARTC, modified and annotated by ATSB for clarity.

At about the same time, the ARTC network controller had contacted Driver 1 and queried the status of train 2122S, noting that it appeared that the wagons had rolled back into the siding. Driver 1 contacted Driver 3 who advised the loaded freight wagons had rolled into the siding and come to a stop before the baulk³ at the end of the siding (Figure 2).

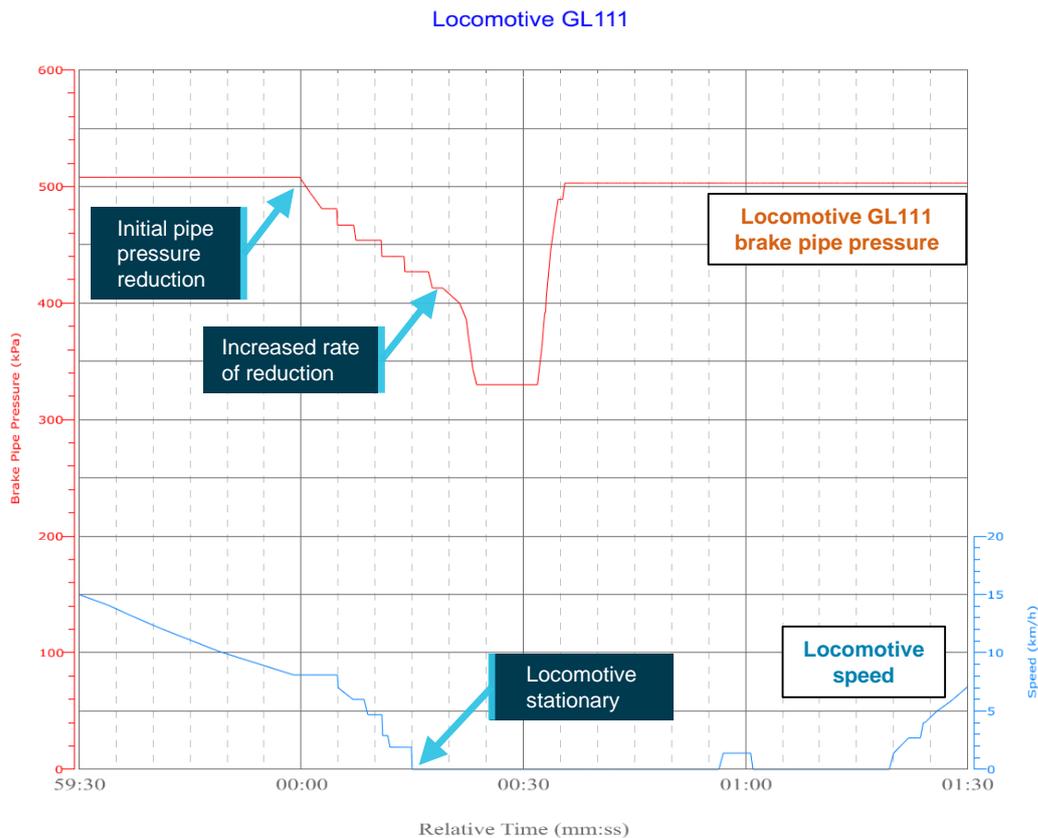
Figure 4: Locomotive data

In this case, the locomotive data log⁴ shows that when bringing train 2122S to a stop in the crossing loop, the brake pipe pressure started to reduce (aligning to time zero in Figure 4) at a constant rate for about 19 seconds (from 508 kPa to 413 kPa), until about 4 seconds after the lead locomotive had stopped (Figure 4). After this time, brake pipe pressure reduced rapidly over about 5 seconds to 330 kPa. Brake pipe pressure remained at 330 kPa for about 8 seconds before brake pipe pressure was restored to about 503 kPa (Figure 4).

Locomotive data showing initial brake application as train 2122S came to a stop. Brake pipe pressure reduces further before full pipe pressure is restored. Note that time scale is relative time from initial brake application. Source: ATSB

In this case, the locomotive data log shows that brake pipe air pressure did not reduce below 350 kPa (full brake pipe application) until about 8 seconds after the train had stopped in the crossing loop. However, 4 seconds after the lead locomotive stopped, there was a rapid reduction of pipe pressure from 413 to 330 kPa over about 5 seconds. It is possible that this was due the pipe pressure reduction being applied to a smaller volume of air, suggesting that Driver 2 had isolated the brake pipes at this point. As such, it is likely that while Driver 1 and 2 communicated with respect to verifying a full brake pipe application, Driver 2 closed the brake pipe air taps before the full service application of the train brake had propagated through to the rake of wagons. The bottled brake pipe air meant that the brake pipe air pressure was maintained at the level existing at the time the taps were closed, which was above 350 kPa. Since full service pressure had not been achieved, the wagon brakes had not fully applied.

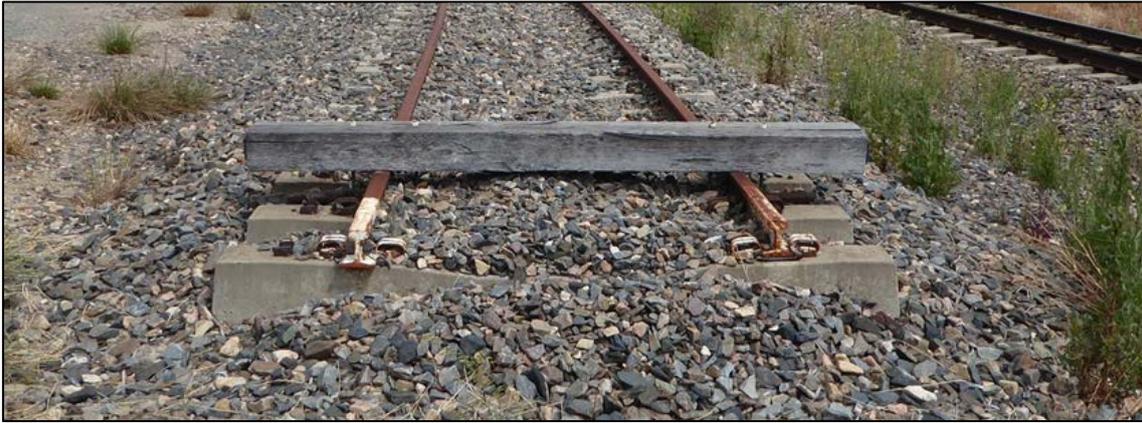
Figure 5: Bordertown siding runaway protection

The restraining device installed at Bordertown was a *Baulk*, defined in the guideline as a rectangular piece of hardwood timber of approximately 300 by 200 mm, bolted to the track (Figure 5). The guideline stated that a baulk is suitable for runaway speeds up to 1.5 km/h, is primarily just a marker that provides little resistance, and would probably require further devices to arrest a runaway.

Restraining device installed at Bordertown. A rectangular piece of hardwood timber of approximately 300 by 200 mm, bolted to the track, known as a baulk. Source: ATSB

The restraining device installed at Bordertown was a *Baulk*, specified as suitable for runaway speeds up to 1.5 km/h (ARTC guideline).

The Australian Rail Track Corporation has installed an arrestor bed on the track at the Bordertown dead end. ARTC has further works planned in October 2020 to complete the arrestor bed with a graded slope as per *ARTC ETH-00-01 Buffer Stops and Restraining Devices for Dead End Tracks – Appendix C*.

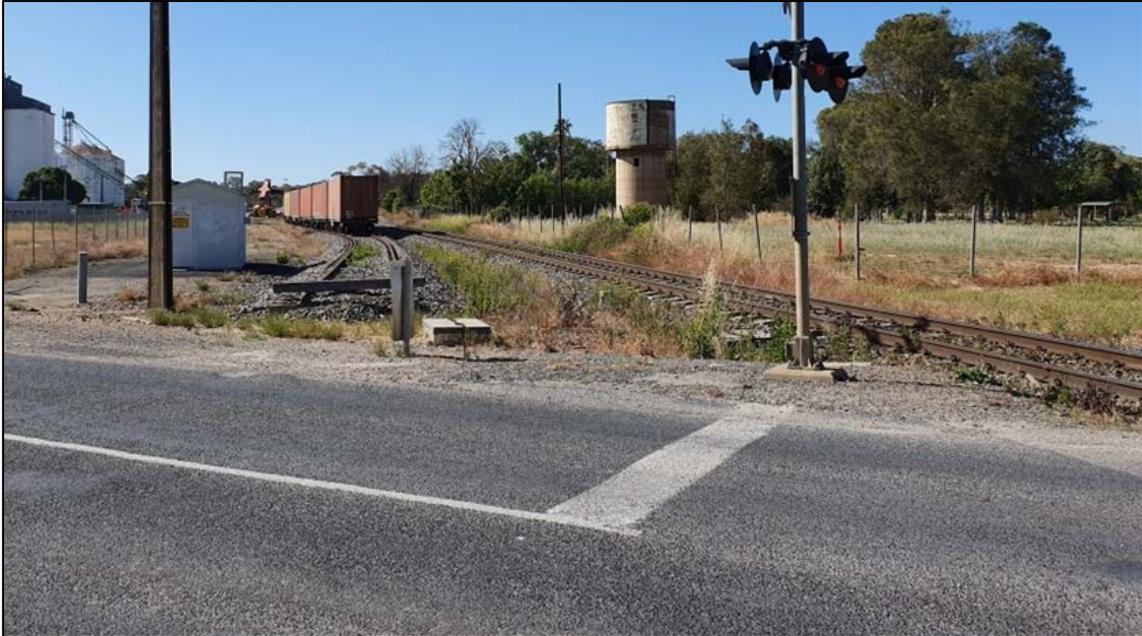
Figure 6: Bordertown siding – runaway wagons, runaway protection and level crossing

The Australian Rail Track Corporation (ARTC) guideline states that a baulk is primarily just a marker that provides little resistance, and would probably require further devices to arrest a runaway. The configuration at Bordertown was likely insufficient for restraining the potential speed

and momentum of runaway wagons, which may subsequently encroach on a road and level crossing.

Runaway wagons stopped about 40 m from the baulk. The image illustrates how wagons that might roll to the end of the track may encroach on the road and level crossing. Source: ATSB

- The restraining device installed on the Bordertown siding track prior to the road and level crossing, was likely insufficient under some conditions, for restraining the speed and momentum of runaway wagons.

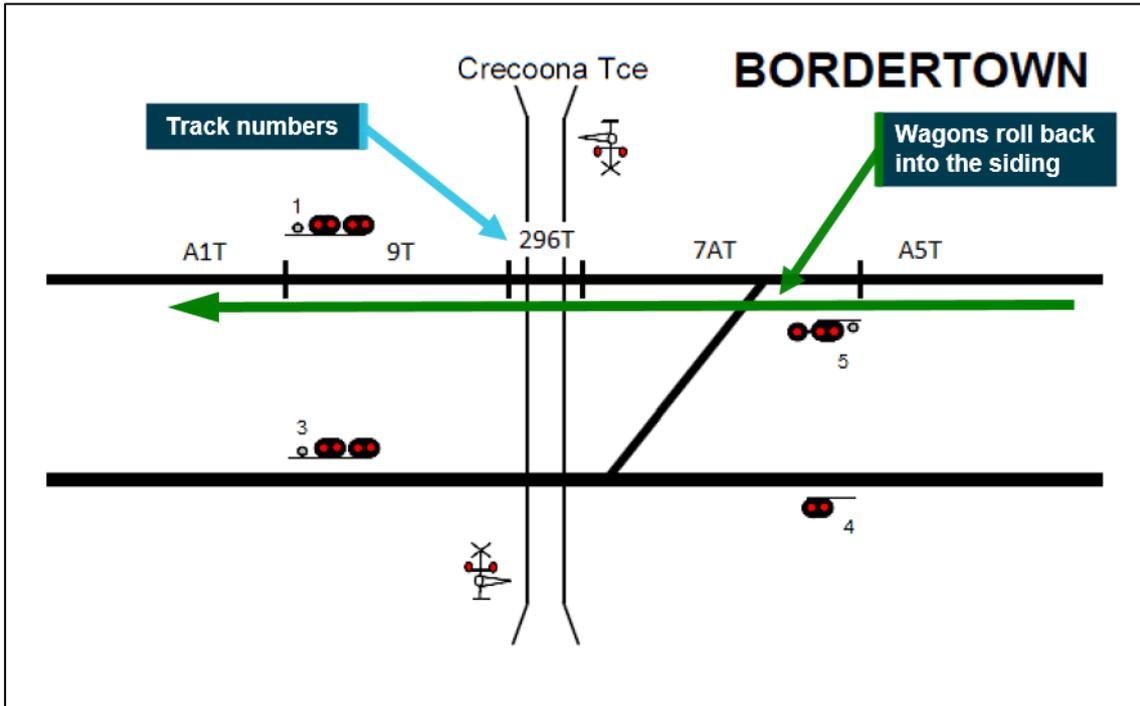
Figure 7: Bordertown track numbers

The signalling infrastructure at Bordertown utilises track circuits to detect rail vehicles as they occupy defined sections of track. The wagons from train 2122S were uncoupled while occupying track A5T (Figure 7). As the unattended wagons rolled back into the siding (Figure 7, green arrow), the lead axle of the lead wagon sequentially occupied tracks 7AT, 296T, 9T and A1T.

Illustration showing track circuit numbers occupied as the unattended wagons rolled back into the siding. Source: ATSB
