# Near collision between Piper PA-28, VH-XDI and ATR72, VH-FVR

Albury Airport, New South Wales, on 19 October 2019

**ATSB Transport Safety Report**  
Aviation Occurrence Investigation  
AO-2019-066  
Final – 12 November 2020

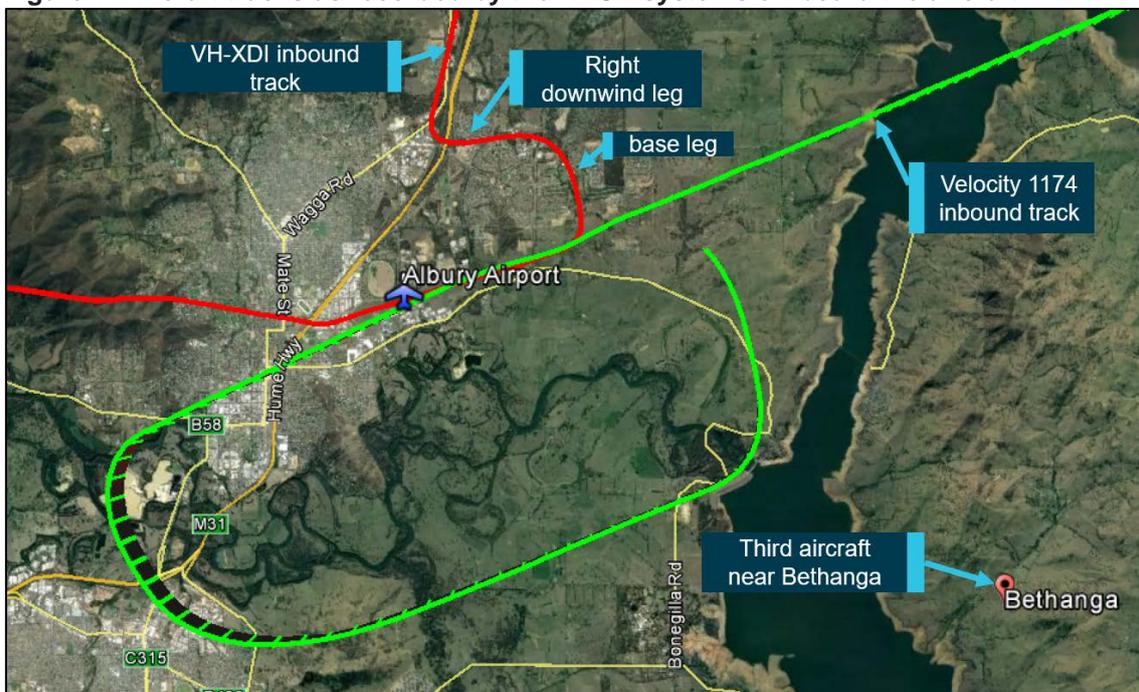
**Figure 1: Aircraft tracks as recorded by the ADSB systems on-board the aircraft**

*Image shows the inbound tracks of VH-XDI joining a right circuit and Velocity 1174 conducting a straight-in approach. The area a third aircraft was operating is also marked.*

At approximately 1118, another aircraft (Aircraft 3) departed Albury on a local scenic flight towards Bethanga (Figure 1). Shortly afterwards, the controller tried to contact the pilot of XDI and after not receiving a response, they attempted contact a second time. This time the pilot responded and was instructed to join the mid-downwind leg of the right circuit for runway 25. The pilot was then provided with an onwards clearance after the touch-and-go landing. Immediately after this, the crew of Velocity 1174 advised the controller that they were at the final waypoint<sup>2</sup> and the controller cleared them to land.

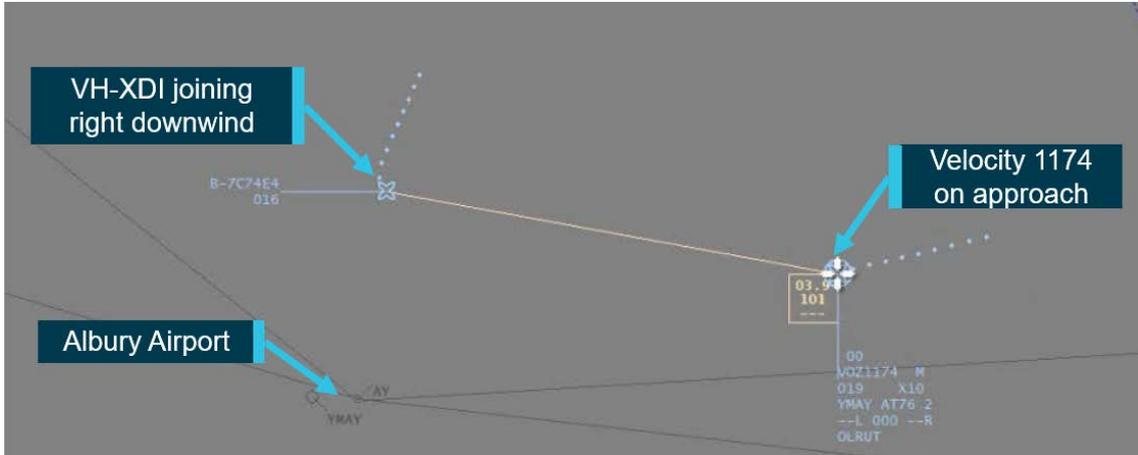
**Figure 2: XDI turning downwind with Velocity 1174 on approach**

The controller subsequently advised the pilot of XDI that ‘...you’re number two following an ATR on about a four-mile final, report traffic in sight’. The pilot acknowledged the instruction by advising the aircraft’s callsign but did not repeat any part of the instruction back to the controller. About 40 seconds later, XDI joined the downwind leg (Figure 1) for a right circuit to runway 25 (Figure 2).

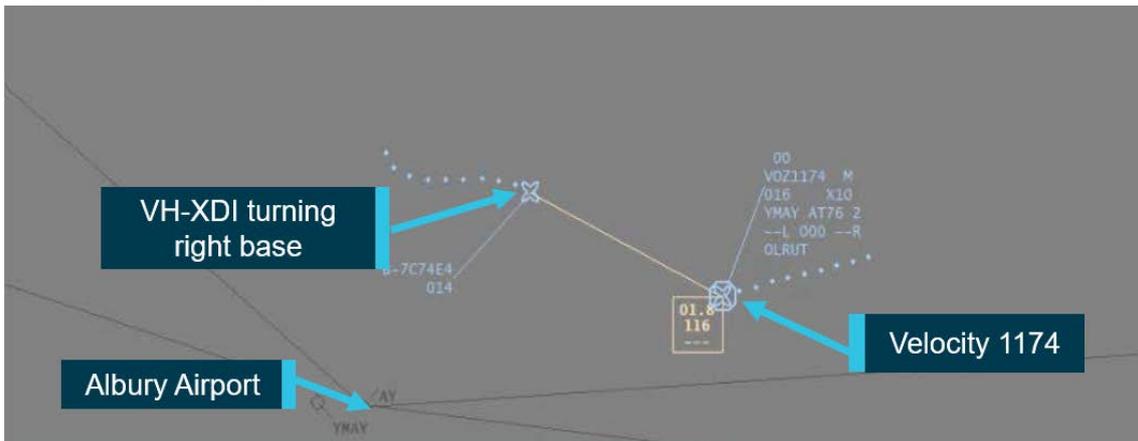
**Figure 3: XDI turning base with Velocity 1174 on about 3 km (1.8 NM) final**

The controller advised the ATSB that, due to their focussed attention on the third aircraft, they were not monitoring XDI as the aircraft continued on the downwind leg and turned on to the normal base leg of the circuit (Figure 1). At that point the pilot of XDI had not sighted the ATR or advised the controller that they did not have it sighted (Figure 3).

As Velocity 1174 passed approximately 600 ft above ground level (AGL), the crew received a traffic collision avoidance system<sup>3</sup> traffic advisory (TCAS TA)<sup>4</sup> and, in response, began to visually acquire the aircraft causing the alert. They quickly identified the PA-28 below them; the aircrafts’

separation at that stage was about 111 metres (.06 NM) horizontal and 75 feet vertical. Due to the proximity of the two aircraft, the crew of Velocity 1174 immediately commenced a missed approach.
