Driveshaft failure and hard landing involving Overseas Aircraft Support UH-1H helicopter, VH-OXI

near Crawford River, New South Wales, on 7 December 2019

ATSB Transport Safety Report
Aviation Occurrence Investigation
AO-2019-070
Final – 16 July 2020
Addendum – 28 January 2021

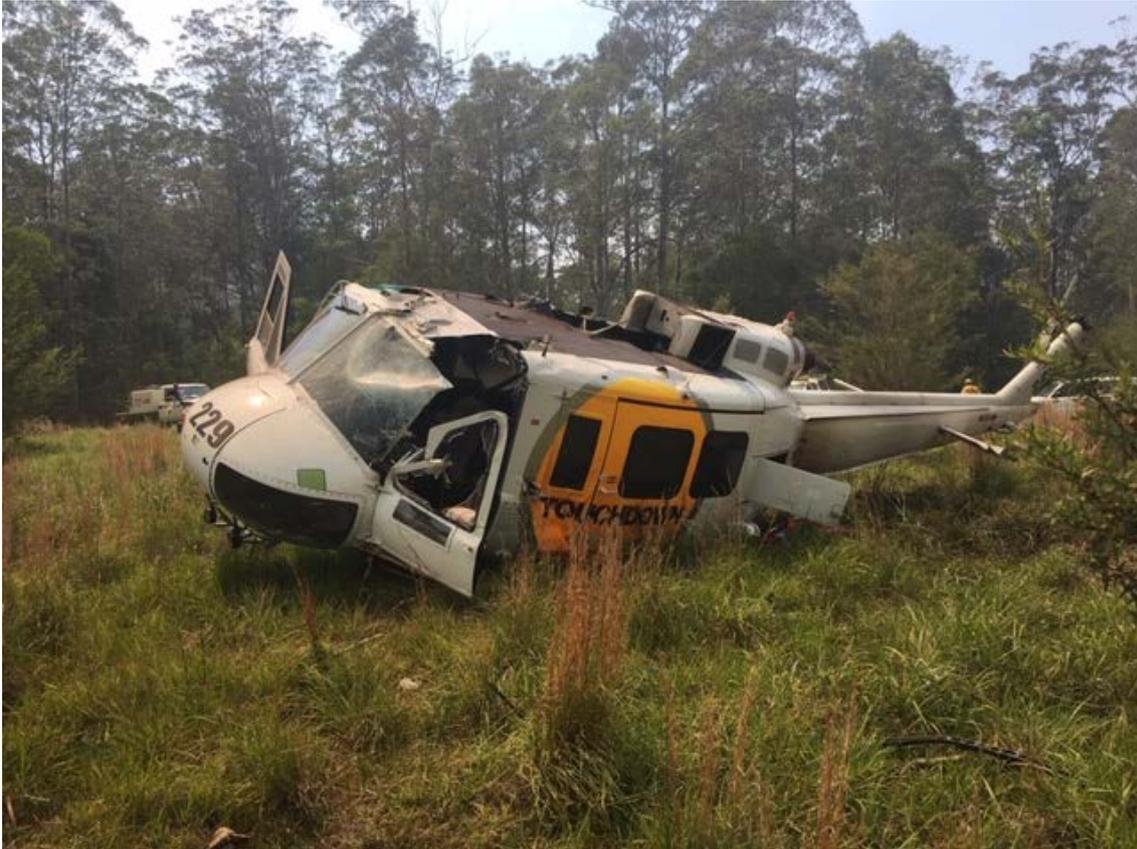
Figure 1: Main wreckage site

Rural Fire Service and National Parks personnel responded immediately and arrived at the accident site shortly after the pilot had exited from the wreckage (Figure 1). They extinguished a small grass fire that had been started by the helicopter. The pilot was transported to hospital by ambulance for observation and then released with nil injuries. The helicopter was substantially damaged.

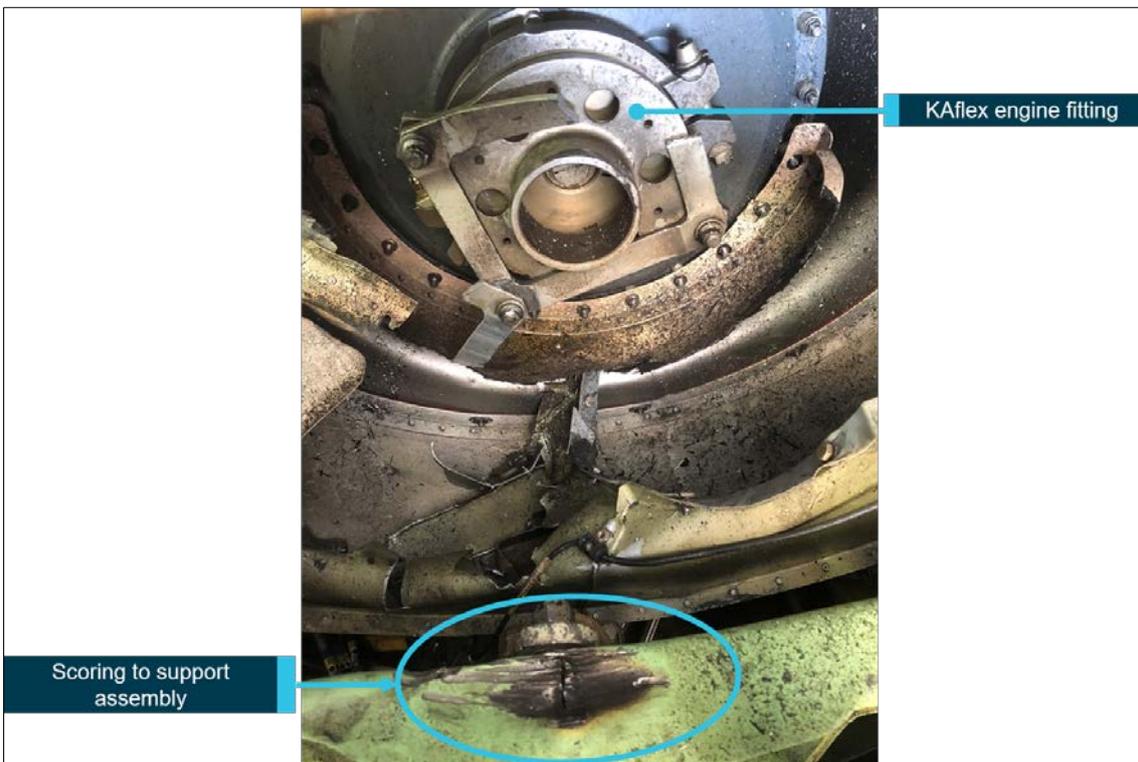
Figure 3: Scoring to the rear transmission mount support assembly

The visual inspection of the driveshaft noted a failure of one of the outer flex plate bolt holes, where the plate was bolted to the main gearbox-end fitting. In addition, there were five recessed washers missing from various fasteners. The rear transmission mount support assembly exhibited scoring below the location of the driveshaft gearbox-end fitting (Figure 3). Discoloration of a section of the failed outer flex plate was consistent with the scoring to the support assembly. The ATSB retained the helicopter's KAflex® driveshaft (serial number 2136) for materials examination.

observed scoring marks to the rear transmission mount support assembly were consistent with the failed driveshaft flex plate striking it during operation. This indicated that the driveshaft failure started before the hard landing and was consistent with the symptoms of noise and vibration reported by the pilot when overhead the Crawford River.

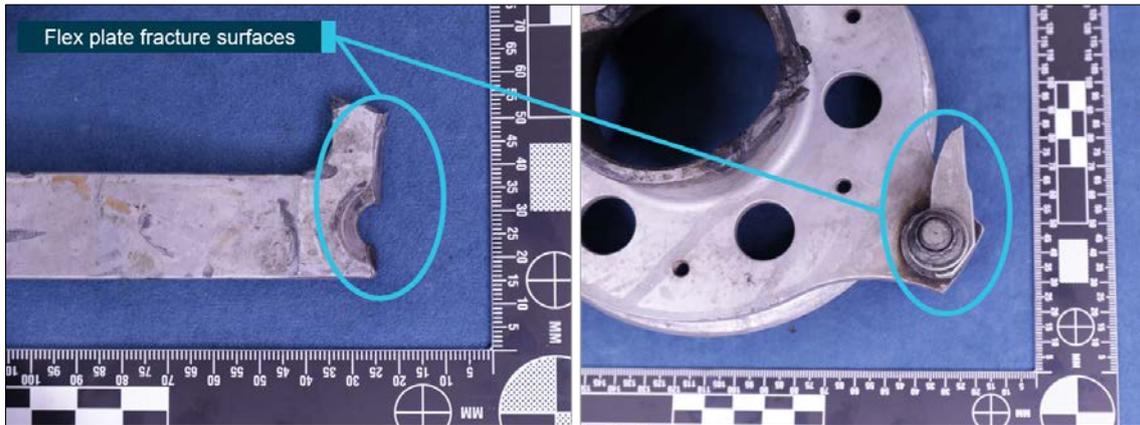
Figure 4: Fractured bolt hole (left) and small section remaining attached (right)

The flex plates from the driveshaft had fractured into multiple segments. The outer flex plate at the main gearbox-end fitting had fractured through the bolt hole, with a small section remaining attached at the join (Figure 4). Examination of the flex plate fracture surfaces revealed evidence of beachmarks, consistent with fatigue crack progression. The fatigue crack had propagated across about 90 per cent of the fractured surface. The surfaces surrounding the fatigue fracture exhibited evidence of surface corrosion and pitting (Figure 5).

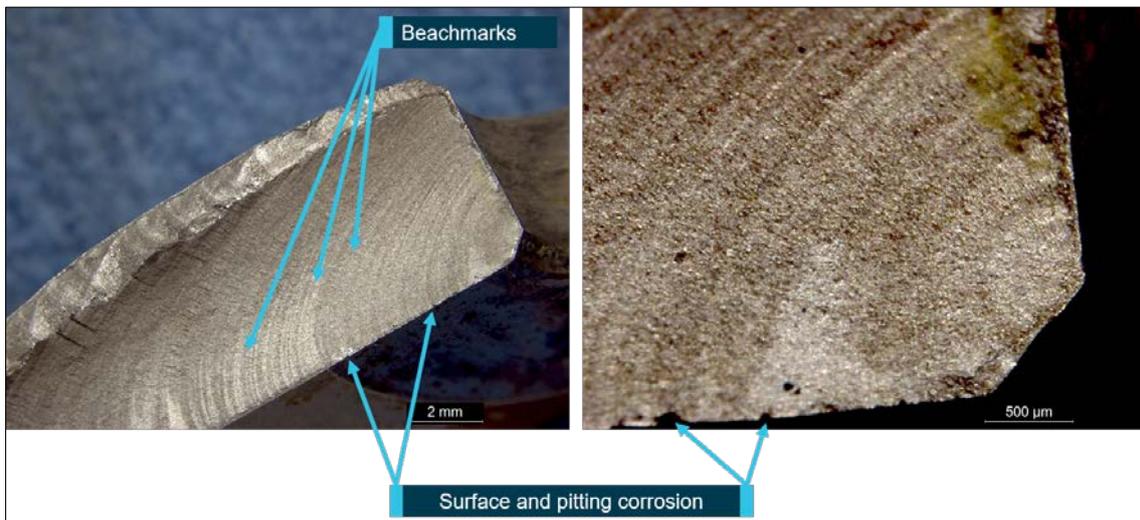
Figure 5: Fatigue failure of flex plate

An inspection of the airframe revealed the KAflex® driveshaft exhibited a fatigue failure of the outer flex plate at a bolt hole where the plate was fastened to the main gearbox-end fitting. The

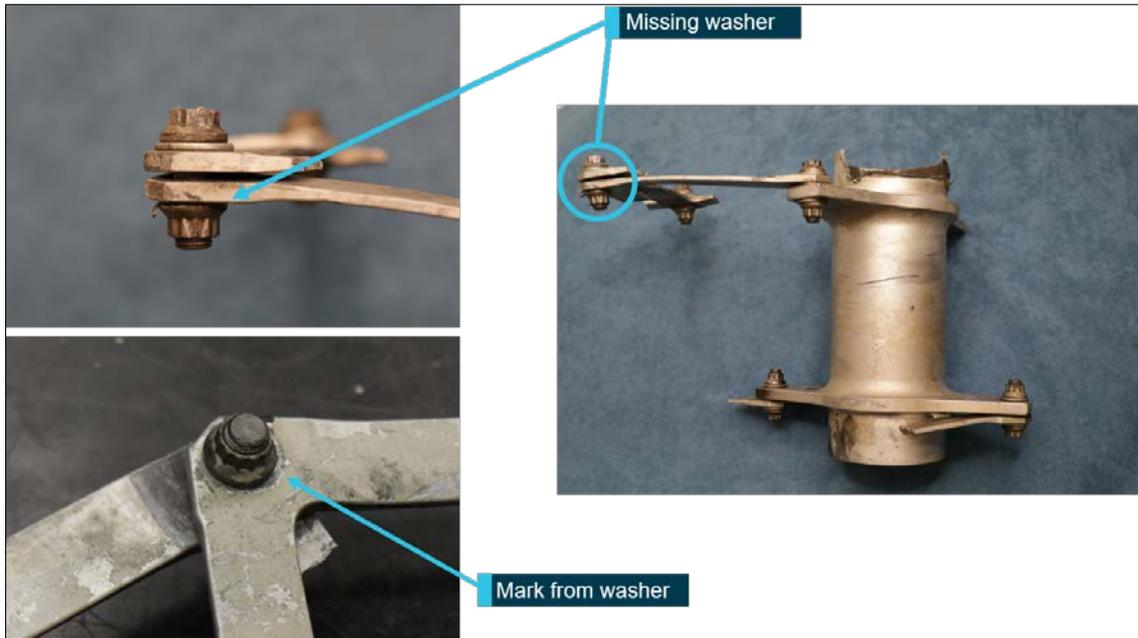
Figure 6: Missing washer

The five missing washers were from four fasteners, and in each of these locations the fasteners were loose and the flex plates free to move with respect to each other. Damage to the fasteners at these locations precluded any useful information with regard to torque values. A witness mark, consistent with a washer, was observed in all the locations. While some marks were more distinct than others, it was considered very likely that a washer had been present at each location at some stage in the life of the component. Figure 6 depicts the location of one of the missing washers.

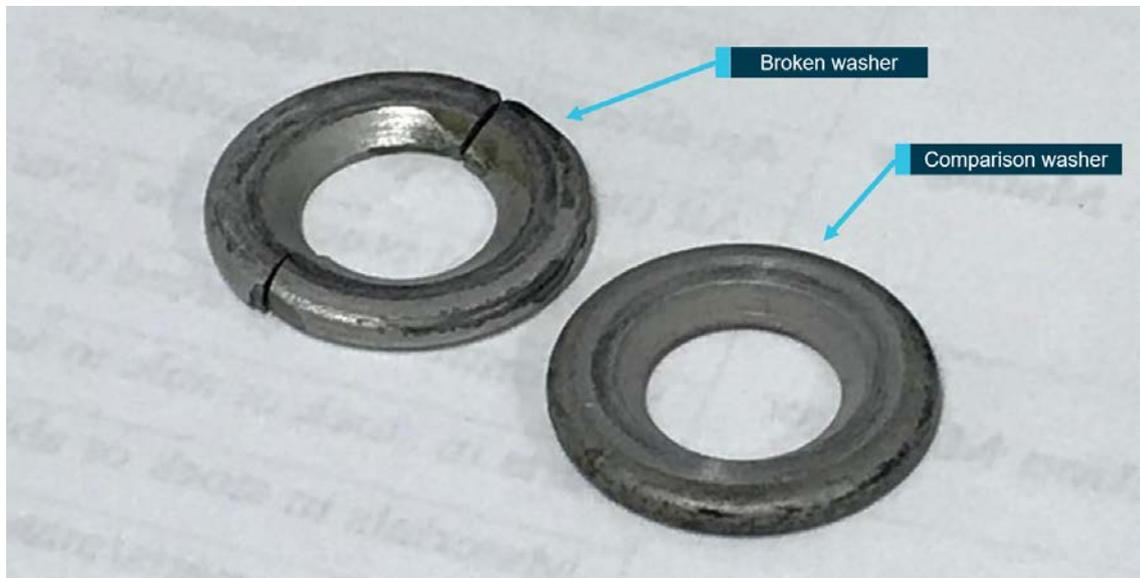
Figure 7: Comparison of washers

Based on a photographic review of the broken washer, Kamatics reported the washer was consistent with those used on the KAflex® driveshaft. Analysis conducted by the ATSB revealed a high aluminium content, which was consistent with the SermeTel® coating used on these washers.⁹ The dimensions were consistent with those for the KAflex® driveshaft recessed washer part number, the surface exhibited signs of fretting and there was no evidence of fatigue on the fracture surfaces. Kamatics reported that fretting is the usual type of wear found on the washers for driveshafts that have accumulated 4,500-6,000 hours operation, but they have never recorded cracked or broken washers during overhaul. Figure 7 below provides a comparison of the broken washer with a KAflex® driveshaft recessed washer.

The additional maintenance information and analysis of the broken washer suggested the most plausible scenario was that the missing washers failed as a result of the break-up of the driveshaft when the main gearbox was forcibly ejected from the airframe.
