Operational non-compliance involving Airbus A380, 9V-SKQ

Sydney Airport, New South Wales, on 9 February 2020

ATSB Transport Safety Report

AO-2020-011

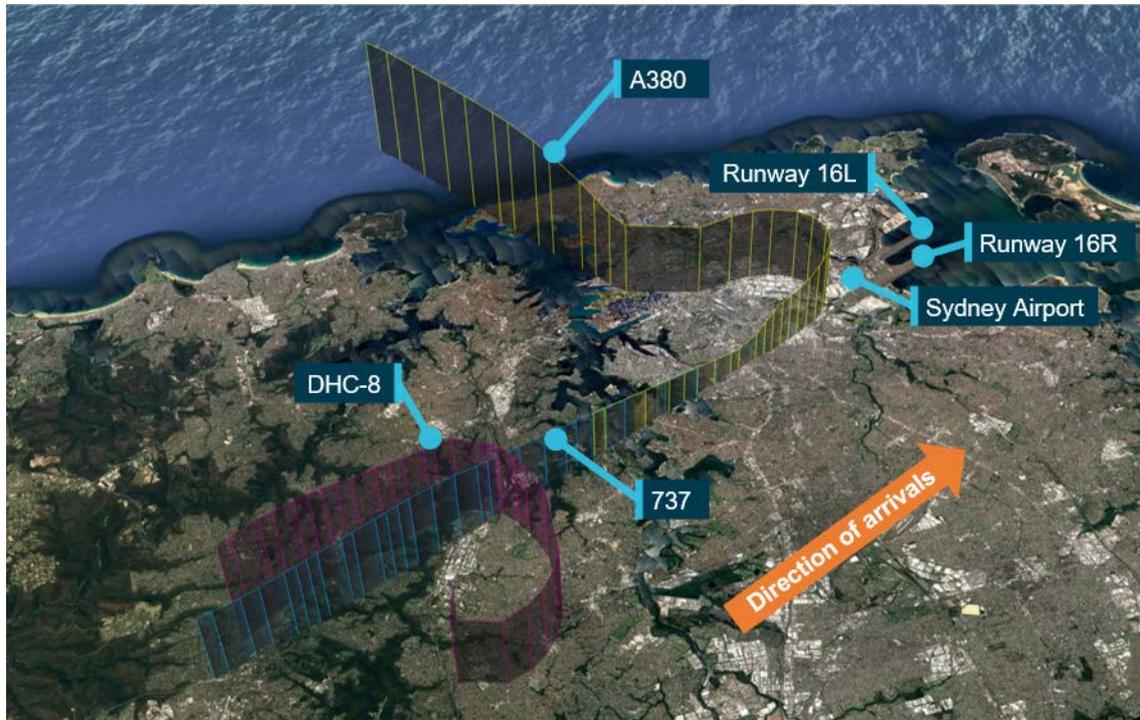
Figure 1: Aircraft tracks at the time of incident

The minimum distance between the two aircraft reduced to 2.6 NM (4.8 km) laterally and 1,300 ft vertically. Figure 1 shows the representative aircraft tracks at the time of the incident.
