# Pilot incapacitation involving Cessna 208B, VH-DQP

53 km west-north-west of Sunshine Coast Airport, Queensland, on 2 July 2020

**ATSB Transport Safety Report**

AO-2020-032

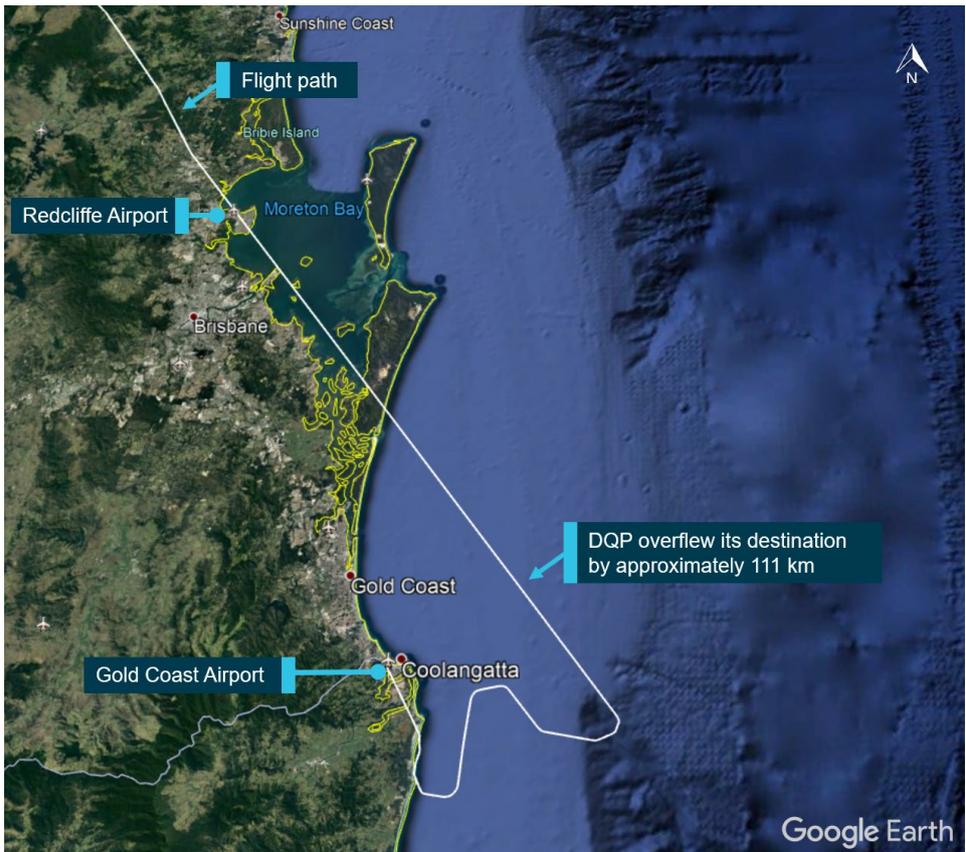
**Figure 1: VH-DQP flight path and distance from Redcliffe Airport**

At about 1735, after 40 minutes without contact and when about 60 NM (111 km) south-south-east of Redcliffe (Figure 1), communications with the pilot of DQP was re-established. Air traffic control instructed the pilot to conduct an immediate descent to 8,000 ft and to change to a discrete ATC frequency. After a minute of no change in the aircraft's altitude, ATC again instructed the pilot to change frequencies and to use oxygen as they were treating the situation as a hypoxic event. This was also reiterated to the pilot of DQP by the B200 pilot. Air traffic control reported that the pilot sounded 'groggy' and 'not really with it' upon first contact and took a few minutes before slowly commencing the descent to 8,000 ft.
