Partial pilot incapacitation involving Piper PA-28, VH-TBB

19 km south-east of Moree, New South Wales, on 23 September 2020

ATSB Transport Safety Report

AO-2020-055

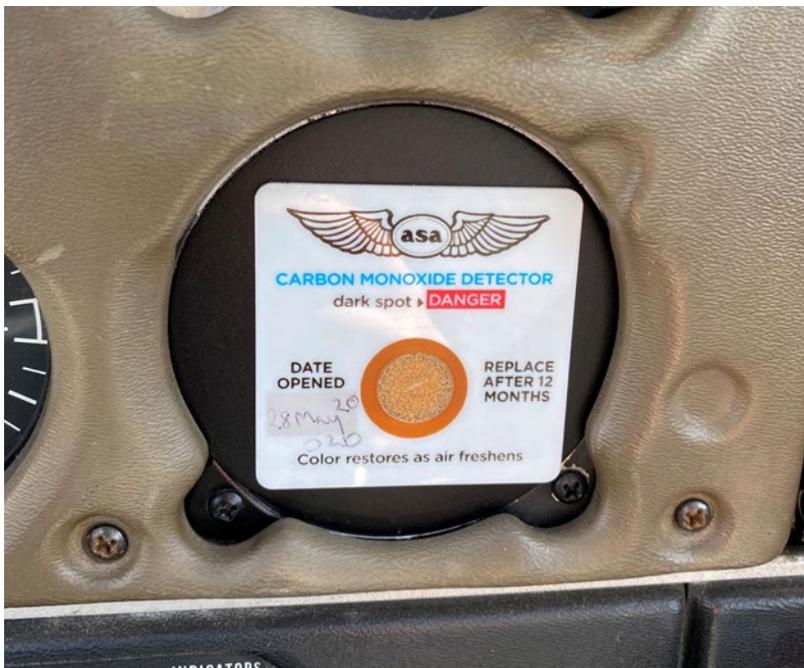
Shortly after take-off, the pilot began to feel unwell, with a warm feeling in their chest, dizziness, breathlessness, some confusion and disorientation. The pilot then conducted a visual scan of the flight instruments and observed a localised discolouration on the disposable carbon monoxide (CO) chemical spot detector. As the pilot looked closer at the detector, they noticed the spot rapidly getting darker. The pilot immediately turned the aircraft back toward the airport, reduced engine power, and opened all the fresh air vents and the side window.

The aircraft was fitted with an Aviation Supplies and Academics disposable CO chemical spot detector, attached to the instrument panel (Figure 1). The detector was only 4 months old, which was within the manufacturer's 12-month replacement period. It consisted of an orange-coloured

circle (spot) in the middle of the card, which was designed to change colour to grey/black following a chemical reaction with CO in the immediate vicinity. The spot then returns to normal (orange) after it has been exposed to fresh air. The chemical reaction depends on the concentration of CO in the air and the time of exposure. This detector was designed to react to a minimum of 50 parts per million (ppm) of CO within 30 minutes, 100 ppm within 10 minutes and 200 ppm within 4 minutes.

Figure 1: Slightly discoloured carbon monoxide detector, after engine shutdown and the detector being exposed to fresh air
