# Level crossing collision between passenger train and road vehicle

Wynnum West, Queensland on 26 February 2021

**ATSB Transport Safety Report** (Defined)

RO-2021-005

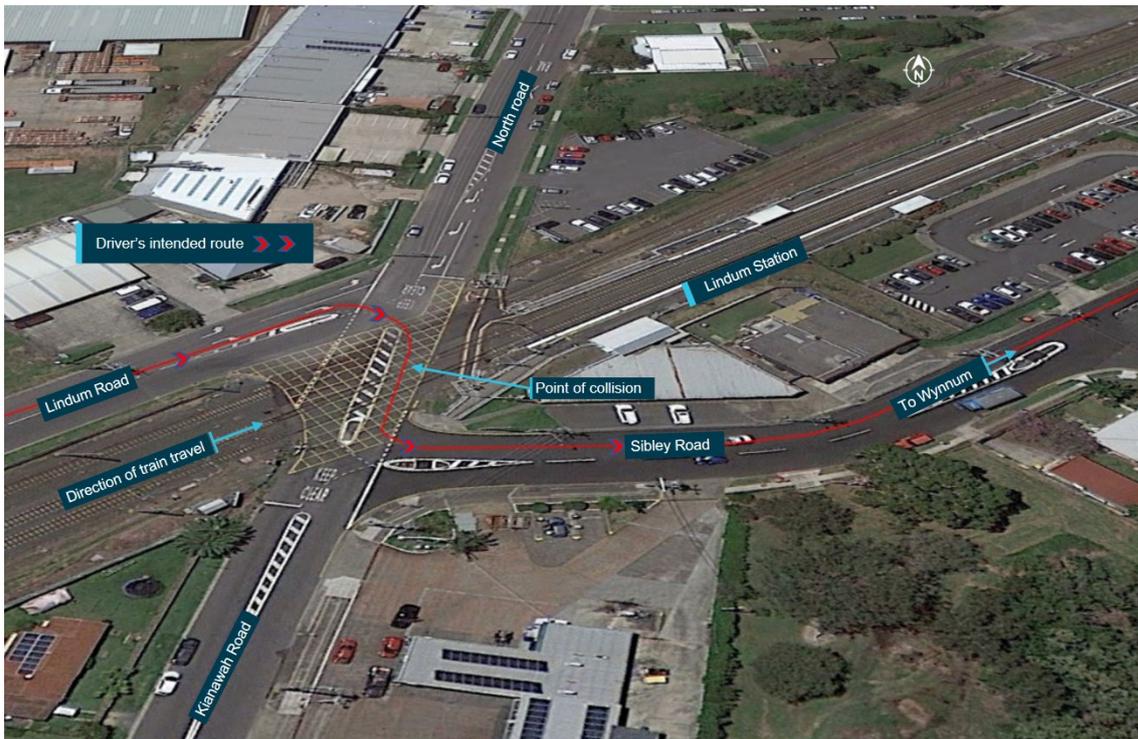
**Figure 1: Driver’s intended route from Lindum Road through the level crossing**

The hatchback travelled in an easterly direction along Lindum Road. At the T-intersection of Lindum Road and North Road, the driver’s intention was to turn right and pass through the Kianawah Road level crossing en route to Wynnum (Figure 1).

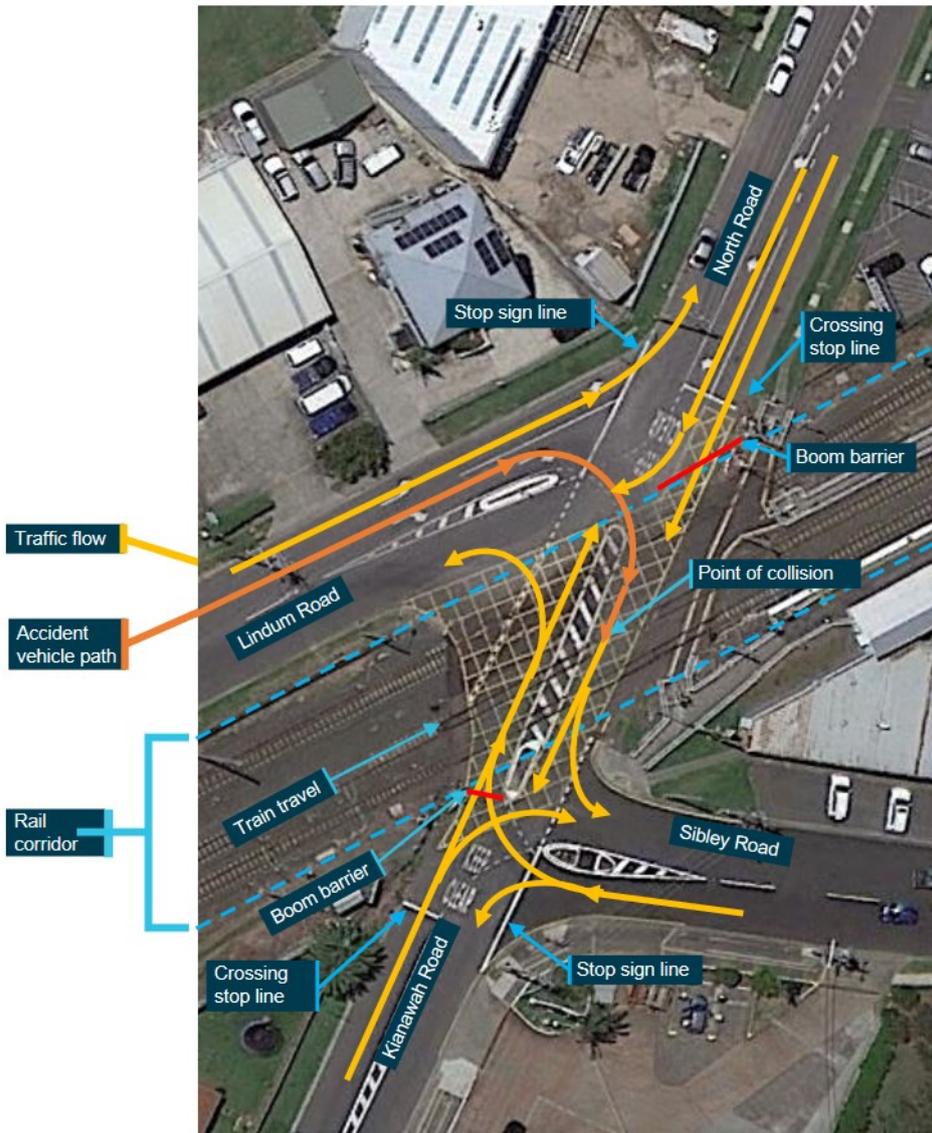
**Figure 2: Kianawah Road level crossing showing interconnecting T-intersections and traffic flow**

There was a stop sign on Lindum Road where it joined North Road, and a stop sign on Sibley Road where it joined Kianawah Road. Traffic flow was such that a vehicle turning right from Lindum Road to cross the level crossing (as was the case during the accident sequence) had to stop and give way to traffic from both North Road and Kianawah Road (Figure 2).

Figure 2 shows the Lindum Road and North Road intersection on the northern side of the level crossing and the Kianawah Road and Sibley Road intersection on the southern side of the crossing. Depicted in the image are the potential variations in road vehicle travel, the path of the vehicle involved in the accident, the direction of the train's travel and the point of the collision.

The position of the two boom barriers on North Road and Kianawah Road are also indicated in Figure 2. The road surface was painted with yellow cross-hatched lines in the area between the two boom barriers. Level crossing flashing signals were positioned on the northern side to face road vehicle users approaching the crossing from North Road. There was also a set of flashing lights positioned to face road users approaching the crossing from Lindum Road (Figure 3).

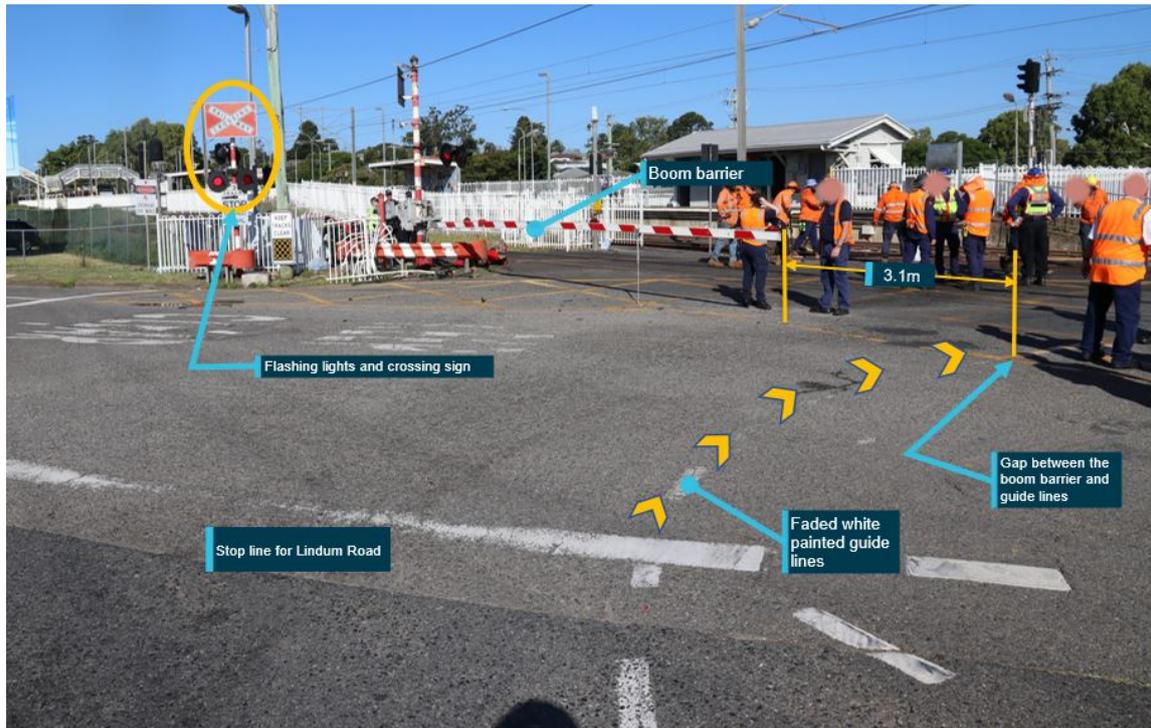
**Figure 3: Gap between Lindum Road to Kianawah Road turn line and the boom barrier**

A post-accident assessment of the Kianawah Road level crossing was conducted by the Queensland Police Service forensic crash unit. It identified that the boom barrier on the northern side, which protected vehicular traffic from entering the level crossing from Lindum Road, was 10 m long and did not extend to the edge of the painted median island or to the centre of the roadway which divided the two-way roadway. The gap between the edge of the median island and the tip of the boom barrier when in its lowered state was 3.1 m (Figure 3).

In comparison, the width of a general traffic lane in an urban environment is between 3.0 and 3.5 m. The width of the road vehicle involved in the accident was about 1.8 m. In other words, a normal road vehicle could turn right from Lindum Road on the correct side of the turn line and easily pass to the right of the lowered boom barrier (as occurred in the case of this accident).

Figure 3 shows the gap between the end of the boom barrier and the edge of the median island, if approaching the level crossing from Lindum Road. The yellow arrows indicate the white painted turn line markings, which had been worn due to vehicle activity.

In contrast, there was no gap between the boom barrier and the centre of the roadway on the southern side of the level crossing (that is, the approach from Sibley Road).

- BCC, QR and the Department of Transport and Main Roads are participating in the Lindum Station Precinct Study. This study is reviewing interim, short-term and long-term options for the level crossing.
- QR has commenced engineering activities to source and trial usage of a longer boom barrier than the one currently installed on the northern side of the Kianawah Road level crossing.
