Landing gear retraction deactivation and return involving a Boeing 787, VH-ZNH

near Sydney Airport, New South Wales, 21 June 2021

ATSB Transport Safety Report
Aviation Occurrence Investigation (Short)
AO-2021-026
Final – 16 November 2021

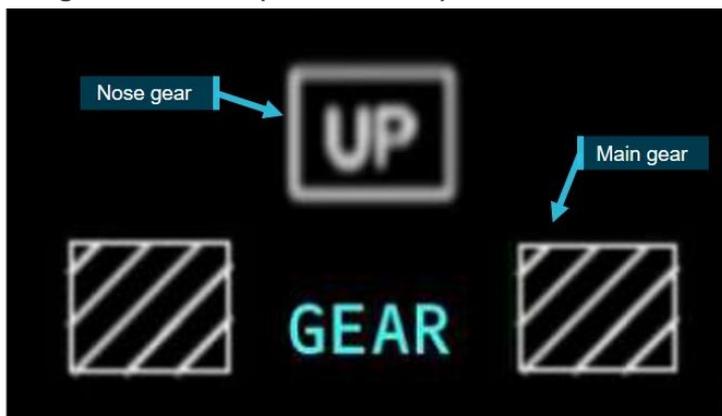
At about 1032, shortly after take-off and with the aircraft established in a positive climb, the PM positioned the landing gear selector to UP. Ten seconds after selecting the landing gear up, the crew received a GEAR DISAGREE caution on the Engine Indication and Crew Alerting System (EICAS) and an associated aural alert. The flight crew observed indications that the nose landing gear had retracted however, both main landing gear continued to display a grey crosshatch symbol, indicating that they remained 'in transit' (see the section titled *Landing gear operation*).

The normal transit time for gear retraction is approximately 10 seconds. If any landing gear is not up and locked after about 40 seconds, the EICAS caution message GEAR DISAGREE is displayed. The EICAS gear position indication then displays an expanded non-normal format. The flight crew can then see which gear is UP, in-transit, or DOWN (if the gear never unlocked from the down position). In this instance, the flight crew were presented with an UP indication for the nose gear and in-transit indications for each of the main gear (Figure 1).

Figure 1: EICAS expanded message indication, showing nose gear up and locked, and main gear 'in-transit' (crosshatched)

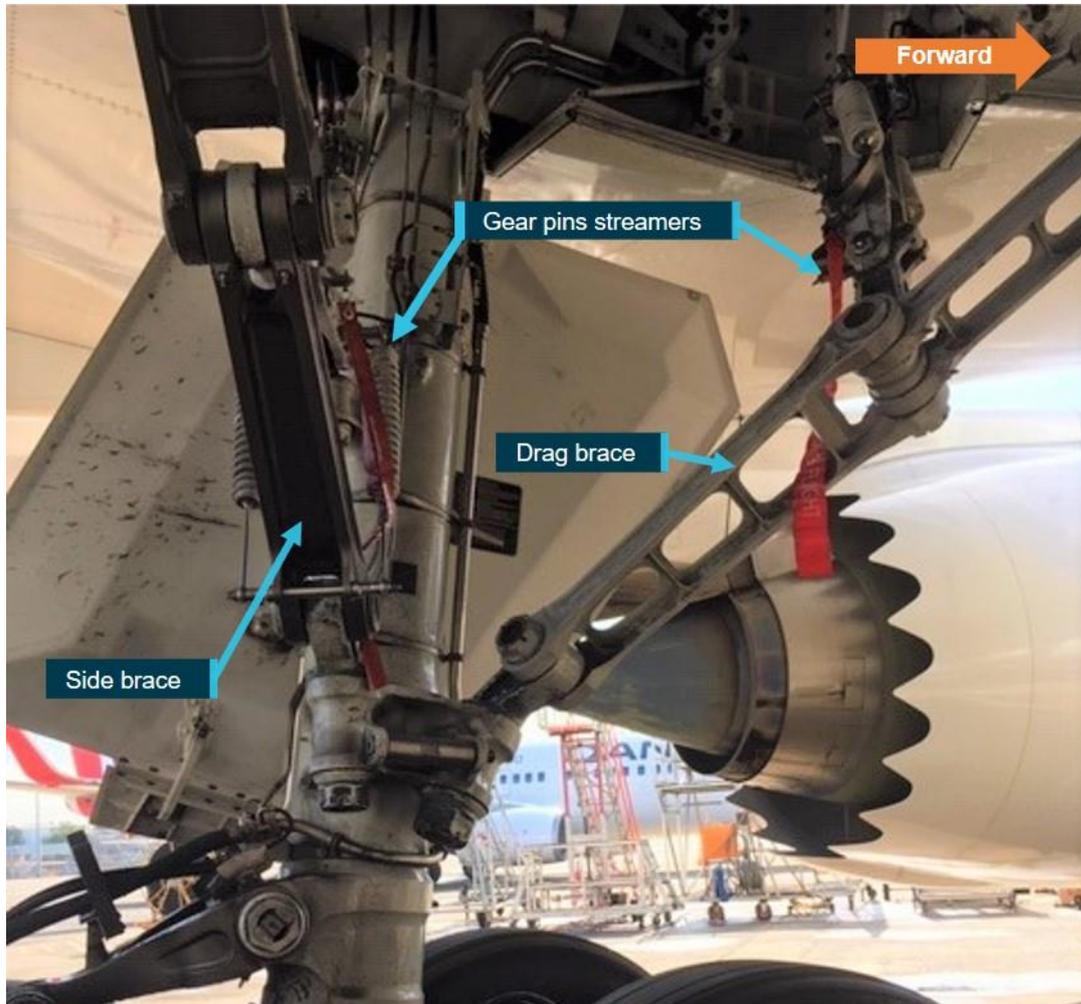
The landing gear downlock pins (gear pins) were installed to prevent inadvertent gear retraction during maintenance or towing operations. The 787 has five gear pins, one for the nose gear and two for each main landing gear (Figure 2).

Figure 2: Typical left main gear showing pins and streamers installed.

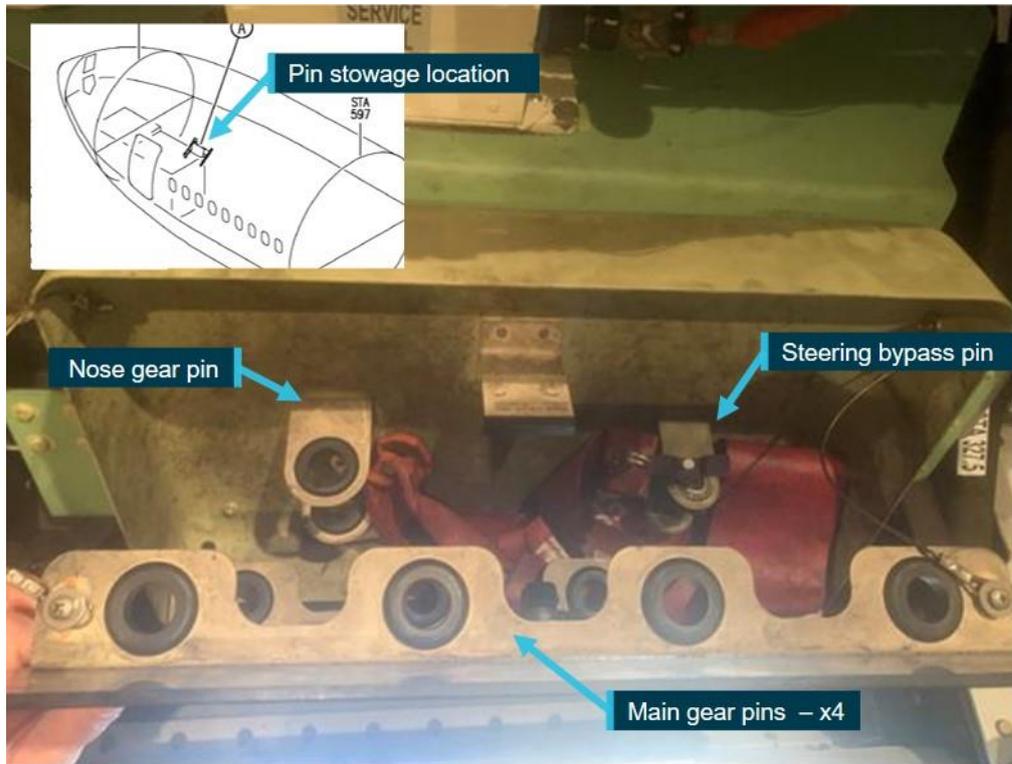
The gear pin stowage box was located in the EEC, just aft of the nose gear, and was attached to the aircraft structure (Figure 3). The hinged door, which had receptacles for the four main gear pins, tilted outwards from the top and included a lanyard to limit swing. The box portion contained two receptacles, one for the nose gear pin and one for the steering bypass pin.⁹ Qantas

engineering personnel reported that a ‘tall ladder’ was required to be able to see into the stowage box.

Figure 3: Gear pin stowage box showing hinged door with four main gear pin receptacles

- The ladder used to access the gear pin stowage location was not of sufficient height to allow visual confirmation of pin stowage. Sighting of 'empty' pin stowage receptacles would have provided a clear indication that not all pins had been removed from the landing gear.

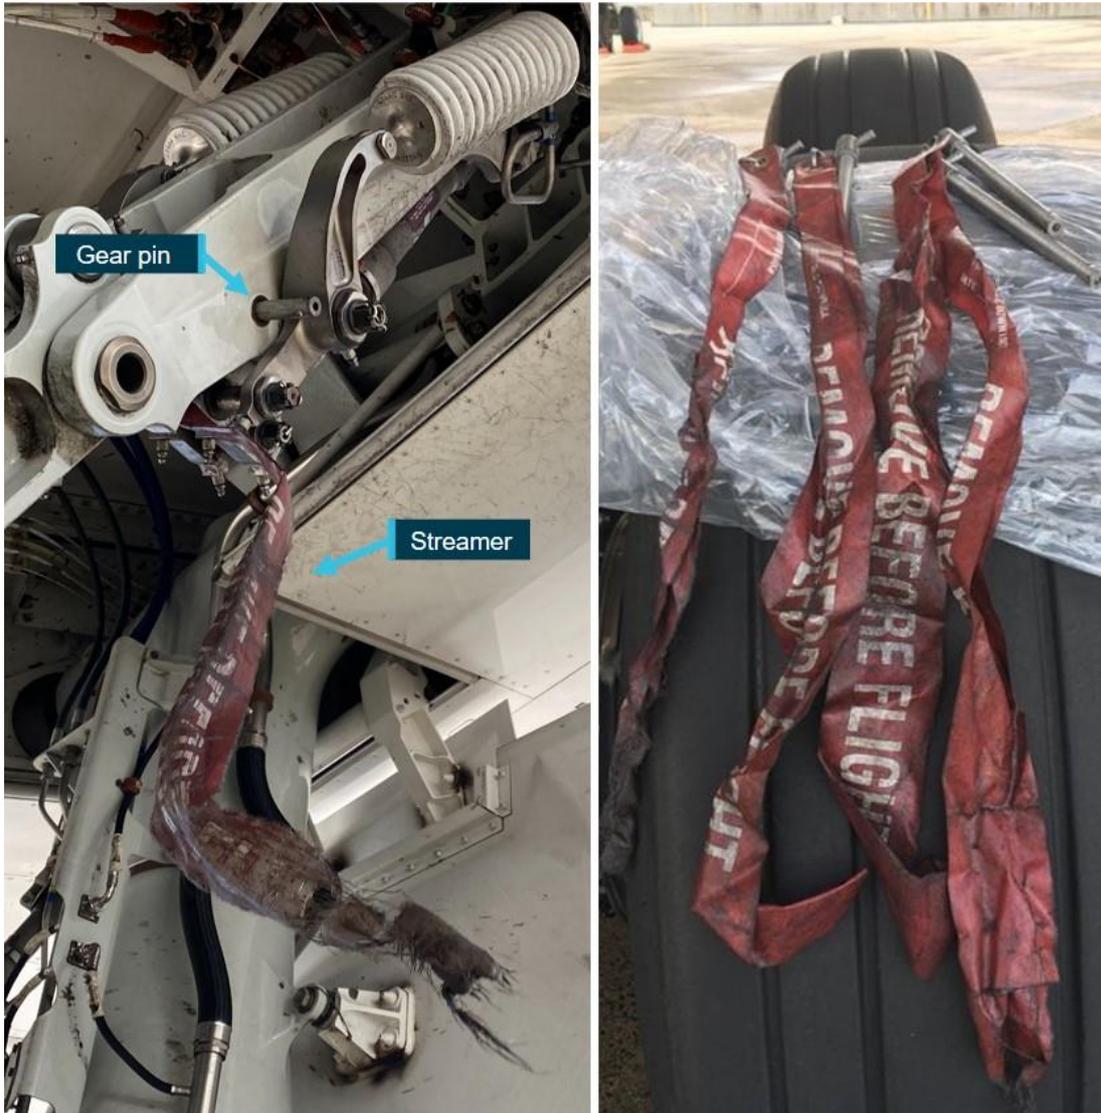
An image of one of the missed main landing gear pins, upon return to Sydney, showed it to be dull and frayed however, it's condition prior to the flight could not be determined (Figure 4).

Examination of ZNH's gear pin streamers noted degraded condition, particularly with respect to the normal intensity of the high-visibility colour.

Figure 4: Gear pin identified on landing (left) and VH-ZNH gear pins (right).

- There was probably reduced visibility of the streamers, due to their degraded condition and the likelihood they were stuck on the gear, from a combination of grime and the recent wet and windy conditions.

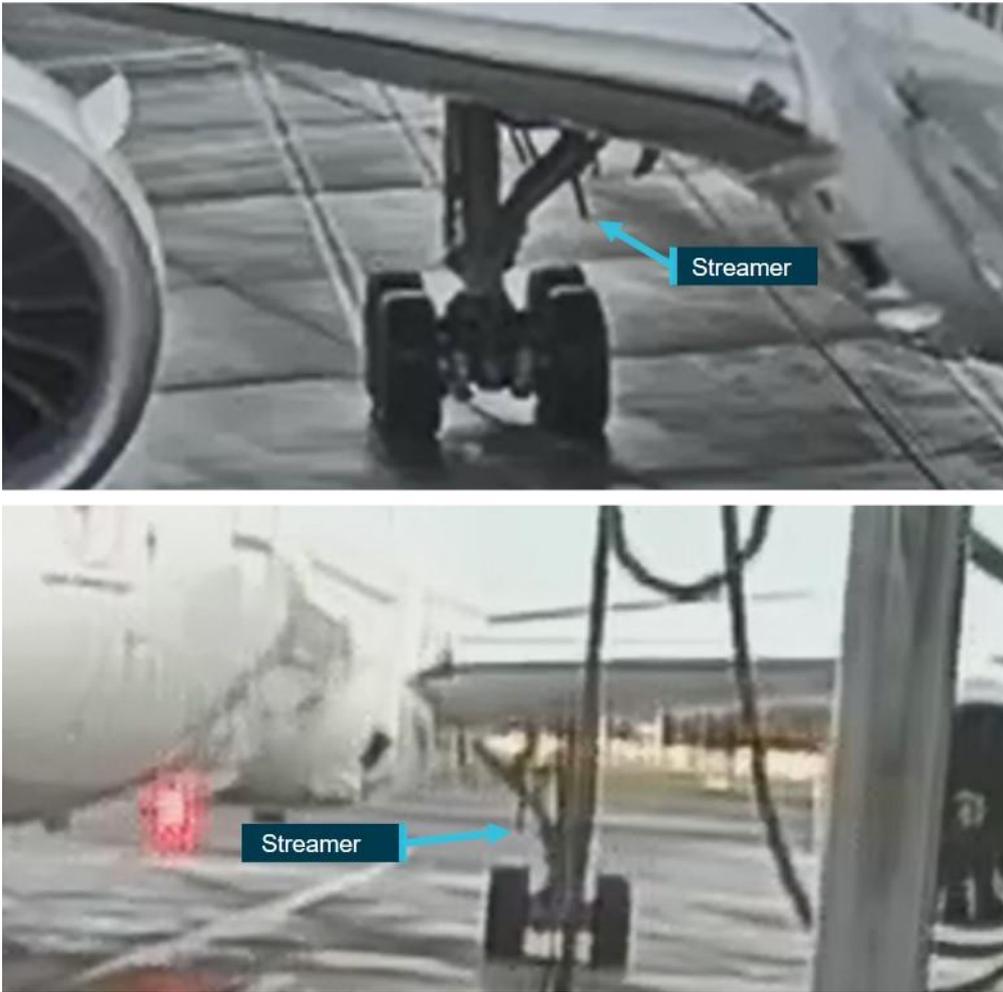
CCTV footage showed that, when ZNH was towed into bay 11, prior to the flight, one streamer on each main landing gear was visible (Figure 5). It was these streamers that were identified and removed by the tow crew. The footage showed the wing walker and the PIC, climb the rear tyre of each main gear¹⁰ and remove a pin (with attached streamer) from the side braces. Streamers associated with the drag braces were not readily visible in the CCTV footage.

Figure 5: VH-ZNH with visible main gear streamers
