Taxiing excursion involving Fokker F100, VH-FKD

Laverton Airport, Western Australia, on 28 September 2021

ATSB Transport Safety Report

AO-2021-041

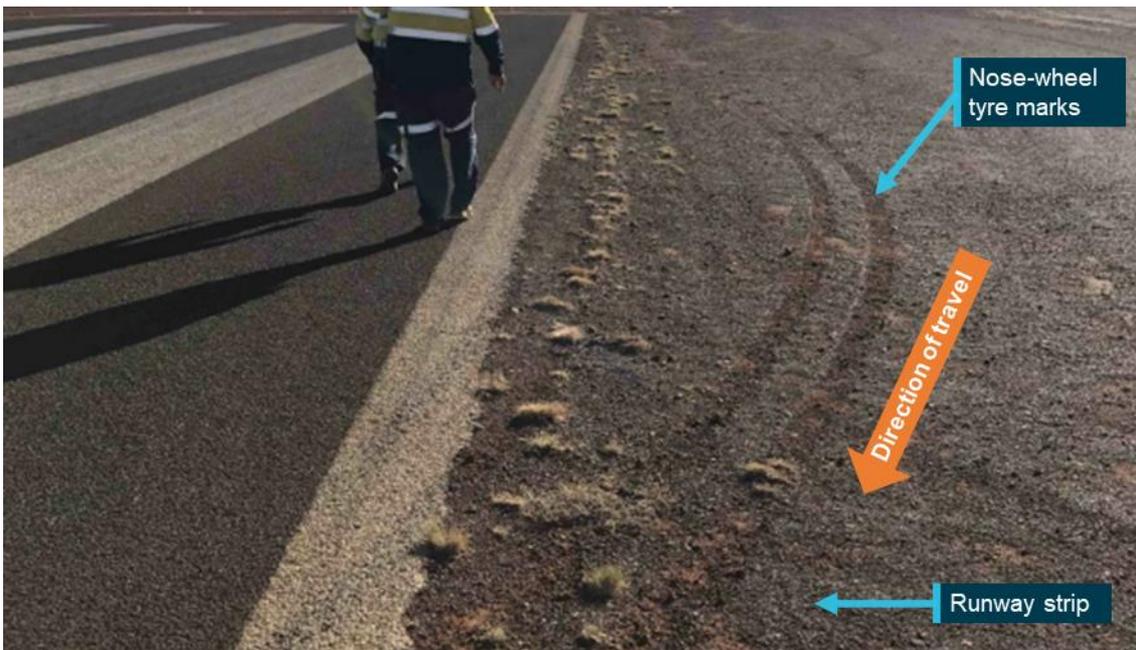
Figure 3: Nose-wheel tyre marks

Following an uneventful landing at about 1536, the captain took control of the aircraft to taxi towards the end of the runway and complete the routine backtrack manoeuvre³ (Figure 2). The aircraft was positioned on the left-side at the end of the runway consistent with operator guidance, and the captain commenced a right turn by rotating the nose-wheel handwheel (tiller). The captain was unable to achieve full tiller rotation, even when using the force of both hands, and attempted to tighten the turn by applying the right inboard brake, and asymmetric thrust, but this did not have the desired effect. During the turn, the aircraft nose-wheel briefly left the side of the runway, and onto the runway strip⁴ – the ground area adjacent to the runway – before returning to the runway and taxiing to the terminal (Figure 3).

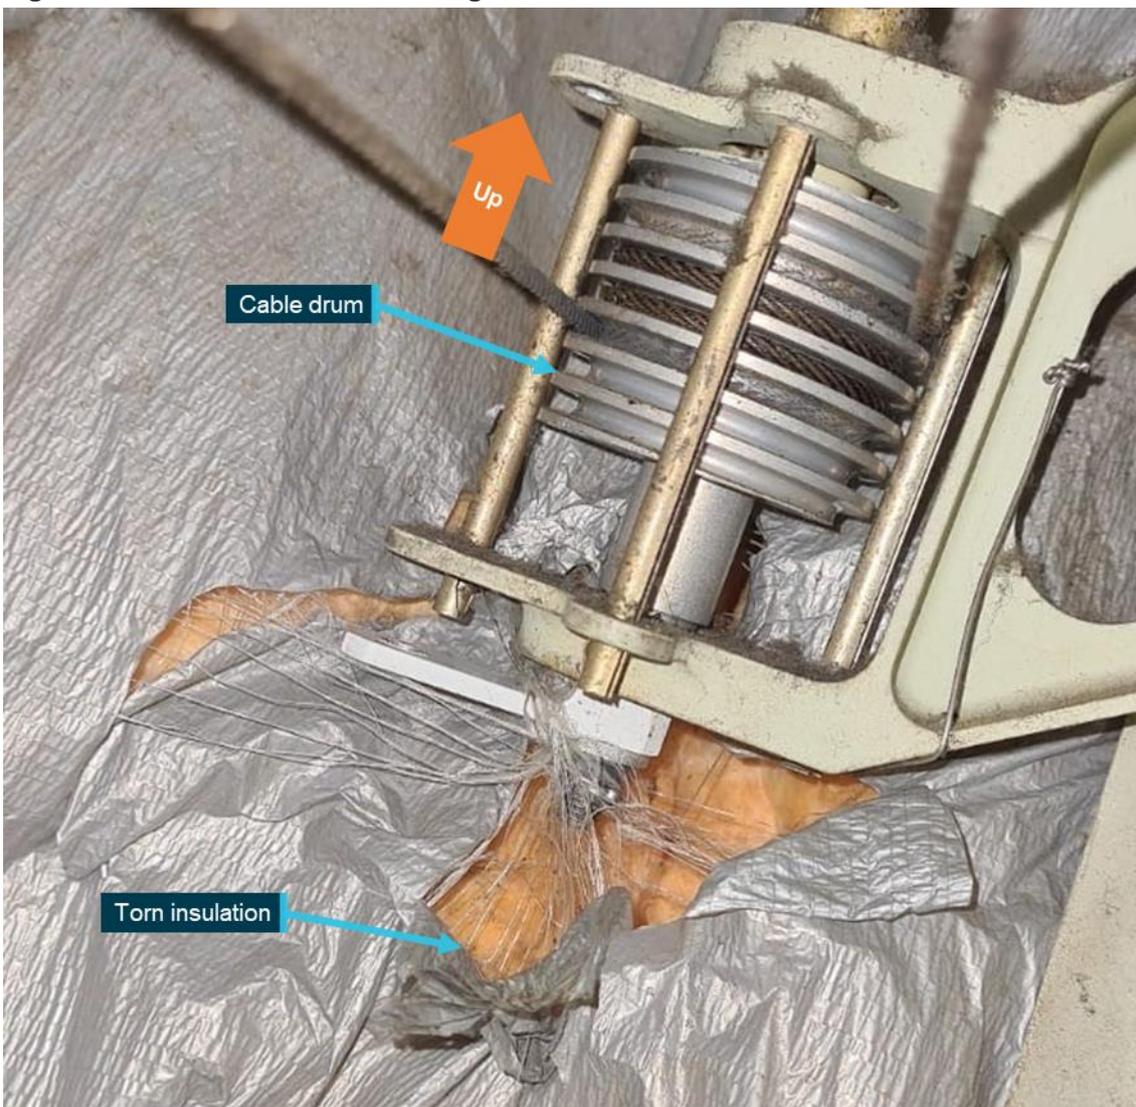
Figure 5: Torn insulation surrounding cable drum

The post-flight examination of the steering system at Laverton identified a correctly secured, but torn insulation blanket, which was contacting the nosewheel cable drum (Figure 5). A torn protective boot on the upper universal joint was also found (Figure 6). The insulation blanket was taped at the torn section and re-secured away from the cable drum, and the torn boot was removed. A taxi test was then successfully carried out before the return flight to Perth.

- Based on torn insulation blanket’s inspection, the reinforcing strands of the blanket covering material were not considered to have sufficient strength to cause the tiller resistance felt by the captain.
- The torn boot was suspected to have been caught in the joint universal joint, causing the resistance in the right turn and was subsequently freed during the two left turns while taxiing taxi to the terminal.

During subsequent maintenance, the torn blanket and handwheel assembly were replaced. The aircraft operator made the following findings with respect to the incident.

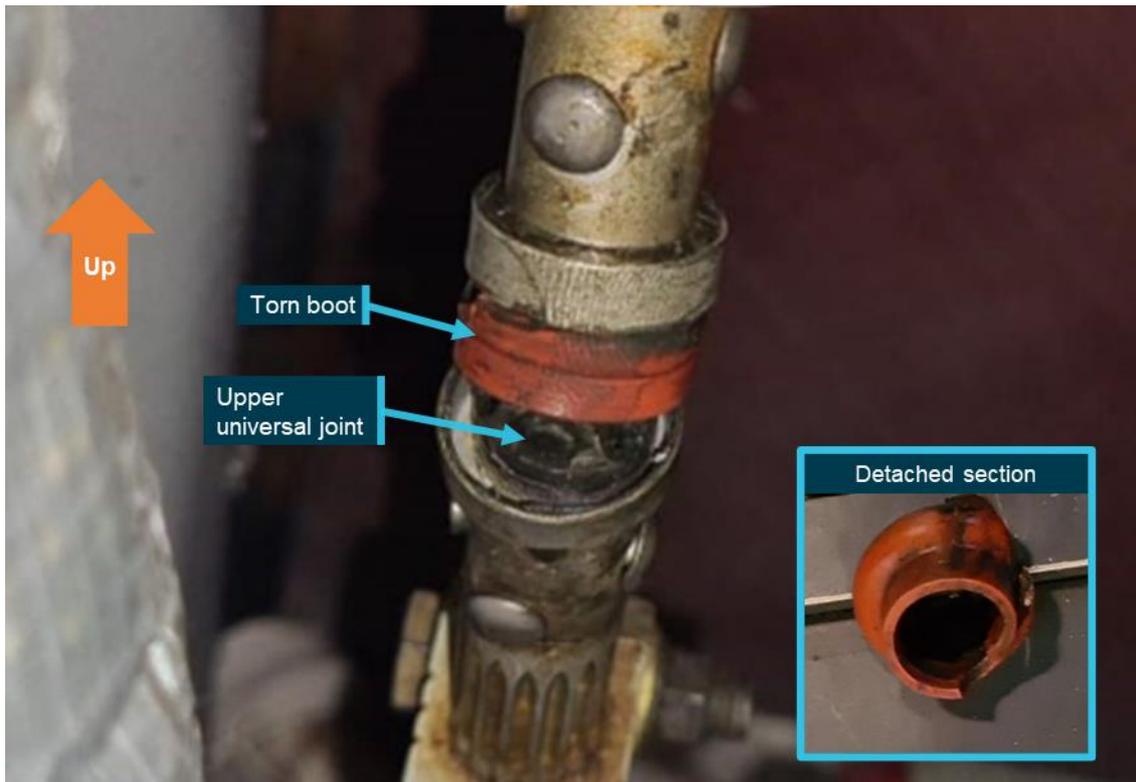
Figure 6: Torn protective boot

The maintenance findings and the captain's statement indicate that it's likely the torn boot reduced the universal joint's range of motion, restricting the operation of the aircraft's nose-wheel steering. This restriction reduced the aircraft's turning ability, preventing it from completing the turn on the runway. It could not be determined how or why the boot was torn.

- A torn boot on a universal joint probably restricted the operation of the aircraft's nose-wheel steering system, preventing the aircraft from completing the turn on the runway.
- The flight crew decided to continue the turn, resulting in the nose-wheel leaving the runway surface.

A fleet wide inspection of the handwheel assembly universal joint is expected to be completed by February 2022.
