Stick shaker activation involving Saab 340B, VH-ZLJ

30.7 km south-west of Perth Airport, Western Australia on 6 July 2021

ATSB Transport Safety Report

AO-2021-027

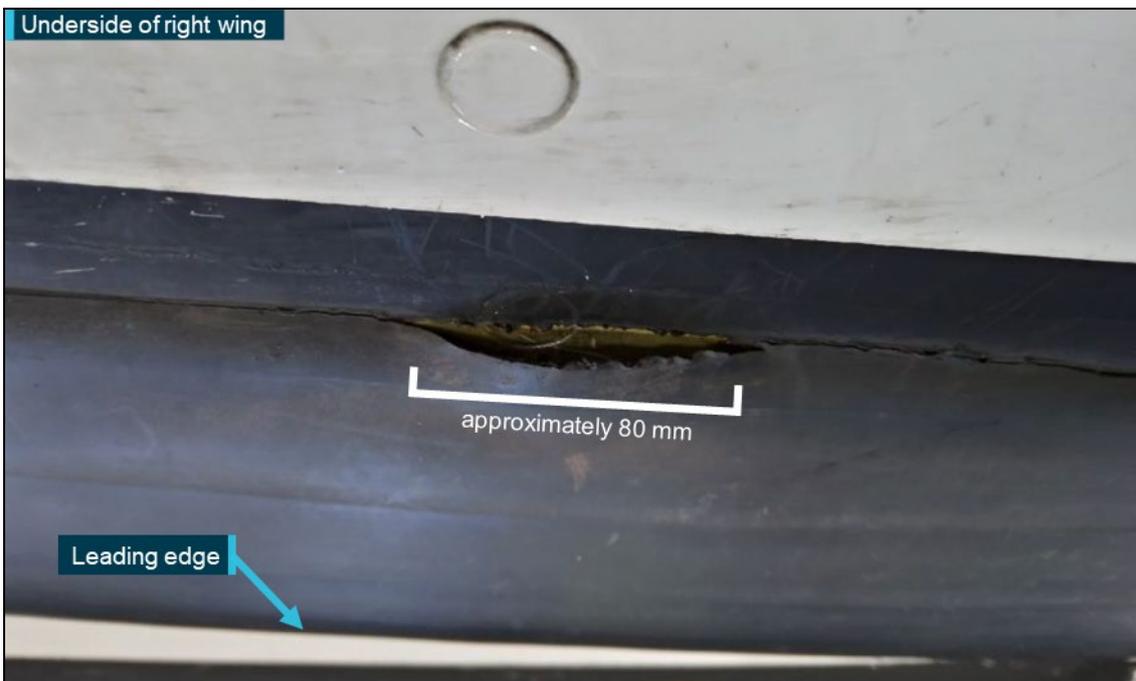
Post-flight examination of the de-ice system revealed a delamination in the right wing inboard de-ice boot on the underside of the wing (Figure 2). The aircraft operator stated that this was probably caused by an internal stitching failure, resulting in the loss of system pressure. The boot was replaced and the de-ice system was subsequently tested serviceable. The ATSB reviewed the aircraft's maintenance history related to the de-ice system and found it compliant with the required maintenance.

Figure 2: Right wing inboard boot delamination

Shortly after the aircraft departed Perth, the flight crew received cockpit indications of a de-ice system fault. The fault was probably triggered by a delaminated de-ice boot on the underside of the right wing that failed during its inflation cycle shortly before encountering icing conditions. With a low freezing level and forecast icing conditions along the planned route, the de-ice fault indication led to the flight crew’s decision to return to Perth.

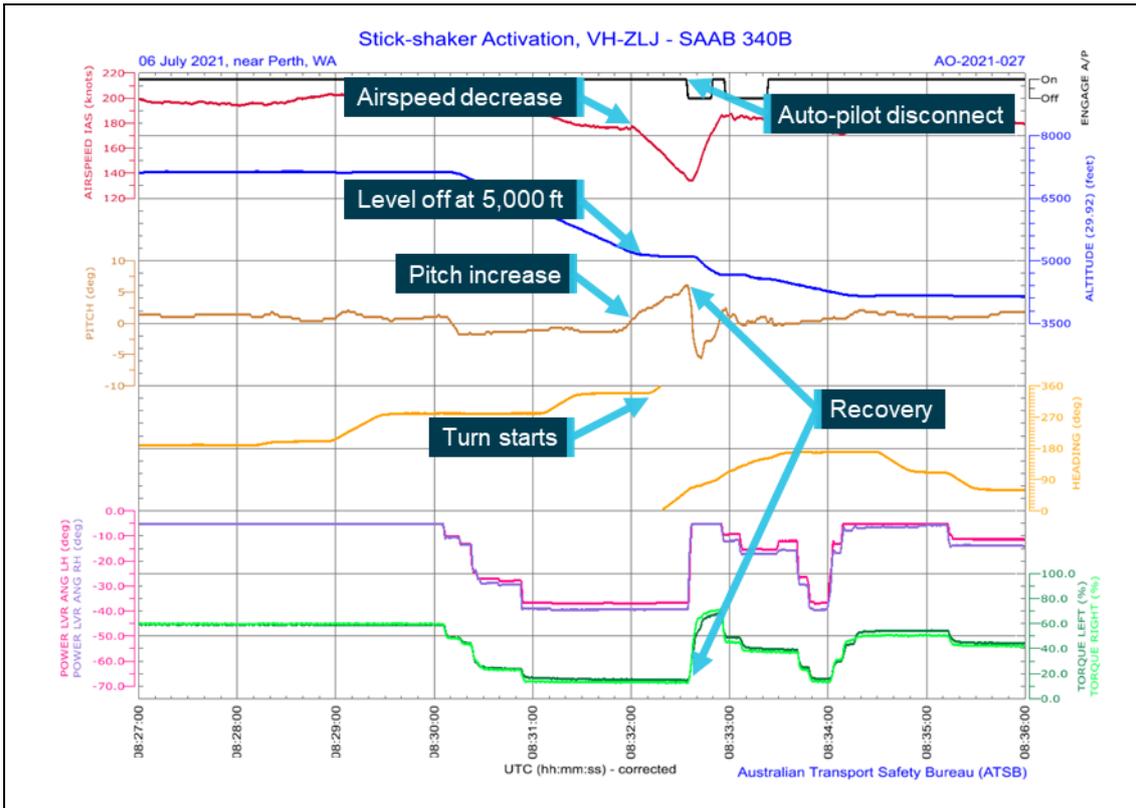
Figure 3 shows verified flight data for certain recorded parameters at the time of the incident. The data shows that during level flight at 7,000 ft, engine power was at about 60% torque. During the descent to 5,000 ft, engine power was reduced by the flight crew to about 15% torque. After levelling off at 5,000 ft, engine power remained at that level, however the aircraft's pitch angle increased, while the airspeed decreased. The pitch increase and airspeed reduction continued after the turn was commenced. About 20 seconds later, the autopilot disconnected, and the flight crew initiated the stall recovery.⁵ Altitude lost during recovery was about 450 ft.

The investigation could not determine which AOA sensor triggered the stick shaker, but the flight data was consistent with the aircraft approaching a stalled condition, so the early triggering of the left AOA sensor did not affect the outcome.

Figure 3: VH-ZLJ flight data
