Runway overrun involving Gippsland Aeronautics GA-8, VH-WSB

East Wallabi Island, Western Australia on 26 December 2021

ATSB Transport Safety Report
Aviation Occurrence Investigation (Short)
AO-2022-001
Final – 27 April 2022

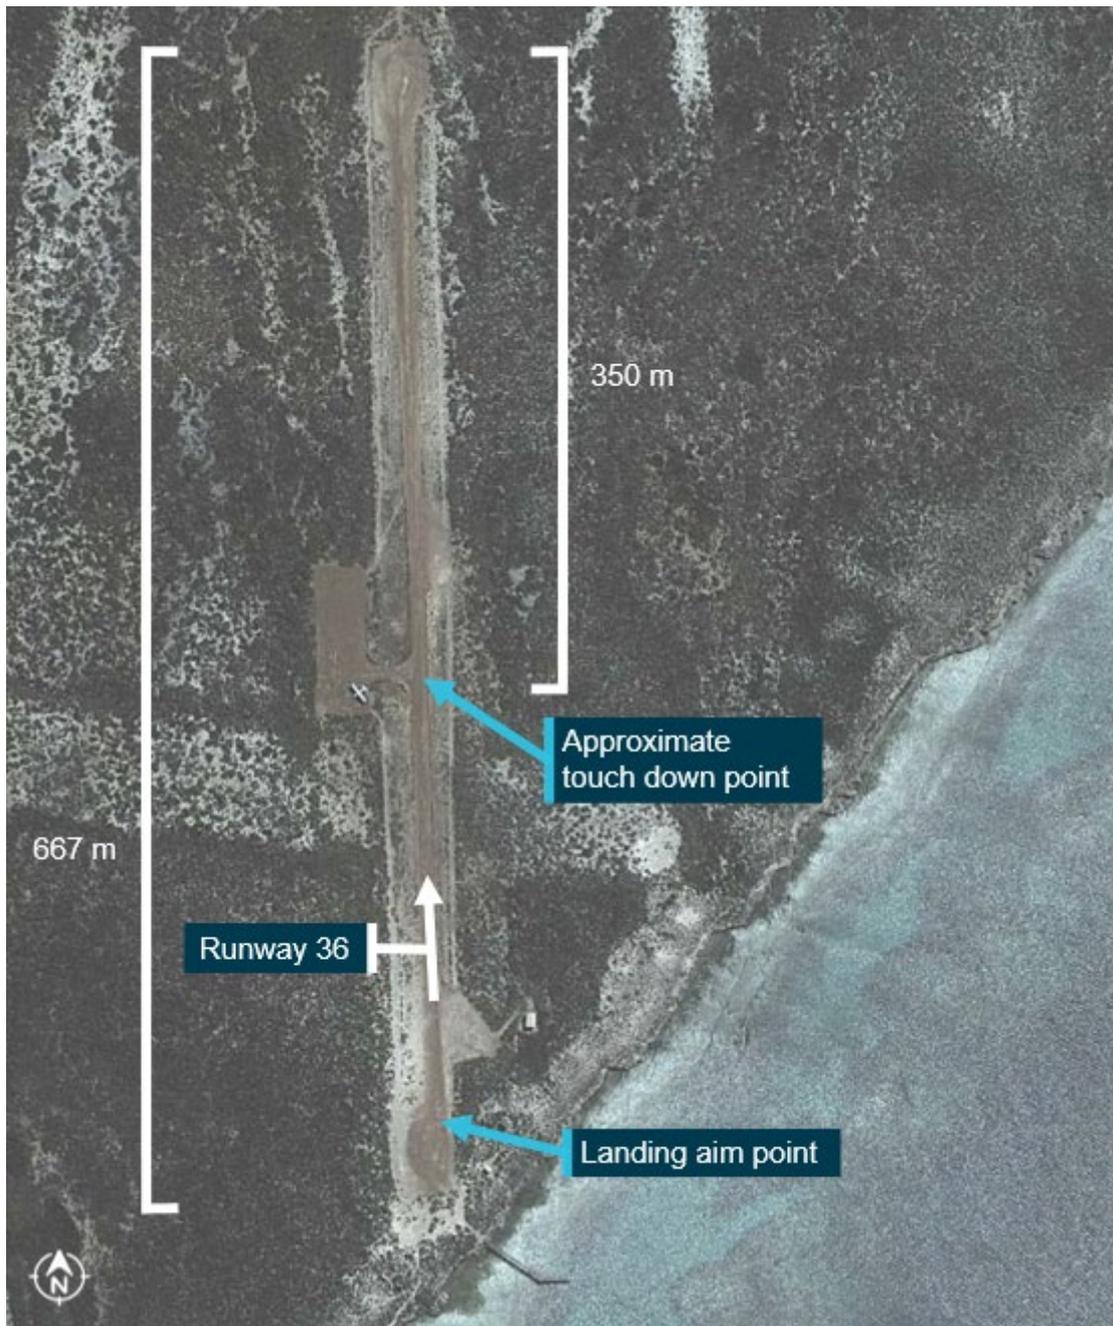
Figure 2: East Wallabi Island airstrip

Runway 36 was 667 m long with a slight downslope. The pilot aimed to touch down in the turnaround area of the runway (Figure 2). As the aircraft crossed the runway threshold at about 70 knots, the pilot reduced engine power to idle and flared³ the aircraft. During the flare, the aircraft floated more than the pilot expected and touched down near the parking area about midway along the runway (about 350 m from the end of the runway).

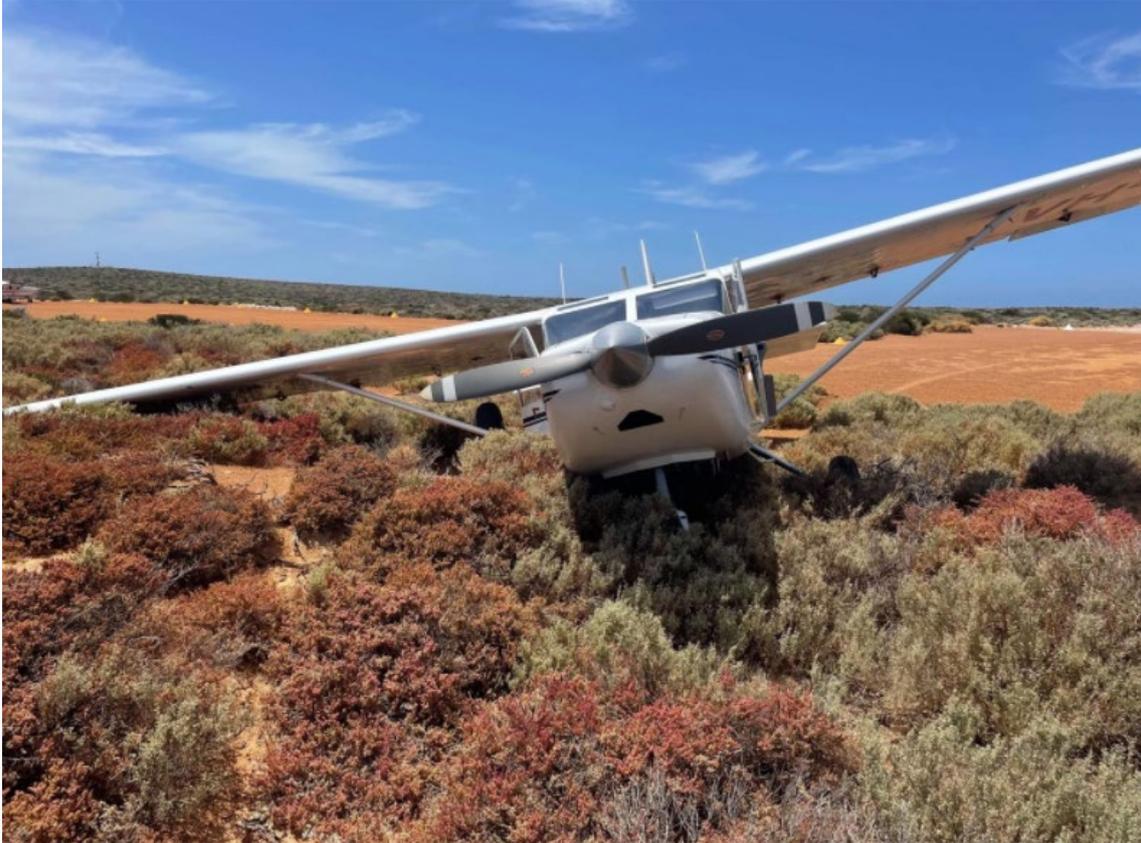
Figure 3: VH-WSB after the runway excursion

After touch down, the pilot followed the operator’s normal practice of retracting the flaps and then applied normal braking. As the aircraft approached the end of the runway, the pilot realised an overrun was imminent, and applied maximum braking. Despite that, the aircraft overran the runway by about 15 m (Figure 3). The pilot and passengers were not injured, however the aircraft was substantially damaged, including detachment of a main landing gear leg.

Following the accident, the operator modified operating procedures to recommend a process of threat and error management be conducted before all flights.

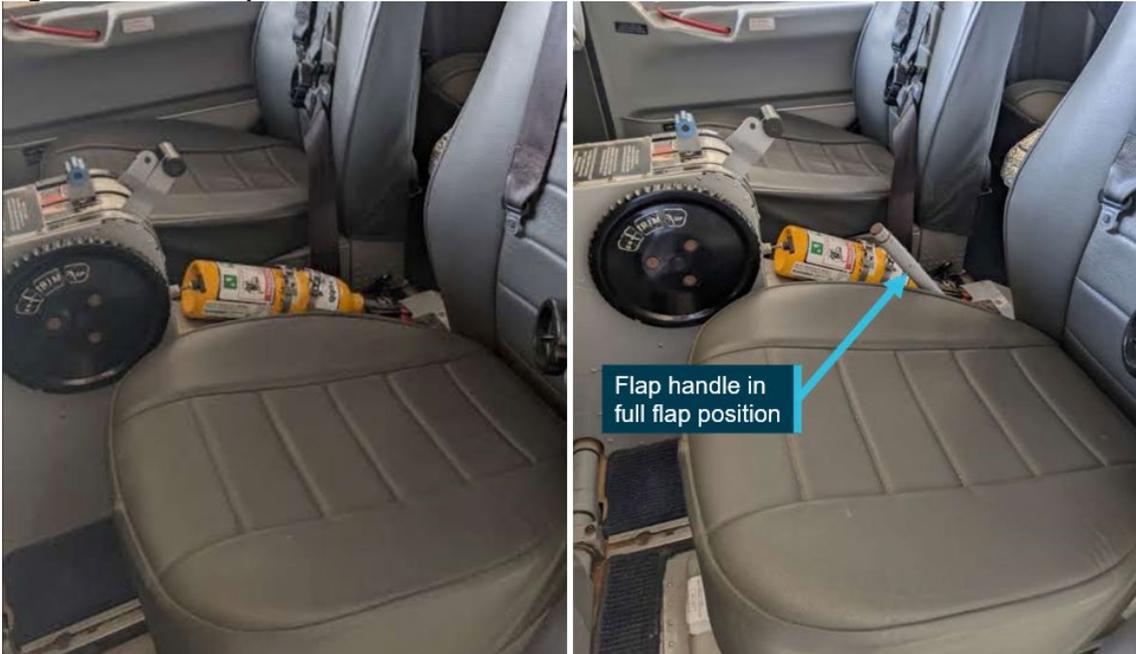
Figure 4: Airvan flap lever

The pilot turned onto the final leg of the circuit and attempted to select full flap for the landing, but the EPIRB obstructed the flap lever movement and prevented it from locking into the full flap position. Multiple further attempts to select full flap were unsuccessful, and the approach was continued with only the first stage of flap extended.

The Airvan is fitted with manually operated wing flaps with three, selectable positions: retracted, first stage (14° down) and full (38° down). The position of the flaps is determined by notches engaged by the operating lever positioned on the cabin floor to the right of the pilot’s seat. In the retracted and first stage positions, the lever remained below the level of the pilot’s seat bolster. In the full flap position, the lever protruded above the level of the bolster (Figure 4). The aircraft flight manual stated that ‘landings are normally conducted with full flaps’.

Note: The flap lever rests below the pilot seat bolster and is not visible in the retracted and first stage positions (left). The flap lever protrudes above the bolster in the full flap position (right).
