ATSB TRANSPORT SAFETY INVESTIGATION REPORT

Aviation Occurrence Report – 200504018

**Operational and flight safety implications of the
installation of hardened cockpit security doors in
passenger aircraft having a seating capacity
of 30 seats or more**

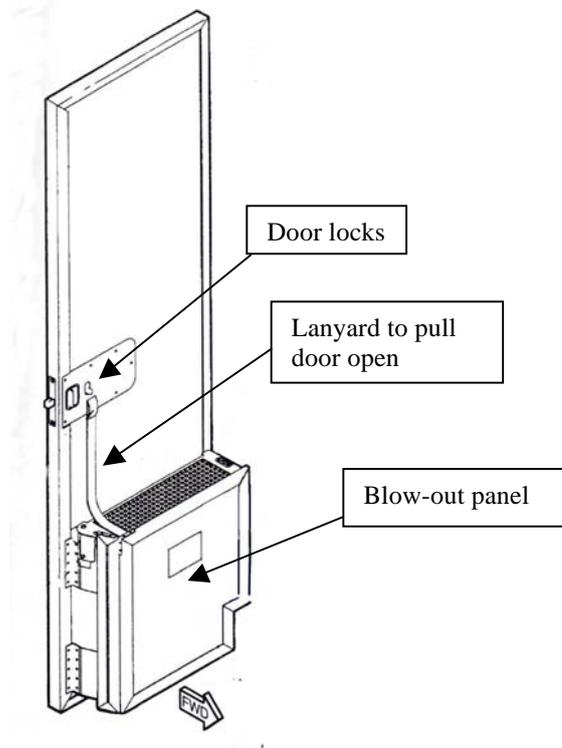
Figure 1: Hardened cockpit security door

On 14 April 2005 a crew member of a SAAB Aircraft AB SF-340B (SAAB 340B) suffered a minor injury as a result of coming into contact with the sharp edges of the recently installed hardened cockpit security door (figure 1). The security door incorporated a cover over the pressurisation blow-out panel² that restricted the available standing room for visitors to the flight deck. A similar injury was reported to have occurred previously in like circumstances.
