# Engine room flooding on board *Great Majesty*

Port Kembla, New South Wales  
27 October 2008

## Abstract

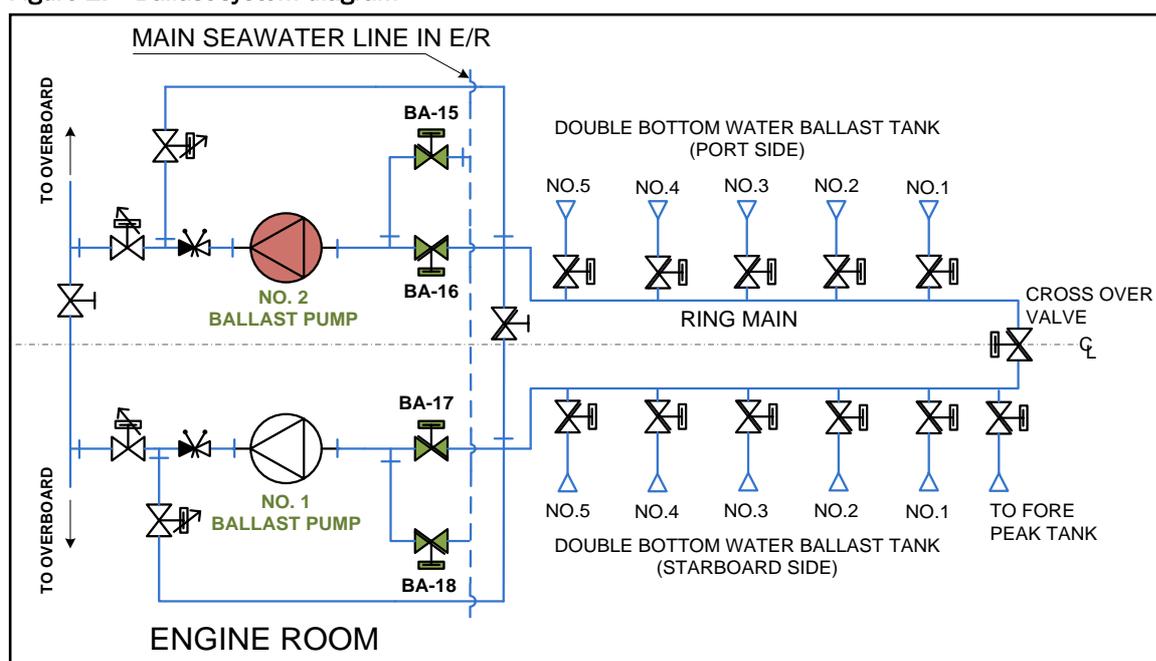
Figure 2: Ballast system diagram

The ballast pumps are connected to the engine room seawater main through either of the remotely operated butterfly valves, BA-15 and BA-18 (Figure 2).

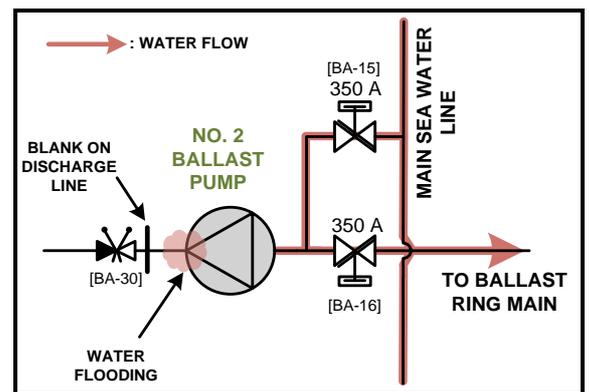
Figure 3: Flooding line

At 1745, the chief mate started to gravitate water ballast into No. 1 WBTK. He opened valves BA-15 and BA-16 (Figure 3) to connect the main sea water line to the ballast main piping.

About 10 minutes later, the motorman who was on duty in the engine room heard the bilge alarm sound. On investigation, he saw seawater flooding into the engine room through the open casing of No. 2 WB P/P. The motorman immediately informed the third engineer who, in turn, called the chief engineer.

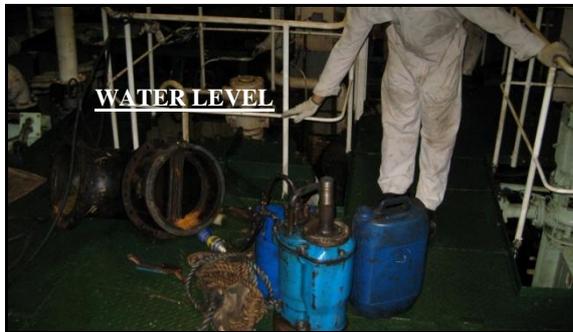
**Figure 4: Flooded water level indicated by hand**

On inspection, it was found that the water level in the engine room was about 1 m above the bottom plates (Figure 4).

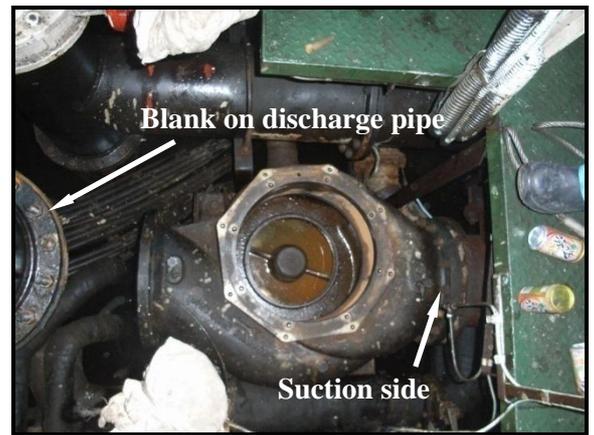
**Figure 5: Disassembled pump casing**

At about 1800 on 27 October 2008, seawater flooded *Great Majesty's* engine room bottom plates when the chief mate remotely opened valves adjacent to No. 2 WB P/P. The pump had been stripped for repairs and while the discharge line from the pump had been blanked, the pump casing was left open and the suction line to the pump and its casing had not been blanked off (Figure 5).

- When the ballast pump was disassembled for repair, the suction pipe was not blanked off and the suction valves were not isolated. Consequently, the chief mate was able to remotely open the pump's suction valves and connect the open pump casing to the main seawater line, which resulted in the flooding.
