A U S T R A L I A N   T R A N S P O R T   S A F E T Y   B U R E A U

MARINE SAFETY INVESTIGATION

Independent investigation into the grounding  
of the Malaysian flag container ship

Sudbury Reef, Great Barrier Reef  
2 November 2000

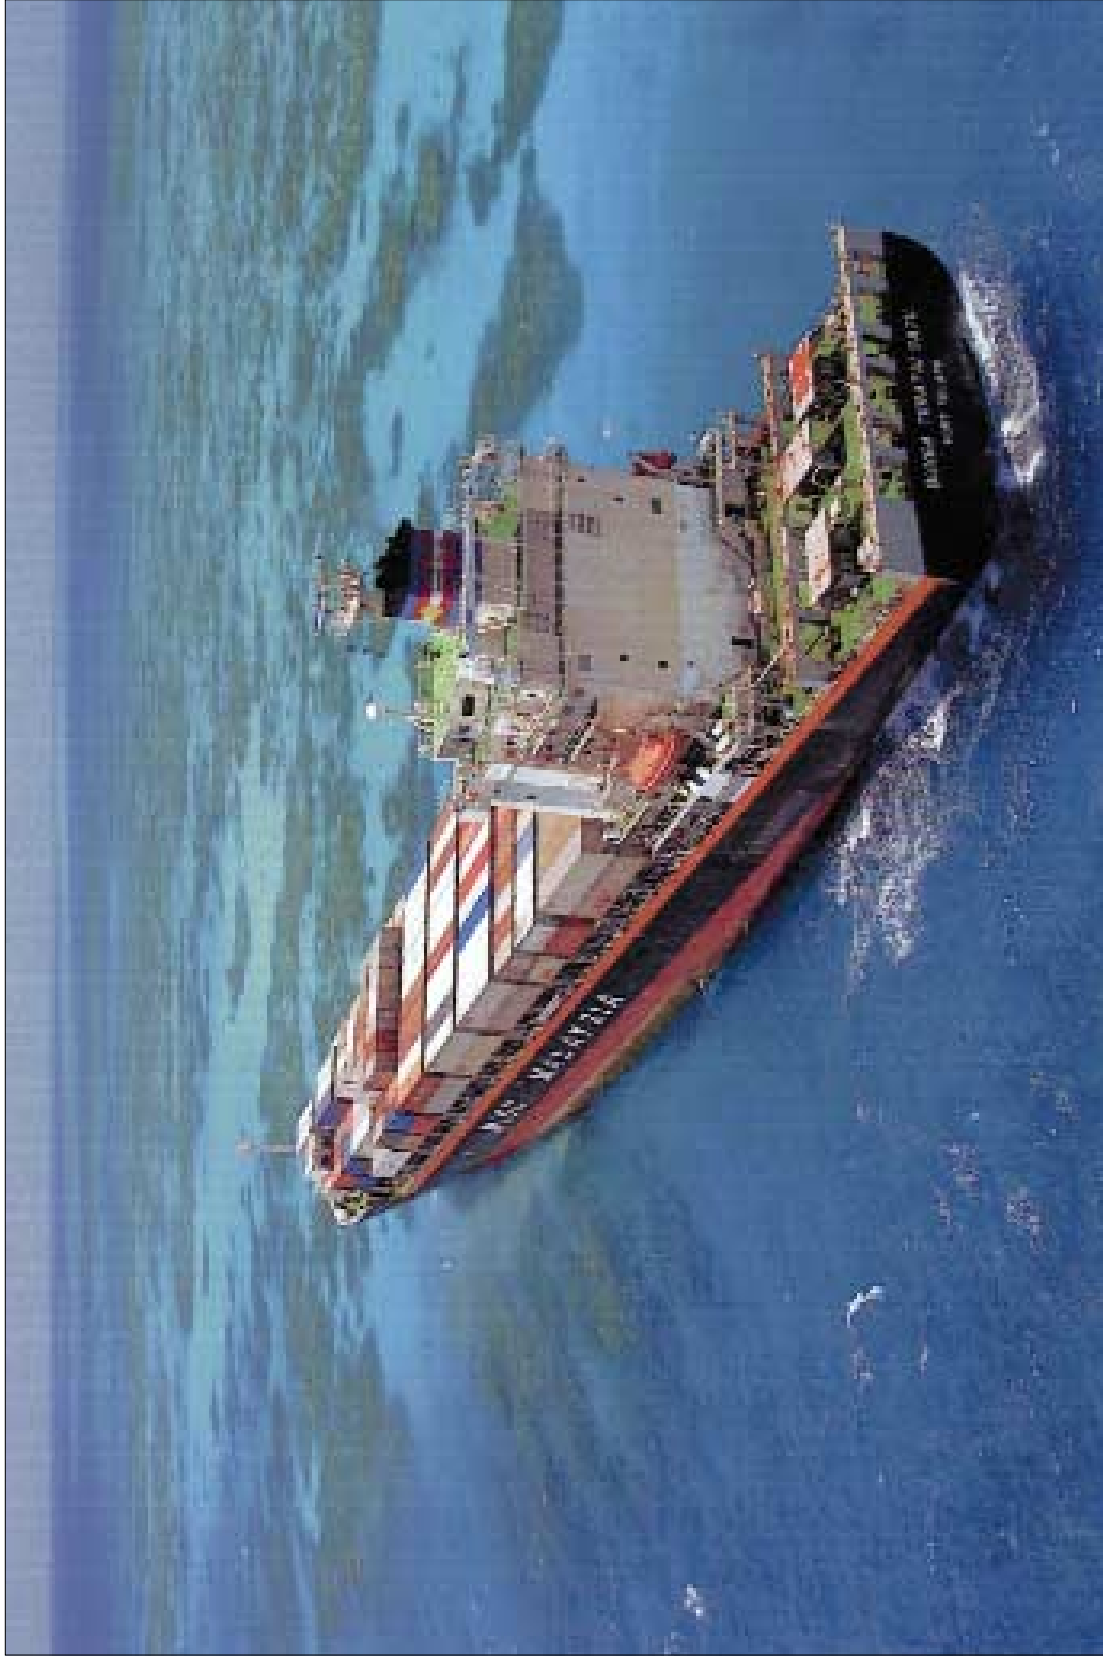
**Figure 1:**  
***Bunga Teratai Satu*** aground on Sudbury Reef

At about 0723, the ship struck the north end of Sudbury Reef at a speed of over 20 knots on a heading of 120°. It was about 1<sup>3</sup>/<sub>4</sub> hours after low water and the vessel's bow rode some 100 metres onto the reef leaving the stern in approximately 12 metres of water.

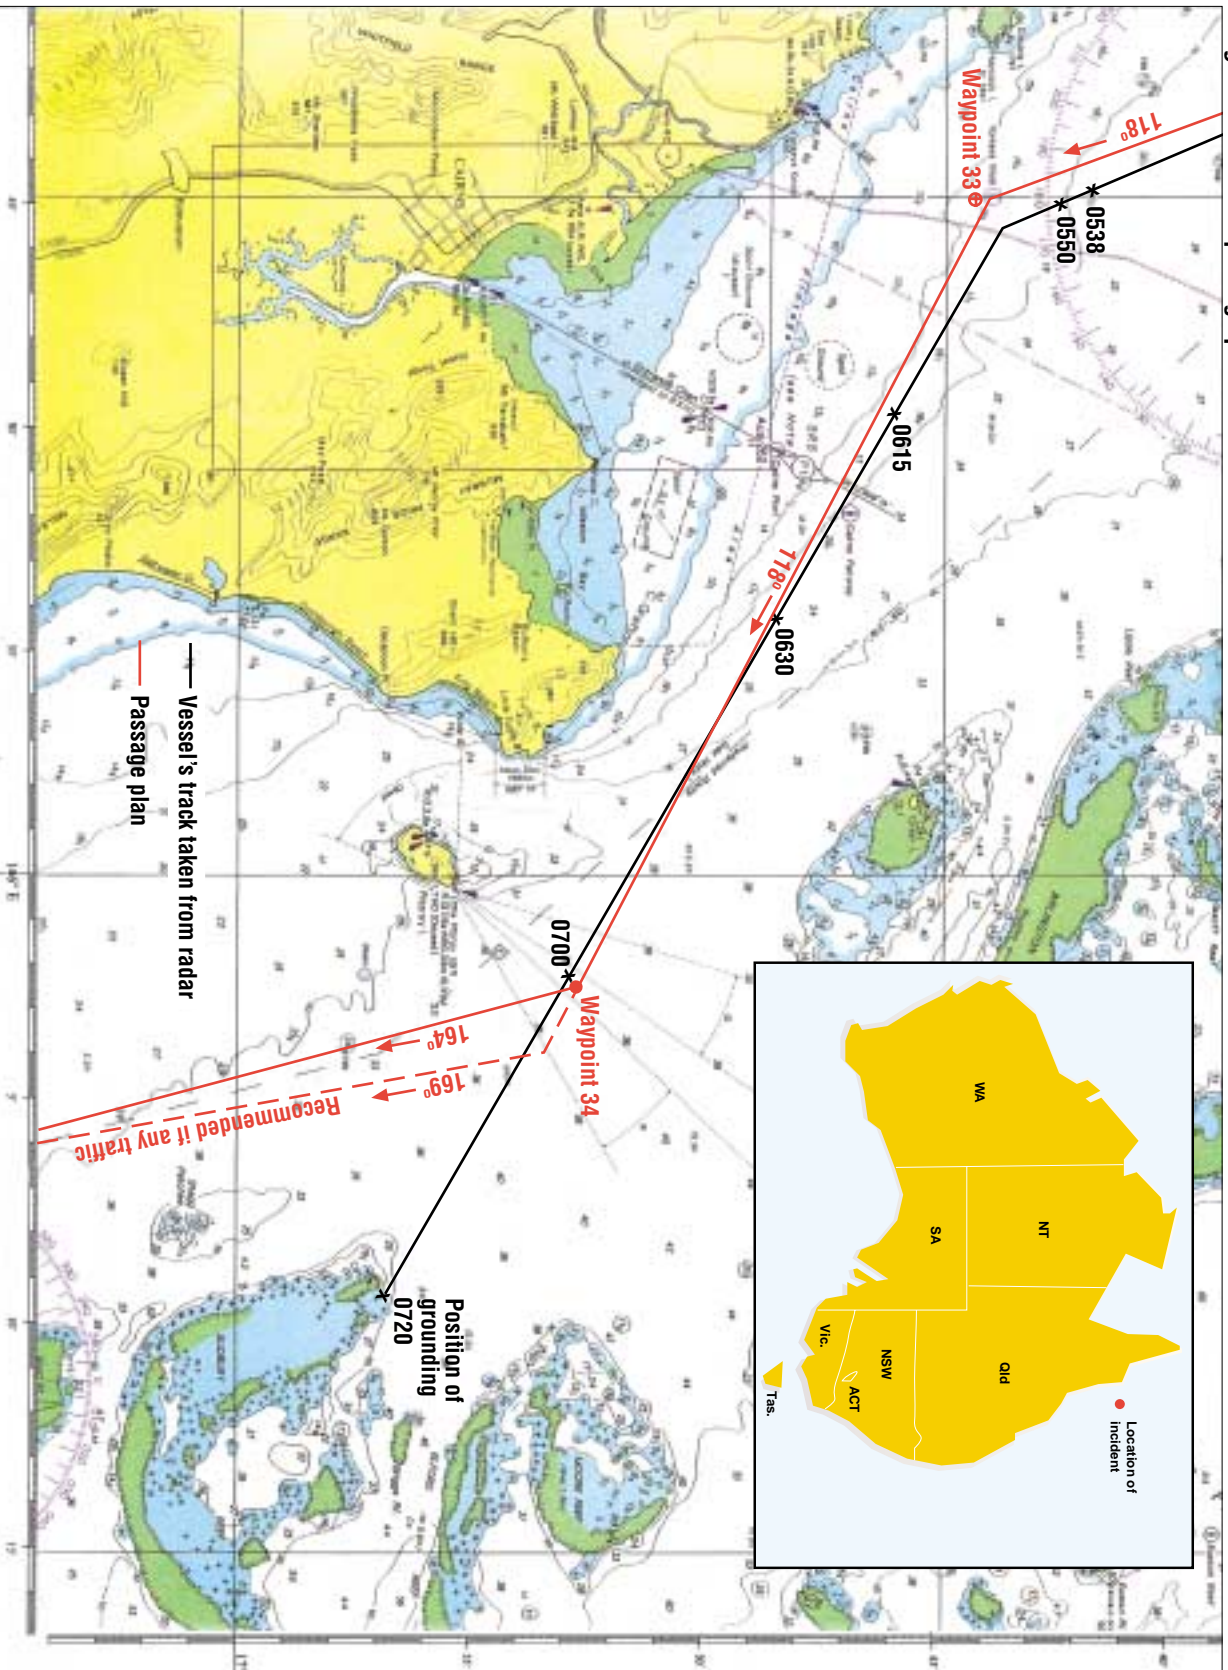
At 0600, 'full away' was rung and the vessel resumed its passage to Sydney on a course of 120° (true). A programmed way-point, at position 16° 52.8' S, 146° 02.3' E, was reached at 0700. At this way-point, the course was supposed to be altered to 164° (true) to round Fitzroy Island and take the vessel to the west of Sudbury Reef. However, no course alteration was made.

Figure 2:  
 Bunga Teratai Satu's passage plan and track

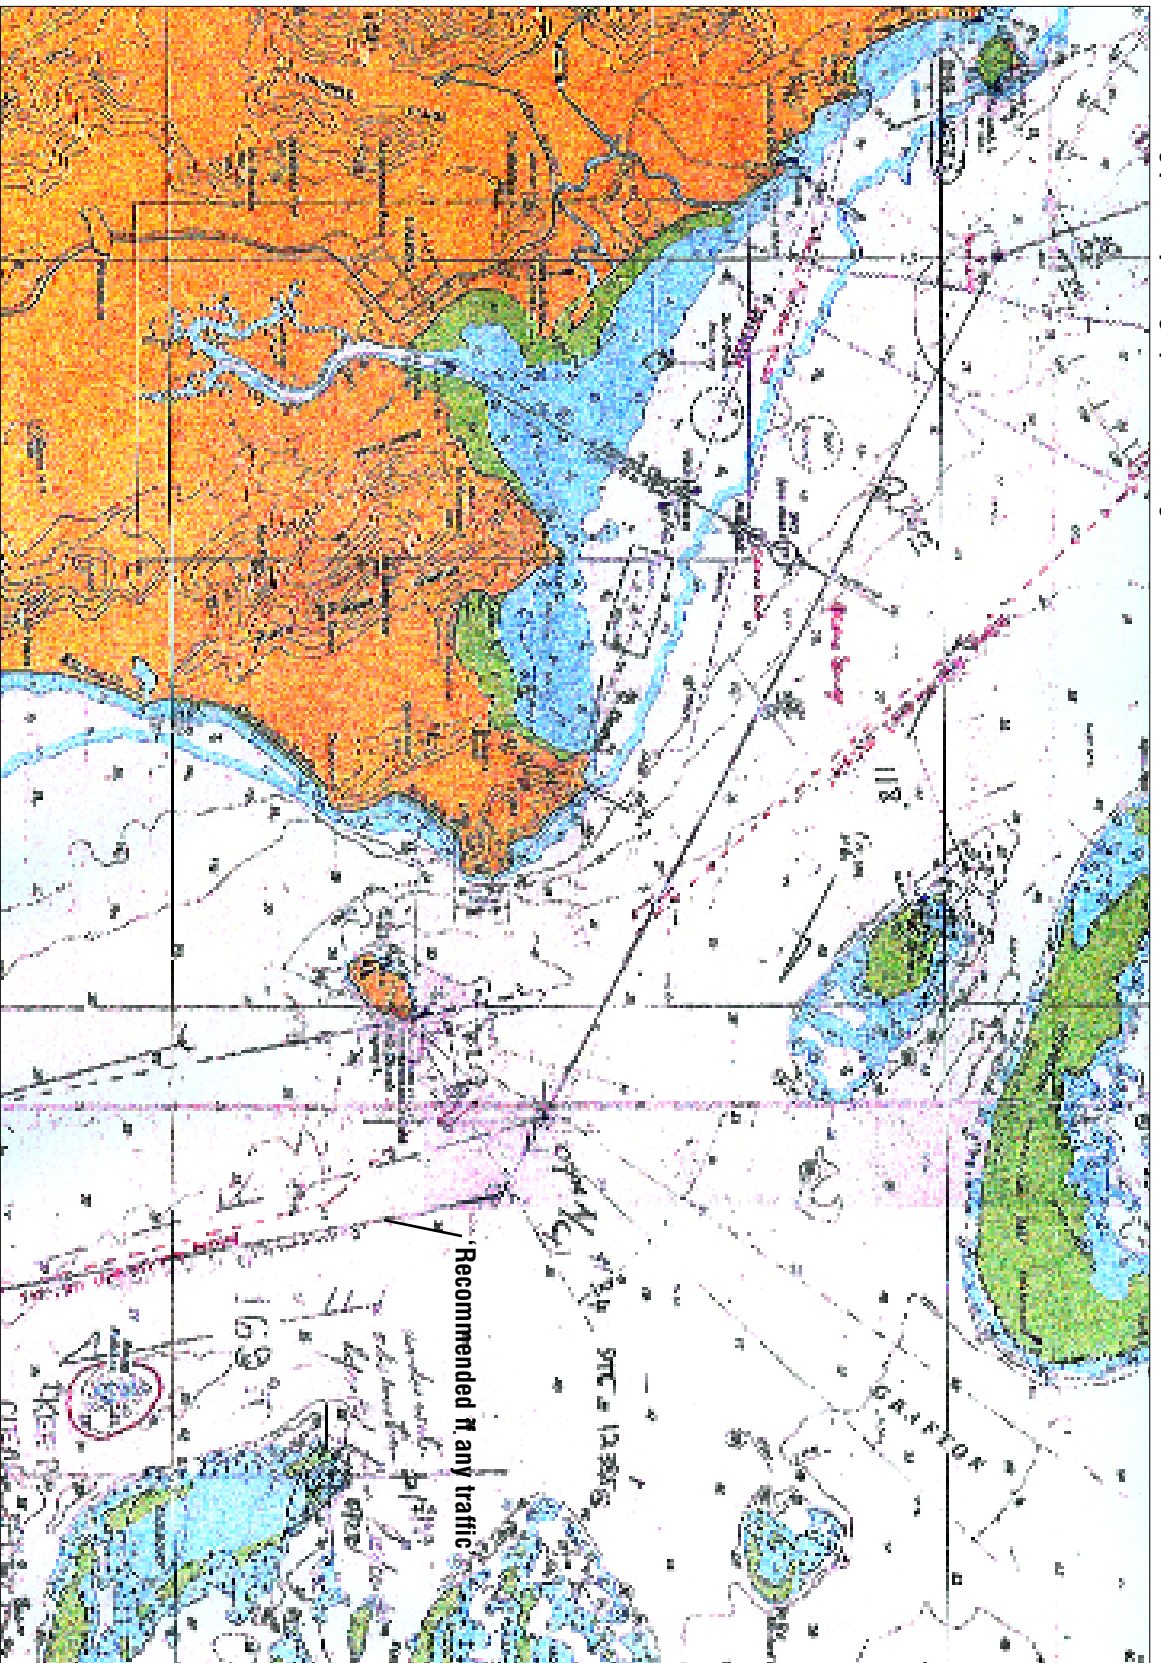
At around 0717, after making coffee, the mate went to the chart table and checked the 0700 position. He looked over the chart table console and told the AB that he had made a mistake in plotting the position. Shortly afterwards he told the AB 'change to hand steering'. He then asked the AB for the ship's heading to which the AB replied '120°', the mate said 'steer 180°'. The AB however, could see a sand cay on the ship's starboard bow and, instead of altering course, asked the mate if he was sure that he wanted to turn to 180°, towards the sand cay. He added words to the effect, 'Chief,

Figure 3:  
Chart showing plotted passage plan from Bunga Teratai Satu

can we go over shallow water?’ The mate then responded ‘turn 180° to port’. Confused, the AB did nothing and, seconds later, they felt the ship shuddering as it took the ground.

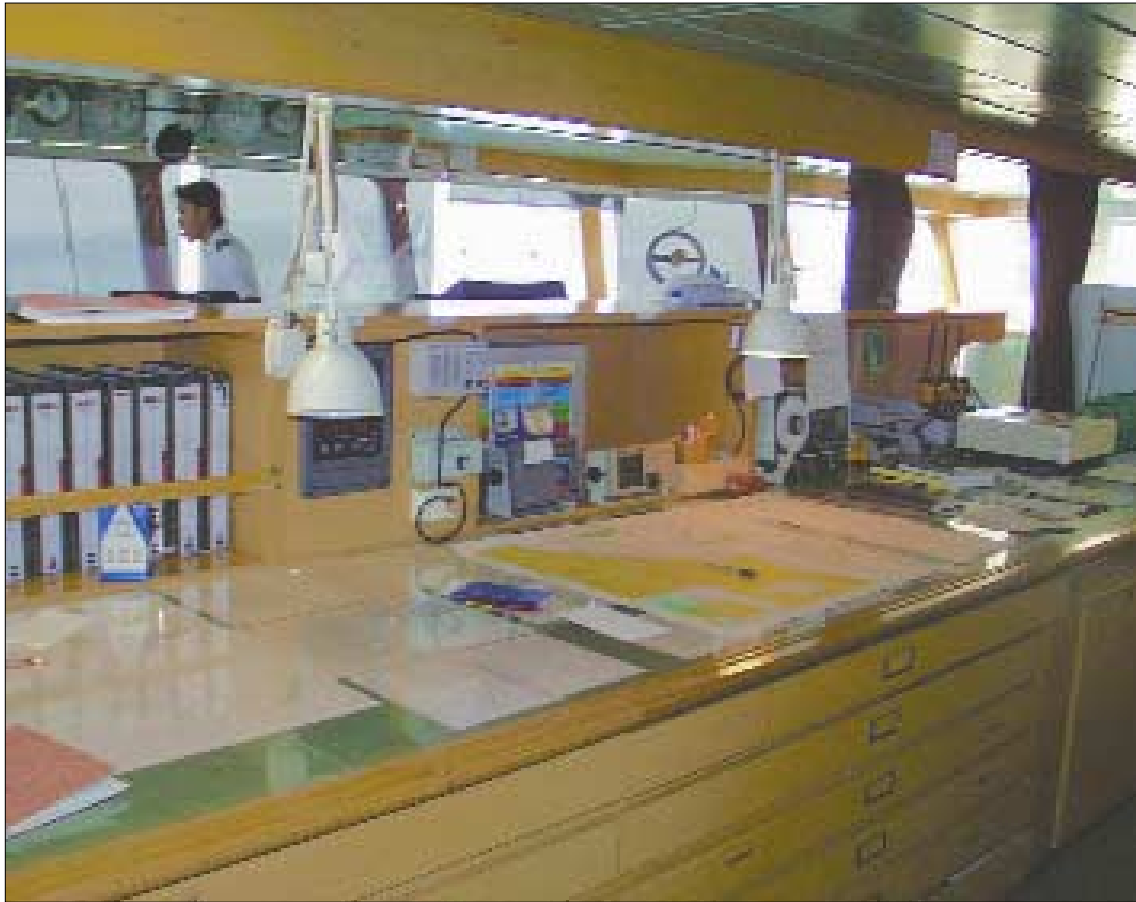
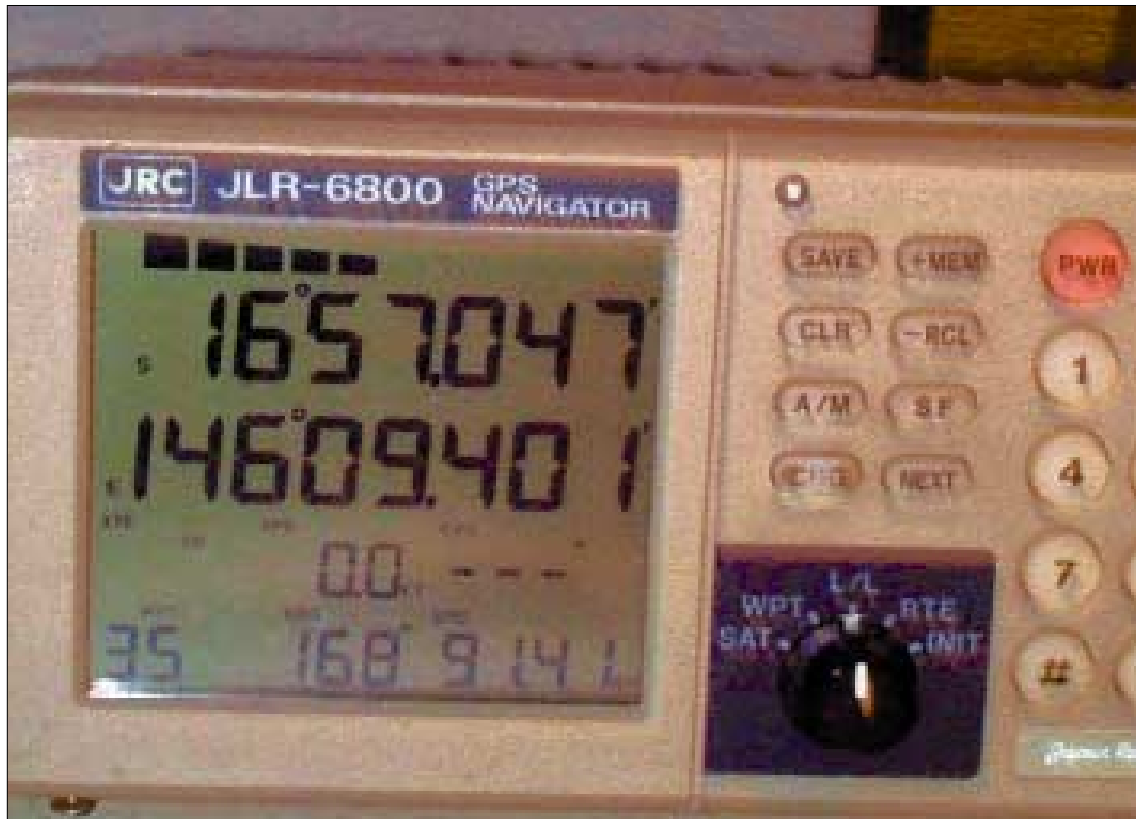
On 21 November, a specialist maintenance engineer examined the ship's GPS on behalf of the Inspector. (Figs. 4 and 5 ) No fault was found either in the aerial or in the receiver. The ship's staff stated that the GPS was functioning properly both before and after the grounding. It is therefore concluded that the GPS was working properly and there was no fault in the system at the time of the incident.

Figure 4:  
*Bunga Teratai Satu's* chart table

Figure 5:  
*Bunga Teratai Satu's* GPS

It should be pointed out that the GPS alarm is not loud and is identical for all alarm conditions. The alarm cannot be heard on the bridge wing, or over the noise of the vacuum cleaner when the bridge is being cleaned. Also it is similar to the Digital Selective Call alarm, part of the GMDSS system, which was located a few metres from the GPS.

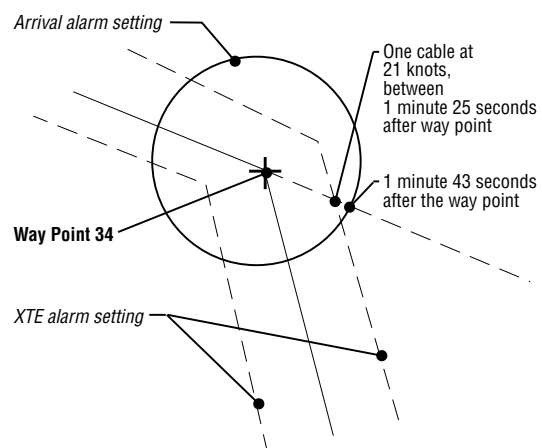
There is no clear evidence as to when any audible alarm was cancelled at, or near waypoint 34. The arrival alarm would have sounded just after 0658 and if it had not been cancelled, would have continued sounding until the XTE alarm was finally cancelled after the grounding. The AB could not recall either the alarm or the mate being inside the wheelhouse after the time his wife arrived on the bridge. The mate stated that he cancelled the alarm, although it is not

**Figure 6:**  
**Diagram showing GPS urgent alarm times**

clear if this took place at 0700, or after 0715 when he checked the ship's position following the phone calls.

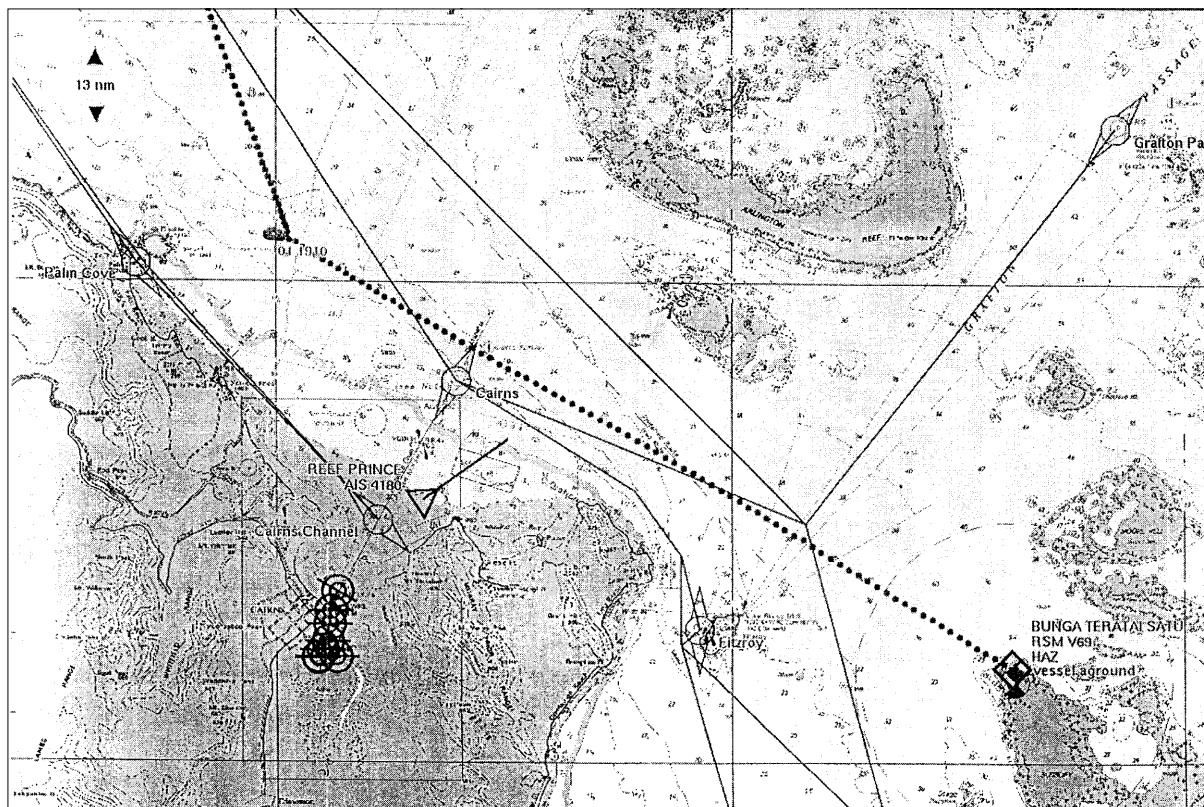
However, the system management records show *Bunga Teratai Satu* had passed its waypoint marginally before 0700. There was a period of about 15 minutes, in which the ship maintained a steady course for 5 miles deviating from its planned track before entering the restricted area and triggering the urgent alert message (fig. 7). The circumstances envisaged in 5-3-10 of the

**Figure 7:**  
***Bunga Teratai Satu's* track on Sirius**

Unless the operator had specifically looked at the Green Island radar display during this time he would not have realised that Bunga Teratai Satu had failed to alter course.

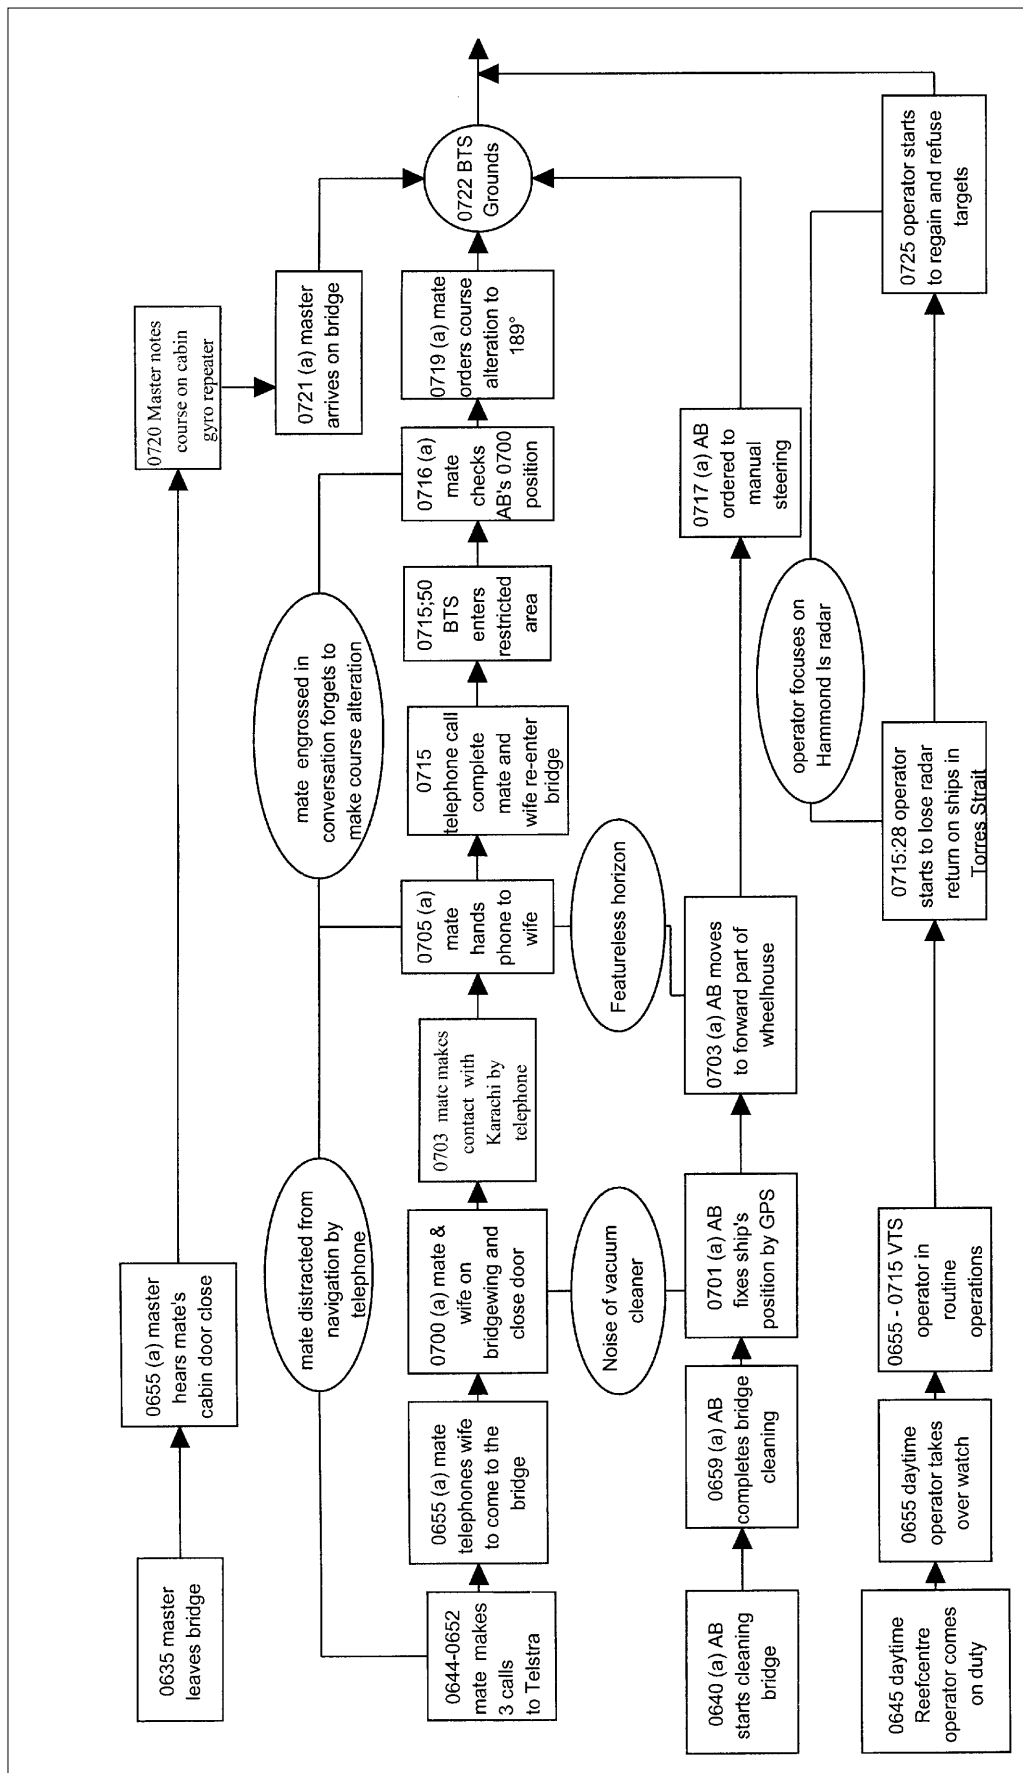
Figure 8:  
Bunga Tertai Satu events and causal factor chart

1. The significant unsafe act that resulted in the grounding was that the mate allowed himself to become distracted, for a period of about 15 minutes, from the navigation of the ship by a telephone conversation between his wife, who was on the ship's bridge wing, and his family overseas.
2. From about 0645 to 0715 the mate had become preoccupied with arranging and making private telephone calls while the ship was in cellular phone range of the coast, rather than monitoring the ship's course, speed, position and his other watchkeeping duties.
3. The manner in which the mate maintained his watch on 2 November 2000 lacked appropriate motivation and fell well below proper professional standards.
