Australian Government
Australian Transport Safety Bureau

Crew member burnt on board ship off Carnarvon, Western Australia

21 April 2005

Crew member burnt in explosion while working on hydraulic pipeline on board *Hui Shun Hai*

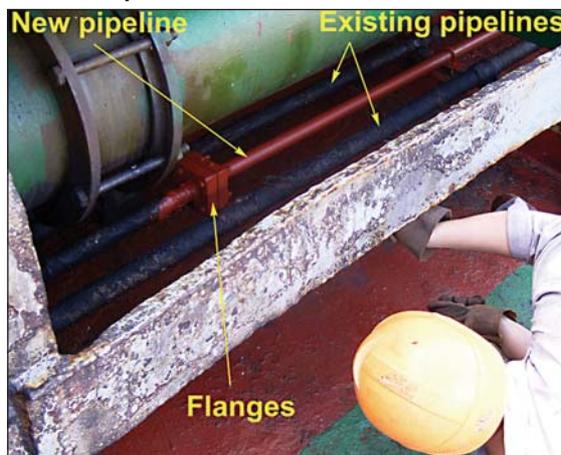
Figure 2: Welder's position on the deck prior to the explosion

In order to access the after flange on the section of pipe which was to be replaced, the welder had to lie on the deck, on his left side, and angle the oxygen-acetylene cutting head up behind another hydraulic pipe (Figure 2).

At 0842, while the welder was in the process of cutting off the third bolt joining the flanges, they separated and hydraulic oil in the pipe, under high pressure, escaped. This oil ignited when it came into contact with the oxygen-acetylene flame.

A fireball about seven metres in diameter enveloped the welder and the oxygen-acetylene bottles nearby.

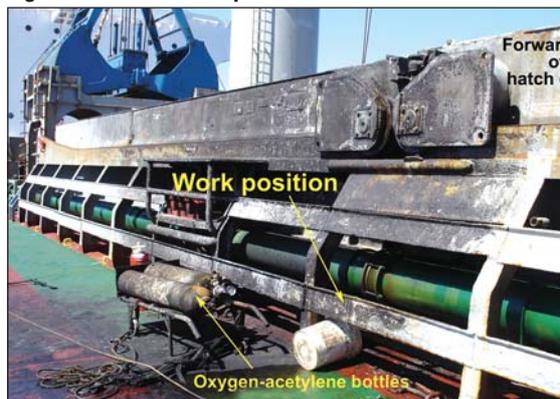
Figure 4: Location of explosion

The trolley on which the oxygen-acetylene bottles were mounted was located in very close proximity to where the welder was working on the flange nuts (figure 4).

While the oxygen-acetylene bottles did not explode, their proximity to the source of the explosion could have resulted in a significantly worse incident occurring.

Given the lengths of rubber hosing connecting the bottles to the cutting head, it may well have been prudent for the trolley and bottles to have been positioned well away from the area of work being undertaken. Had this been done, the risks associated with using these flammable gases would have been lessened.

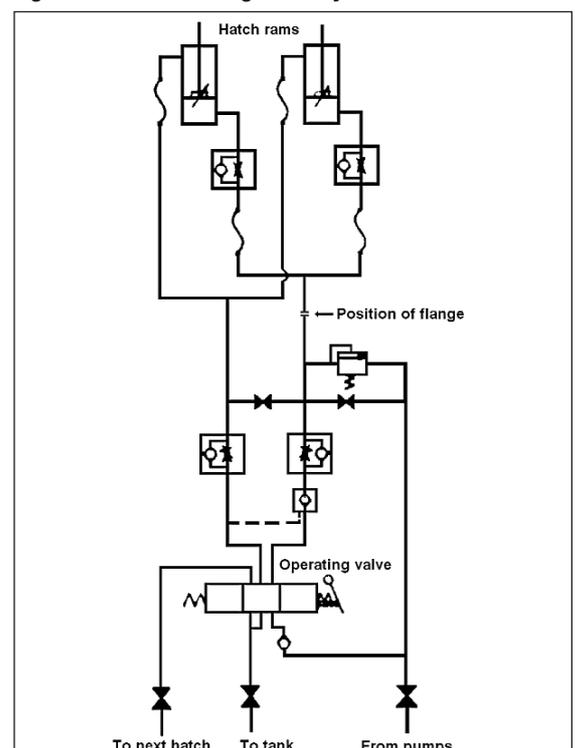
Figure 5: Schematic diagram of system

However, no-one involved in the work on number four hatch that morning had considered the pressure in the hydraulic circuit. This residual pressure was present due to the loaded state of the hatch cover actuating rams with the covers only partially open. The hydraulic rams were the only thing holding the covers in the half open position and resulted in oil pressure, due to the weight of the hatch covers, still being present in the supply side of the ram's pistons.

There was no securing device to enable the covers to be locked in the half open position (only in the fully open position), which would have allowed the pressure to be released from the hydraulic system. Had the covers been in either the fully open or closed position, the pressure in the hydraulic circuit could have been relieved, rendering the line safe to work on.

The fact that the ship's crew did not realise that the half open hatch cover would result in residual oil pressure in the hydraulic system was directly causal in this incident.

Ship's managers and masters should review their safety management systems and the associated permit to work arrangements, to ensure that hydraulic systems are correctly isolated and relieved of pressure before work on the system has commenced.
