Interrupted engine start and evacuation involving SAAB 340B, VH-ZRK

Melbourne Airport, Victoria, on 5 April 2022

ATSB Transport Safety Report

AO-2022-019

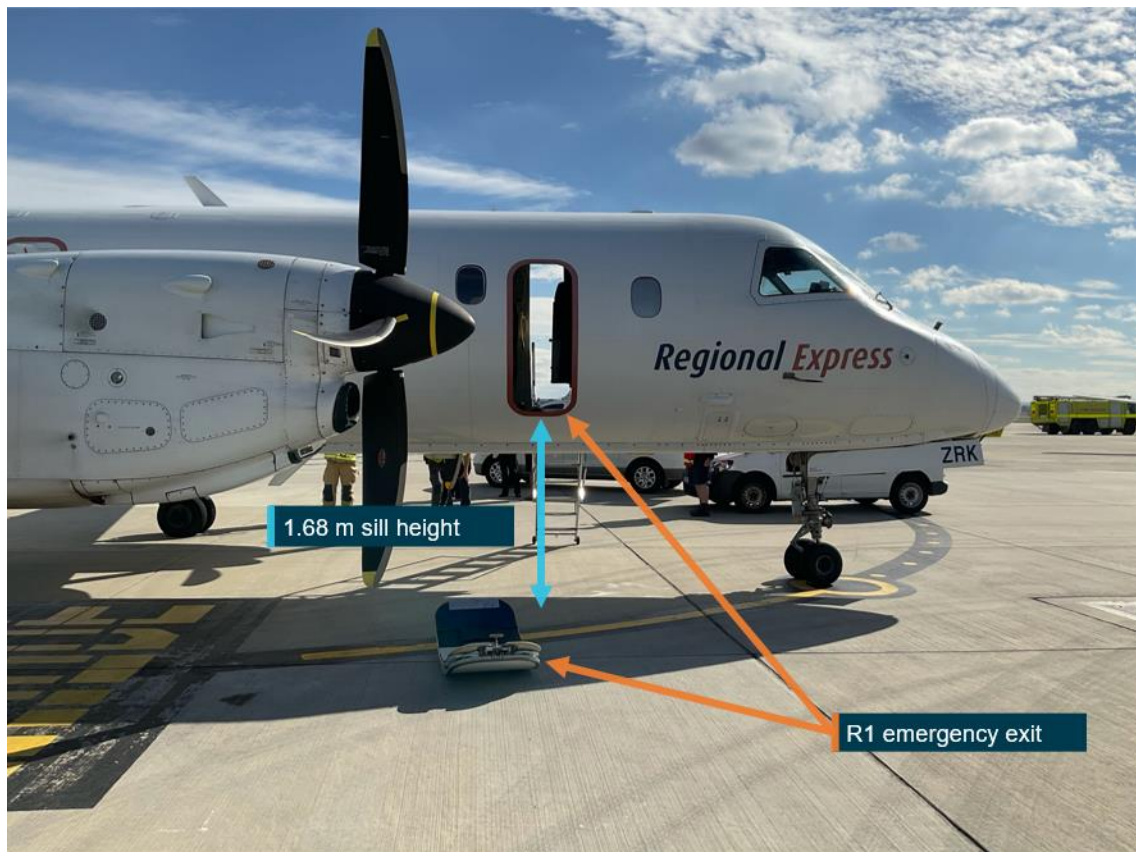
Figure 1: Forward right (R1) emergency exit

- After the right propeller stopped rotating, the R1 exit was opened. Shortly after, the first passenger exited the aircraft. The evacuation of all passengers and crew via the R1 door (Figure 1) took about 4 minutes.

The R1 door has no escape slide. Passengers are instructed to 'sit and jump' from the door sill.
 Source: Melbourne Airport, annotated by the ATSB
