# VFR into IMC and in-flight break-up involving Van's Aircraft RV-7A, VH-XWI

90 km south of Charters Towers, Queensland, on 23 April 2021

**ATSB Transport Safety Report**

AO-2021-017

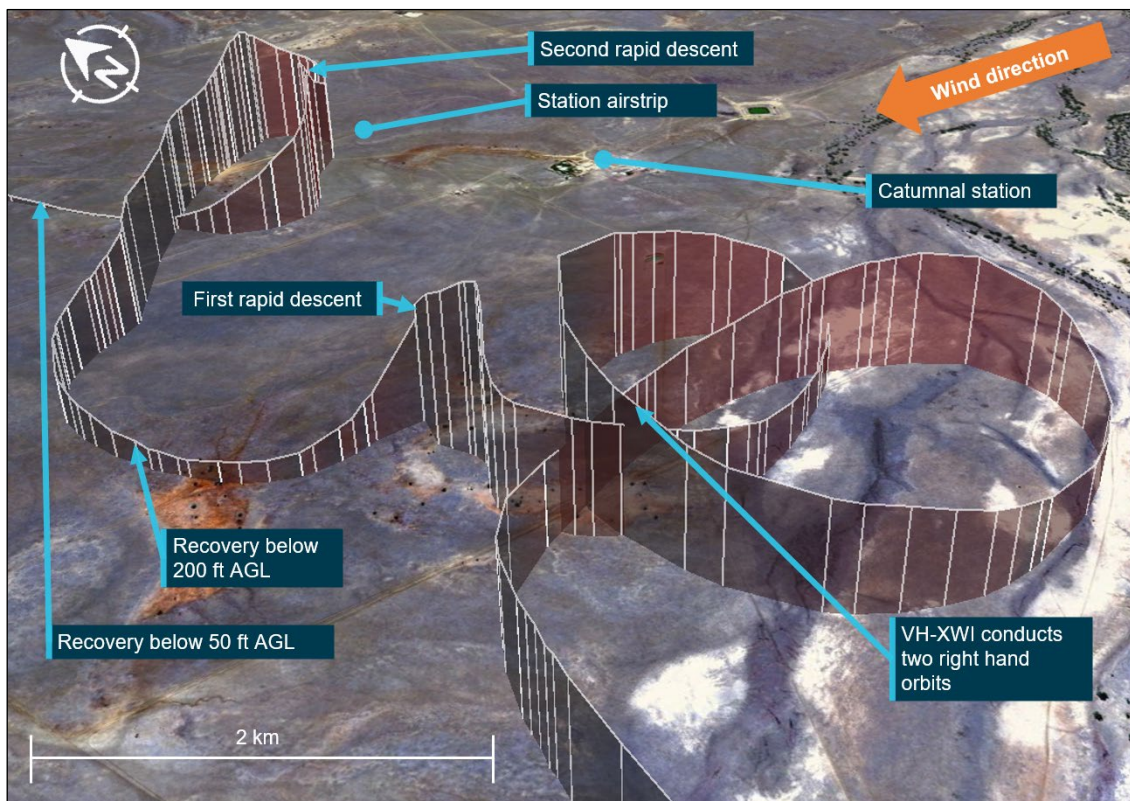
**Figure 1: Flight path of VH-XWI over Catumnal Station**

At 0826, when the aircraft was near Catumnal Station, about 100 km north-east of Winton, the aircraft descended to about 500 ft above ground level (AGL) (Figure 2). The aircraft conducted 2 right orbits about 7 km to the south-west of Catumnal Station at indicated airspeeds as low as 25 kt, before rapidly descending to less than 200 ft AGL.

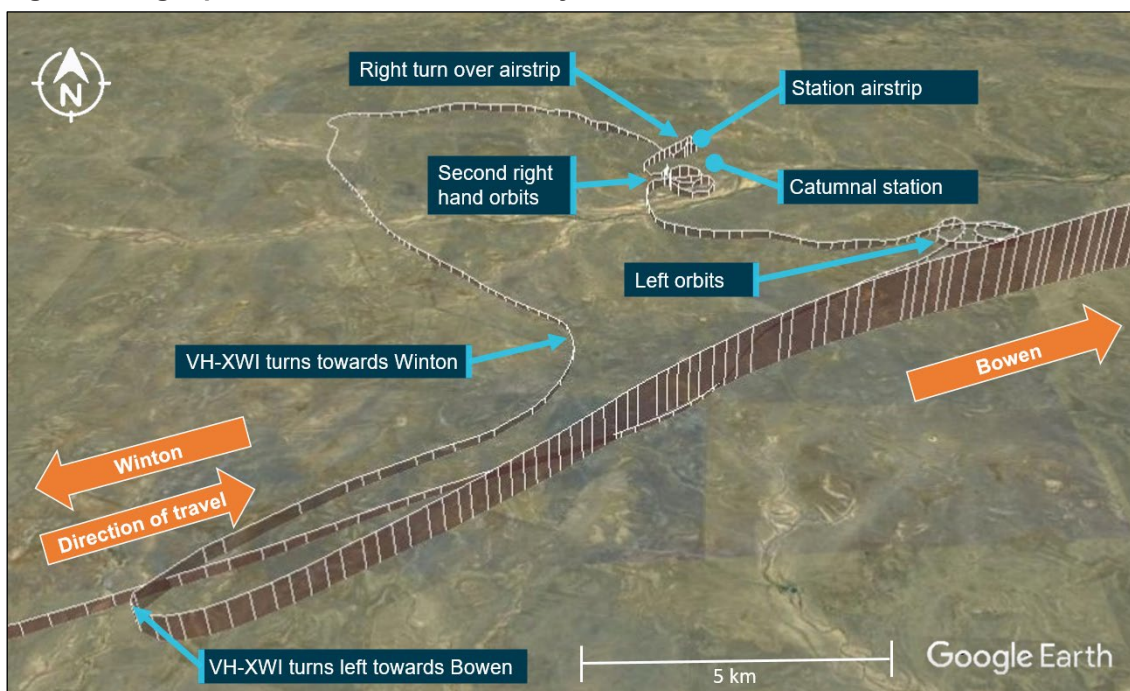
**Figure 2: Flight path of VH-XWI in the vicinity of Catumnal Station**

The aircraft then climbed back up to about 1,000 ft AGL. At about 0829, when overhead the station airstrip, the aircraft's airspeed reduced to about 43 kt while the aircraft conducted a right turn. It then rapidly descended to less than 50 ft AGL before climbing away from the station, and turning back towards Winton (Figure 3).

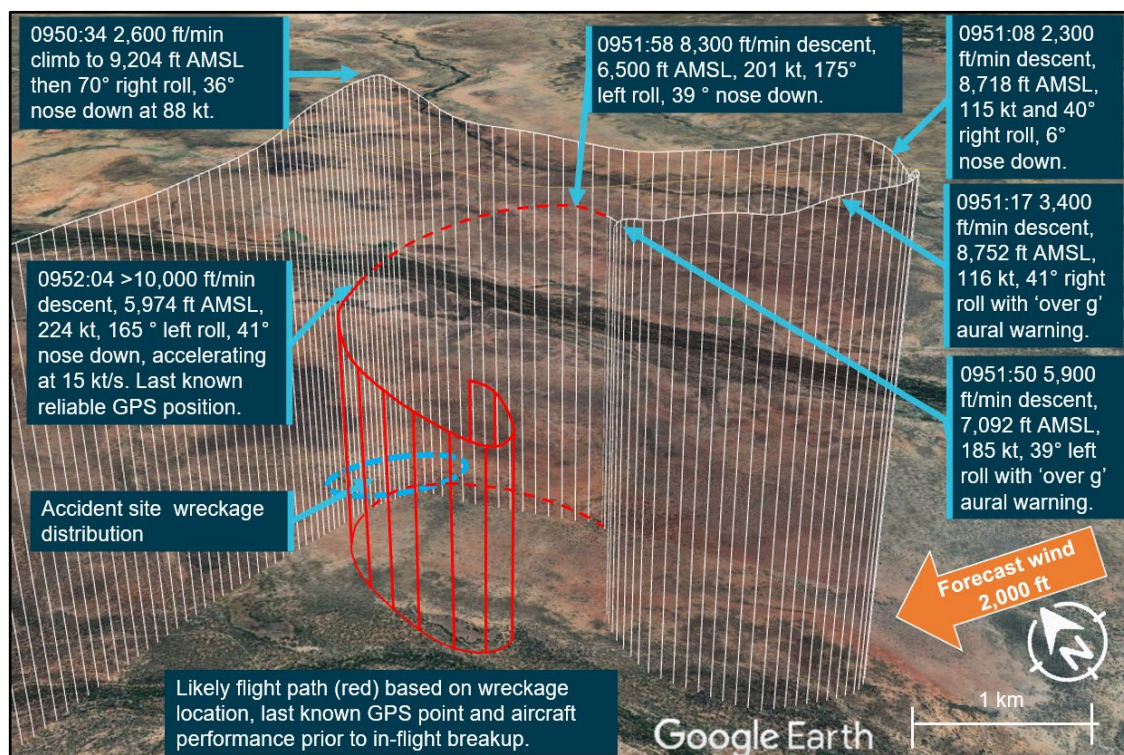
**Figure 3: VH-XWI accident sequence**

At the last recorded GPS position (0952:04), the aircraft was at a recorded altitude of about 6,000 ft, where it had rolled 165° to the left and pitched down 41°. It was descending at more than 10,000 ft/min at an indicated airspeed of 224 kt and was accelerating at 15 kt/s (Figure 4). This recorded airspeed was more than 20% over the never exceed speed ( $V_{NE}$ ) for the RV-7A.

Based on the wreckage distribution and the nature of the wreckage, it was evident that VH-XWI sustained an in-flight break-up before the wreckage collided with terrain. The pilot was fatally injured, and the aircraft was destroyed.

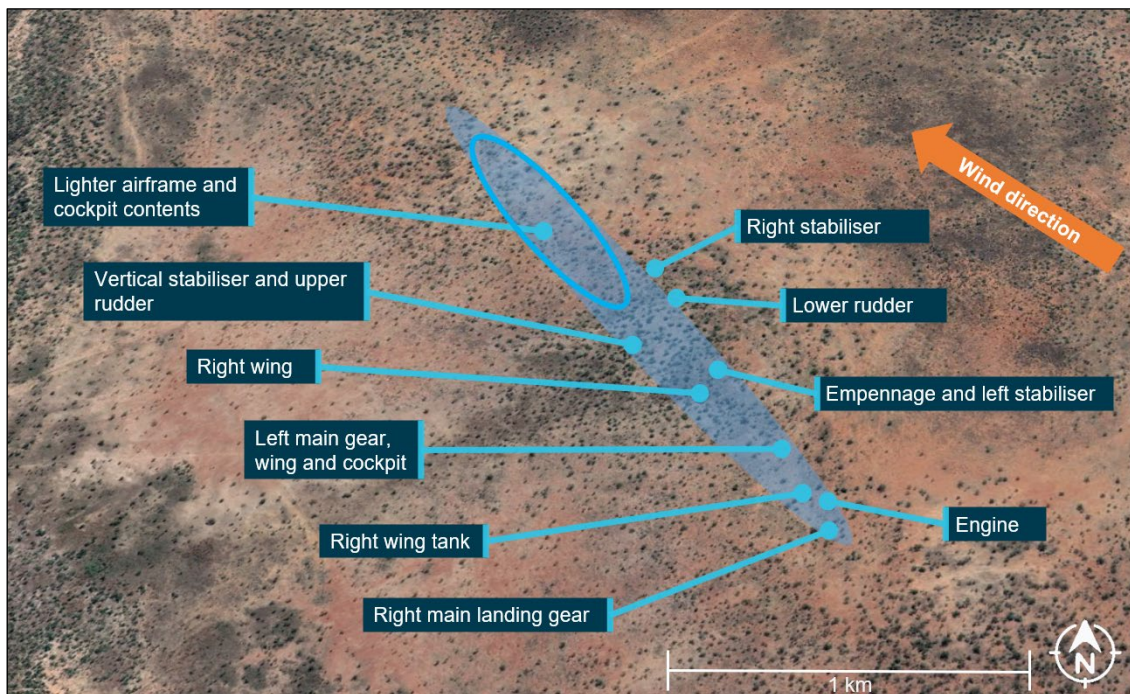
**Figure 5: Accident site scatter pattern**

sections located closer to each other, and lighter, smaller sections of wreckage found to the north-west of the main wreckage, consistent with the forecast wind direction (Figure 6). All major aircraft components were accounted for, and there was no evidence of pre-impact defects.

The propeller, engine, and associated structure was located separately to the rest of the wings, cockpit, and rear tail sections.

The left wing and centre section/cockpit floor with part of the right-wing spar remained attached to the fuselage and was deformed downwards. The right wing was found nearby and showed transfer marks on its lower surface from the right main landing gear tyre.

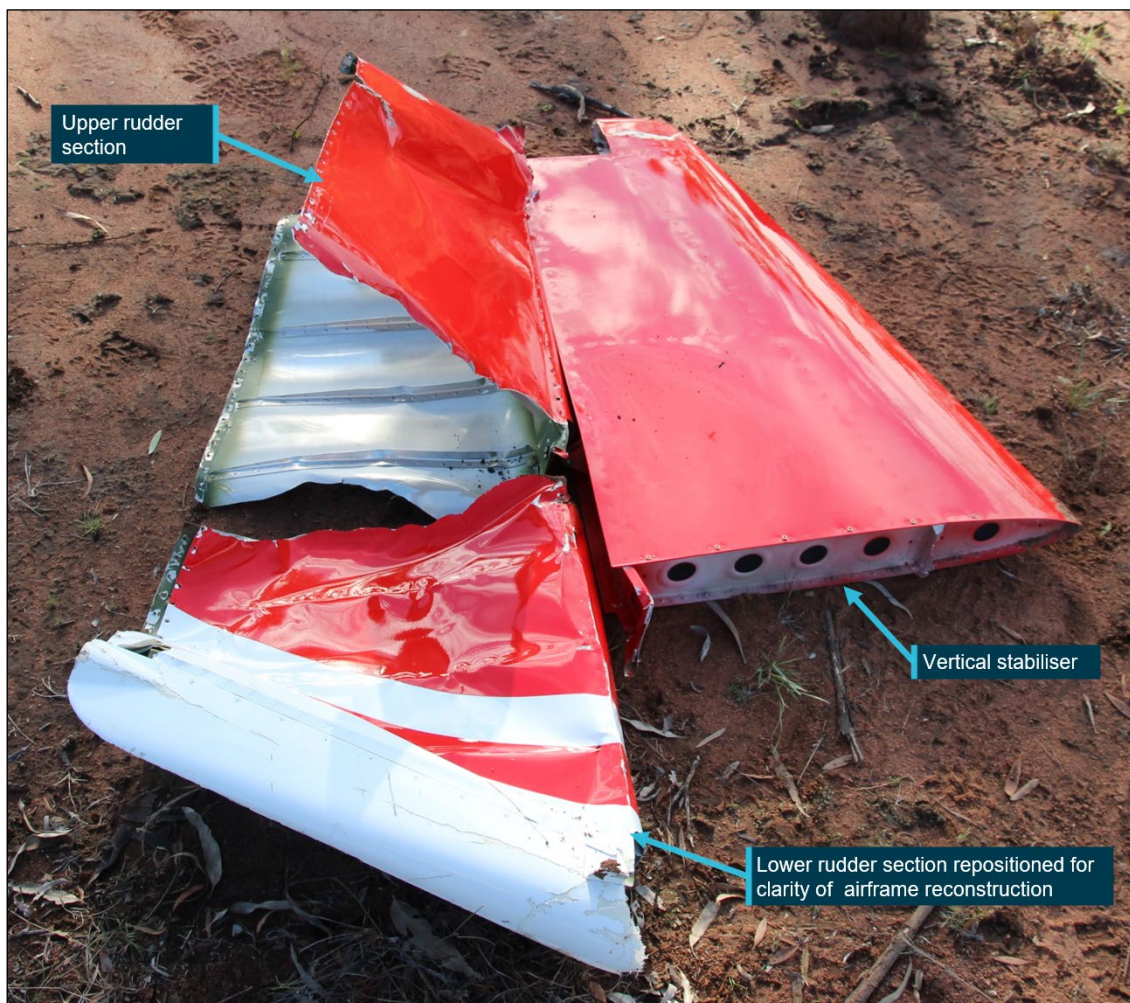
**Figure 6: Rudder and vertical stabiliser**

The vertical stabiliser and the upper rudder section had separated as an assembly from the main fuselage. The rivet line at the trailing edge of the rudder had burst open, and the aerodynamic mass balance (normally located on the top of the rudder) was not found at the accident site (Figure 7). The lower section of the rudder had torn away immediately below its centre hinge point and was located some distance away from the vertical stabiliser and rudder assembly.

Examination of the aircraft wreckage did not identify any pre-existing defects, however wreckage at the accident site indicated cascading failures that likely followed the rudder and vertical stabiliser separating from the aircraft. Subsequently, the horizontal stabilisers likely failed and unbalanced the aircraft's aerodynamic forces, rapidly pitching the aircraft downward. The aerodynamic overload on the main wing structure resulted in the right-wing main spar failing in a downwards direction, and the right wing separated from the aircraft.

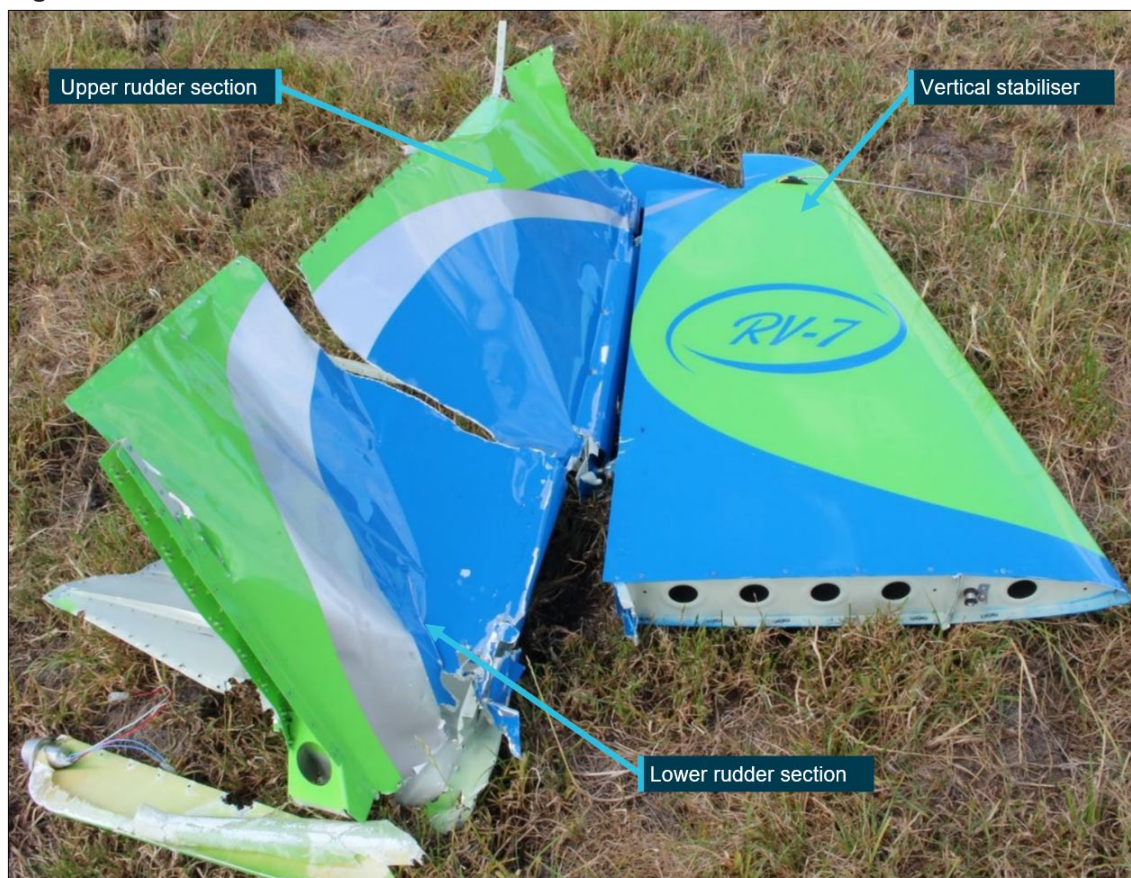
**Figure A1: Rudder and vertical stabiliser from ZK-DVS**

- The aircraft entered a high-speed descent from an unusual attitude.
- The pilot did not recover the aircraft from the unusual attitude or subsequent high-speed descent, which resulted in structural failure and in-flight breakup.
- In-flight breakup occurred as a result of rudder flutter, as the aircraft airspeed exceeded the design limitations.

The Civil Aviation Authority of New Zealand found that to avoid the potential of structural failure and in-flight break-up, pilots must fly within the aircraft limitations. Accidents can occur whenever the aircraft limitations and/or the pilot's own capabilities are exceeded. It is important to understand and be familiar with the aircraft characteristics, limitations, and associated risks. These risks can be minimised by preparation, awareness, and training.

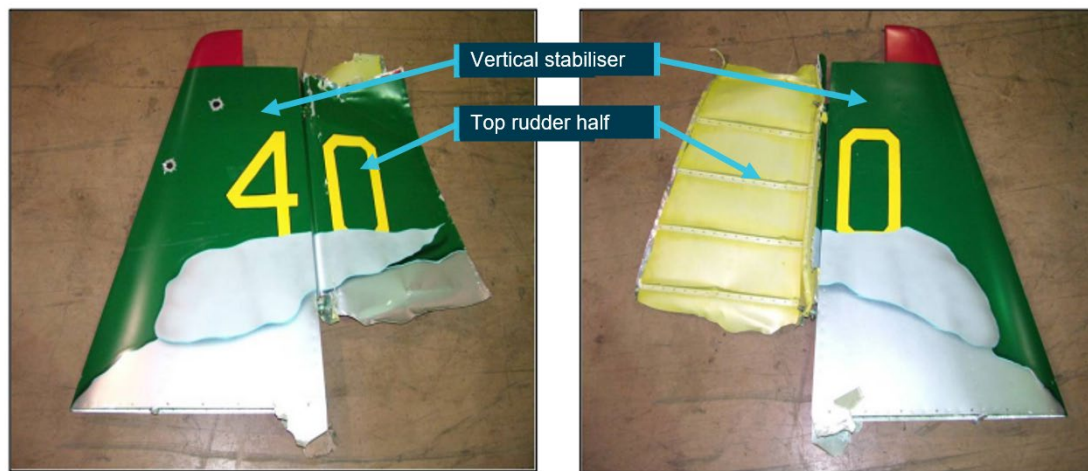
**Figure A2: Rudder and vertical stabiliser from C-GNDY**

**Photo 2. Left side of rudder**

**Photo 3. Right side of rudder**
