Uncommanded power reduction involving Beechcraft King Air B200C, VH-VAH

Essendon Fields Airport, Victoria, on 19 August 2021

ATSB Transport Safety Report

AO-2021-034

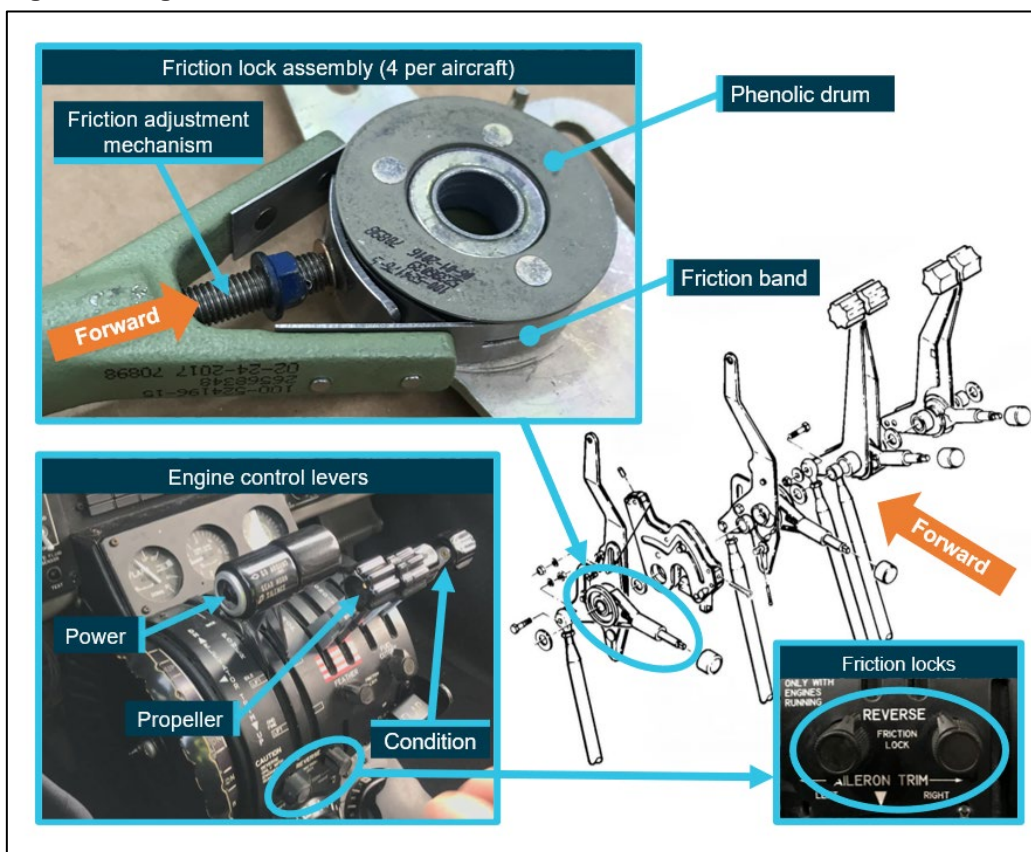
Figure 1: Engine control levers and friction locks

Four friction locks were located on the engine control pedestal. One each for the left and right power levers, one for the propeller levers, and one for the condition levers (Figure 1). The friction lock assemblies consisted of an adjustment mechanism, a phenolic drum, and a friction band. When the friction lock was rotated clockwise, the band around the phenolic drum tightened, which increased the friction between the 2 parts. The respective lever would become progressively resistant to movement, preventing the lever from moving out of position. When rotated counter-clockwise, the lever moved freely. The design of the friction lock had been used since the 1965 model 88 Queen Air through to current production King Air aircraft.

A characteristic of the King Air friction locks was that they required careful setting as some aircraft had a narrow range between no friction and too much friction. The operator reported that there was no consistency in setting friction locks for a desired resistance between power levers in the same aircraft and other aircraft, and this changed over time due to wear. Worn friction locks were required to be replaced.

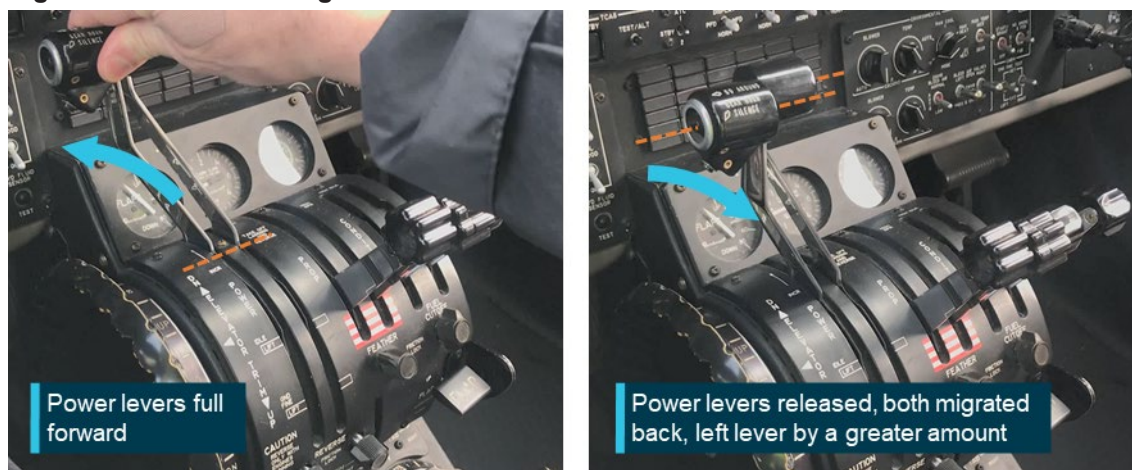
Figure 2: Power lever migration demonstration

The cockpit to engine nacelle power lever control cables were connected to a cam assembly on the right side of each engine via a lever. This lever was spring loaded towards idle to prevent an uncommanded acceleration in the event of a power lever cable malfunction that could damage the engine when torque and temperature limits were exceeded. The springs also reduced the effect of hysteresis⁶ when power was reduced, which could cause the rate one engine's power reduced relative to the other to be different. An additional spring could be fitted during production or maintenance to further balance the rate of power reduction between both engines. This additional spring was not fitted to the incident aircraft. The effect of the springs migrating the power levers toward idle during normal operations was overcome by setting the friction locks.

In addition, as the power lever cables were connected to the right side of each engine, the cable for the left engine was shorter than the right, and therefore less affected by hysteresis. Due to this, if the friction locks were not correctly set, the left power lever could migrate further aft than the right, resulting in an uncommanded left yaw. The operator demonstrated this on the ground without the engines running. With both power lever friction locks loosened and the levers full forward, when they were released the left engine power lever migrated further aft than the right (Figure 2).
