Collision with terrain involving Robinson R22

200 km south-west of Winton, Queensland, on 17 June 2022

Aviation Occurrence Brief

AB-2022-003

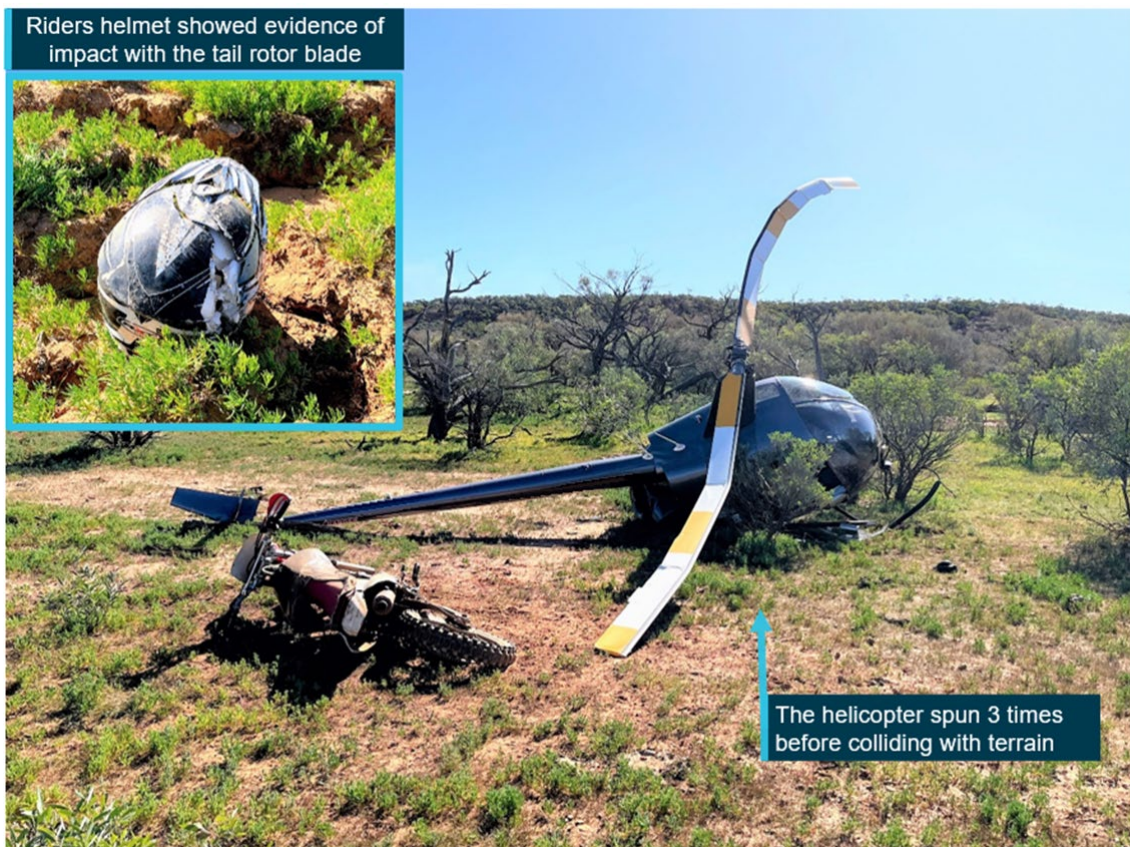
The cattle were moving in a northerly direction when they suddenly turned right. The pilot moved to cut them off, positioning the helicopter in front of cattle about 3 ft above the ground. This put the cattle out the left side of the helicopter on the opposite side of the cabin to where the pilot was seated. While manoeuvring in the hover and remaining focussed on the cattle, the pilot reported hearing a loud bang and feeling large vibrations. The helicopter began to spin, and the pilot immediately suspected a tail-rotor failure. After approximately 3 spins, the pilot was able to regain partial control, reduce the rate of rotation and conducted a controlled crash. After exiting the helicopter, the pilot reported seeing a motorbike on its side and a helmet on the ground nearby Figure 1.

Figure 1: Helicopter after collision with terrain

The helicopter was destroyed in the crash landing, but the pilot was uninjured. The rider of the motorbike sustained serious injuries and was taken to hospital before being released. Their helmet was found to have been split by the impact with the tail rotor.

- A ground crew safety briefing was conducted to re-iterate the importance of following the established procedures when assisting with aerial mustering.
- In a situation like this, it was emphasised that the best course of action for the ground crew would be to remain under the trees or away from the helicopters area of operations until the cattle were under control. If in doubt, give way to the helicopter.
- Managers of other properties run by the company were advised of the accident and instructed to hold similar briefings with their staff as soon as possible.
- The operator of the helicopters held a meeting with all mustering pilots to re-iterate the importance of maintaining awareness of people on the ground.
