Collision with terrain involving Robinson R22, VH-RAS,

13 km south-west Koorda, Western Australia on 2 October 2022

ATSB Transport Safety Report

AO-2022-045

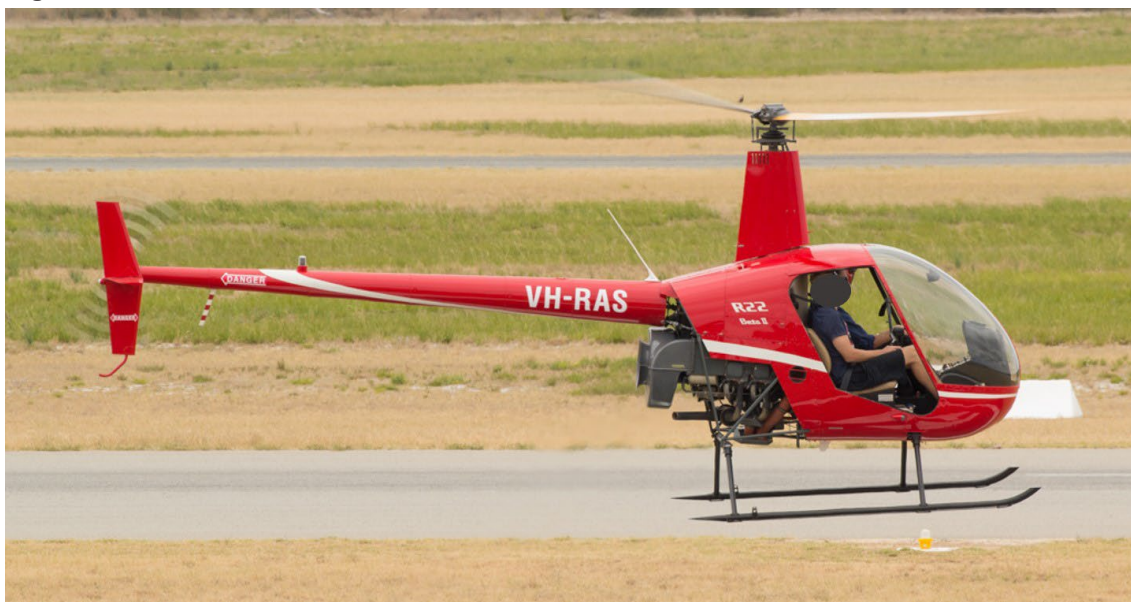
Figure 2: VH-RAS

VH-RAS (Figure 2) was a 2-seat Robinson Helicopter Company R22 Beta helicopter, serial number 4617, powered by a Textron Lycoming O-360-J2A, 4-cylinder piston engine. It was manufactured in 2013 and registered in Australia the same year. It was purchased by the pilot in 2016 and had been maintained by the same maintenance organisation since that time. At the time of the occurrence, the helicopter had accrued about 2,080 hours total time in service.

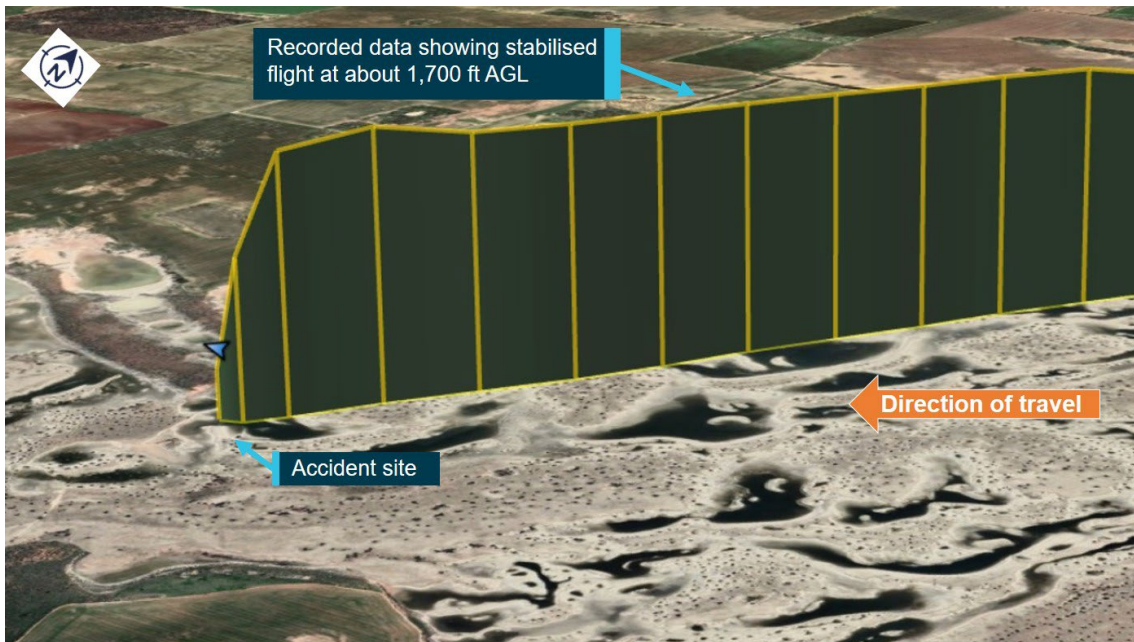
Figure 3: Last one minute of recorded flight data

Flight tracking data, recorded at 5-second intervals, showed the helicopter initially tracking in a stable south-westerly direction at about 1,700 ft above ground level (Figure 3). About 5 minutes into the flight the altitude increased by about 100 ft, followed almost immediately by a rapid descent. The data stopped in the vicinity of the accident location, about 10-15 seconds after the commencement of the descent.
