Cabin pressurisation issue involving a De Havilland Canada DHC-8, VH-QQD

30 km north of Perth Airport, Western Australia, on 20 November 2021

ATSB Transport Safety Report

AO-2021-050

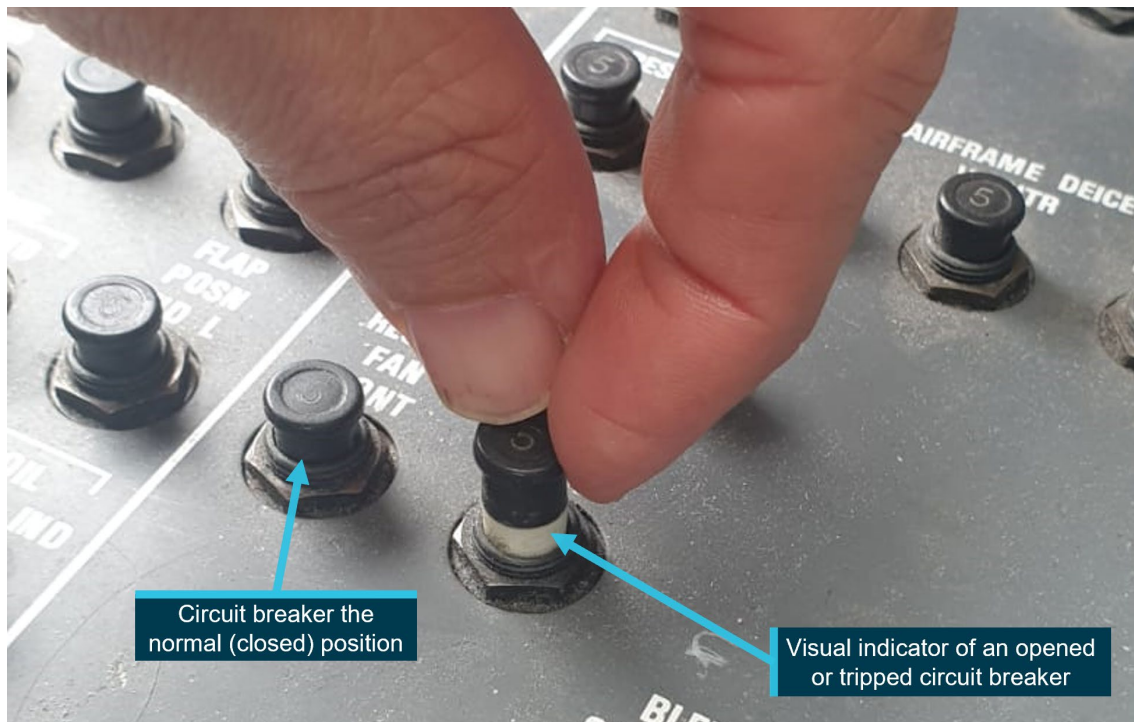
Figure 2: Exemplar aircraft circuit breakers

From about 0430, the captain and first officer continued the flight crew pre-flight tasks. To facilitate the removal of the recirculation fan the previous day, engineers had opened its relevant circuit breaker (see *Aircraft circuit breakers*). The captain re-set it, believing that (based on their knowledge of the system) the circuit breaker had tripped.

Circuit breakers incorporate a white band as a visual indicator to show that the relevant electrical system has been intentionally or unintentionally isolated (Figure 2).

In addition, the first officer did not check the aircraft documentation, as there was no requirement to do so. Finally, the circuit breaker that had been opened to facilitate the recirculation fan removal was another prompt for the captain to review the maintenance log for recent or open defects. However, probably due to expectation bias, the prompt was not successful on this occasion.

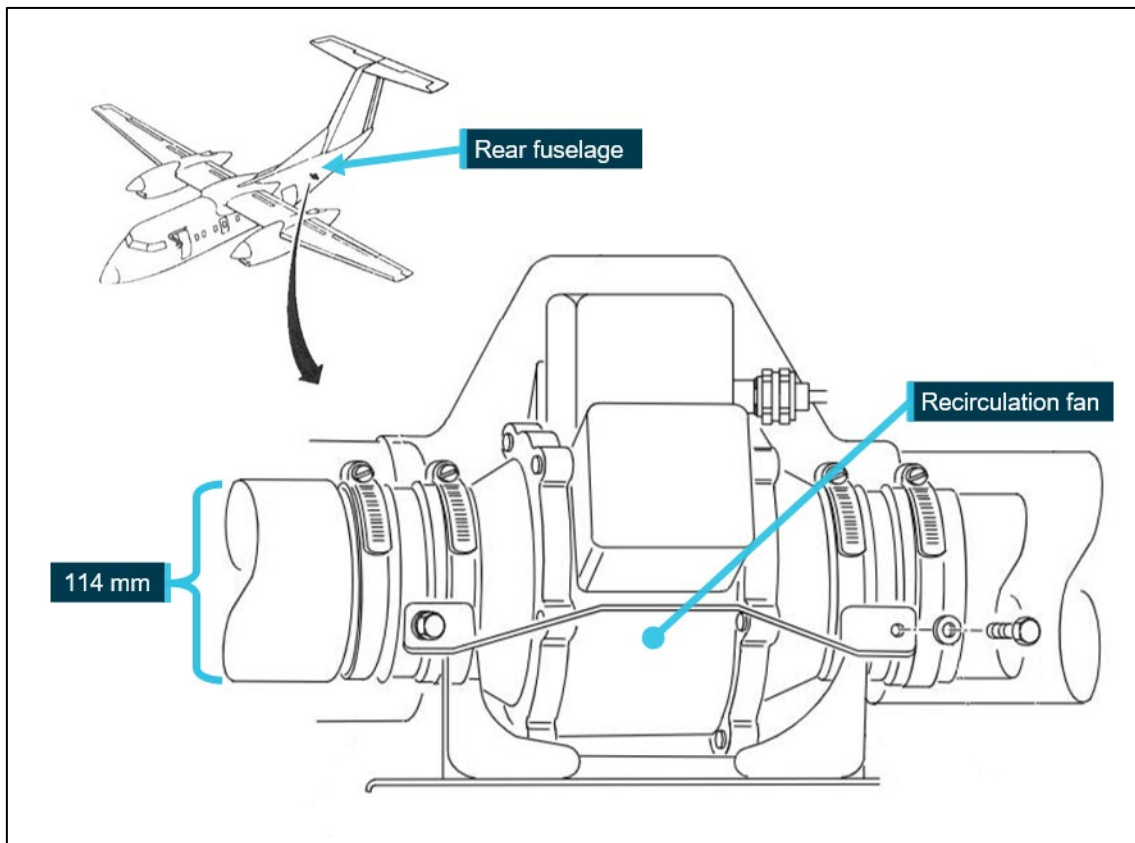
Figure 3: Flight compartment recirculation fan installation

The aircraft's air-conditioning and pressurisation systems were designed to maintain a safe and comfortable environment within the flight deck, cabin, and cargo bay (collectively known as the flight compartment) during all phases of flight. The recirculation fan is located outside the flight compartment in the rear fuselage, and is not visible externally (Figure 3).

The flight compartment is pressurised by maintaining a balance between airflow entering and airflow leaving the flight compartment. On the occurrence flight, the absence of the recirculation fan allowed airflow to leave the flight compartment at a rate greater than what could be supplied, so the aircraft could not be pressurised.

On the day of the occurrence, the aircraft was not serviceable because it had no recirculation fan fitted, which prevented it from pressurising. The removal of the fan the day before was entered into the maintenance log. However, the unserviceable status of VH-QQD was not entered into the operations management system (AvSys) by the operations department, so the aircraft remained assigned to the flight and on the flight manifest visible by the flight crew.
