Collision with terrain involving Piper PA-25, VH-SEH

Seaview, Victoria, on 23 February 2022

ATSB Transport Safety Report

AO-2022-008

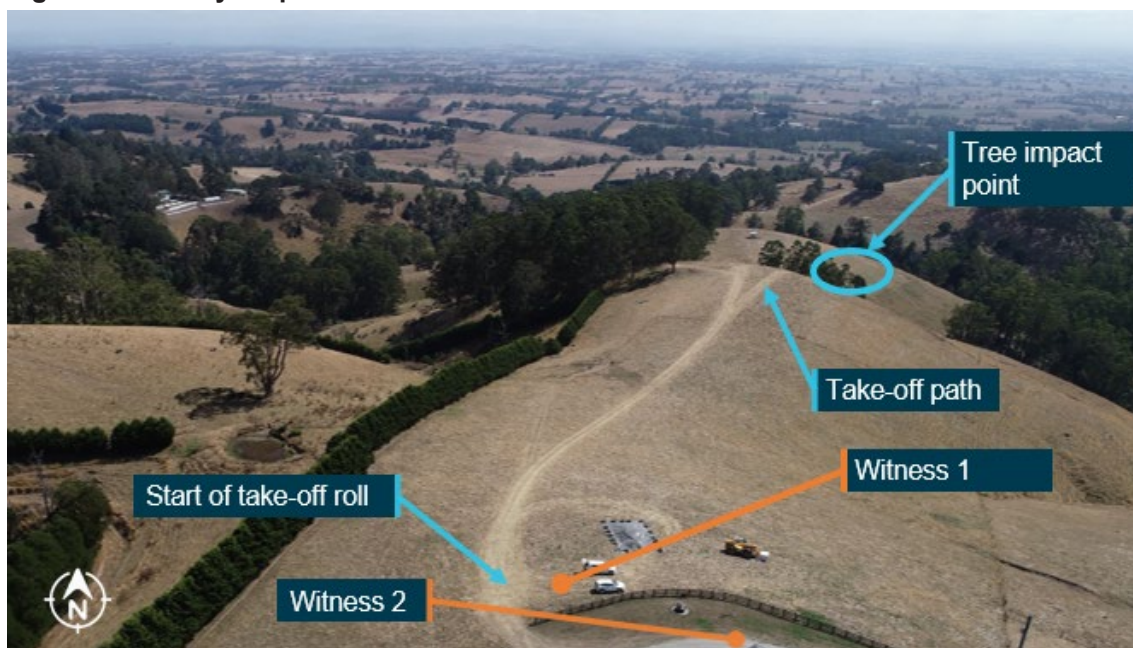
Figure 1: Runway strip overview

According to witness reports, the pilot was wearing a 4-point harness and a helmet. Data from an onboard GPS device showed that the pilot commenced the take-off on the prepared runway strip at about 0711 (Figure 1).

The runway strip went downhill, and then uphill, where it branched into 2 sections. According to the 2 witnesses and the recorded video, the aircraft accelerated along the strip and traversed the right section where the strip divided.

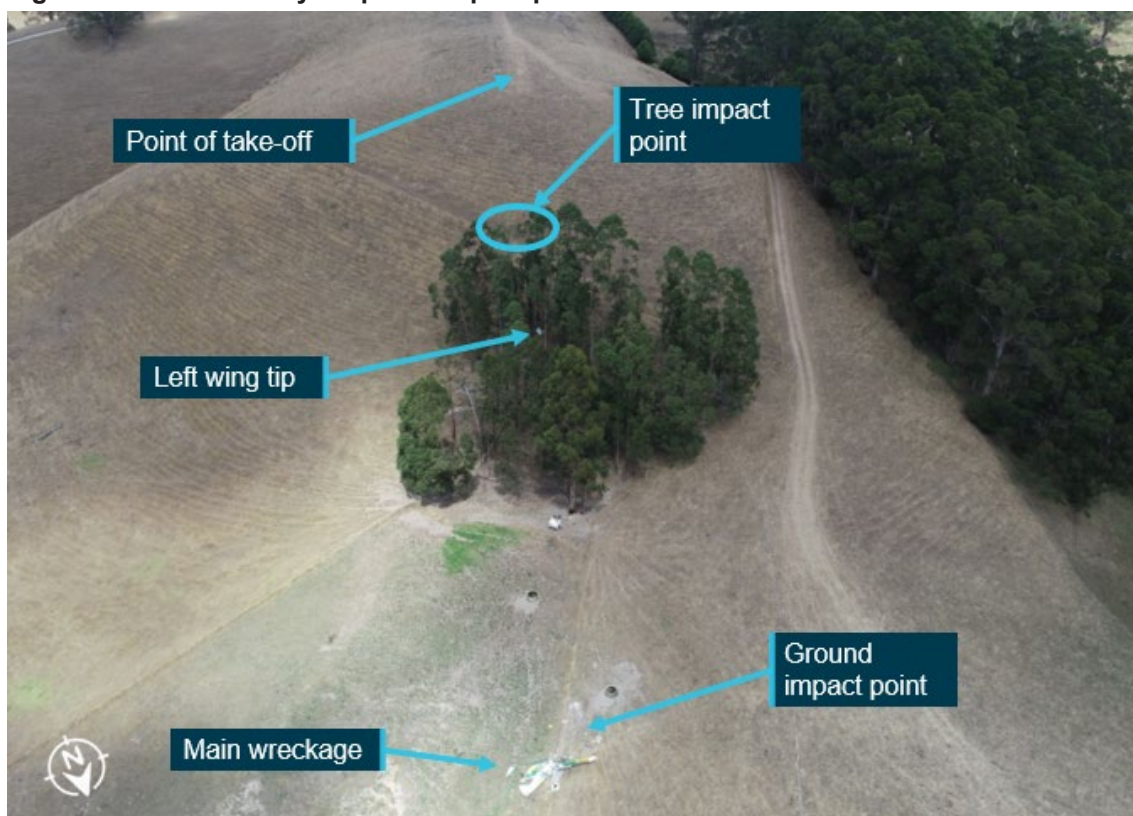
Figure 2: End of runway strip and impact points

The aircraft briefly became airborne at a point at the end of the strip where the terrain dropped away. The outboard section of the aircraft's left wing then impacted trees and separated the left outboard section of wing. The aircraft rolled to the left, pitched down, and collided with terrain about 30 m beyond the trees (Figure 2). The pilot was fatally injured and the aircraft was destroyed.

The wreckage was located about 30 m north of the stand of trees at the northernmost end of the strip. The trees were about 90 ft in height above ground level (AGL). Damage to the trees indicated the left wing impacted the trees at a height of about 74 ft AGL. Examination of the accident site indicated the aircraft impacted the ground inverted with an angle of entry of about 50° with the left wing low, and came to rest about 8 m from the initial impact point. The cabin sustained significant damage (Figure 5). Significant curved compression damage was evident on the leading edge of the left wing consistent with tree impact damage (Figure 6).

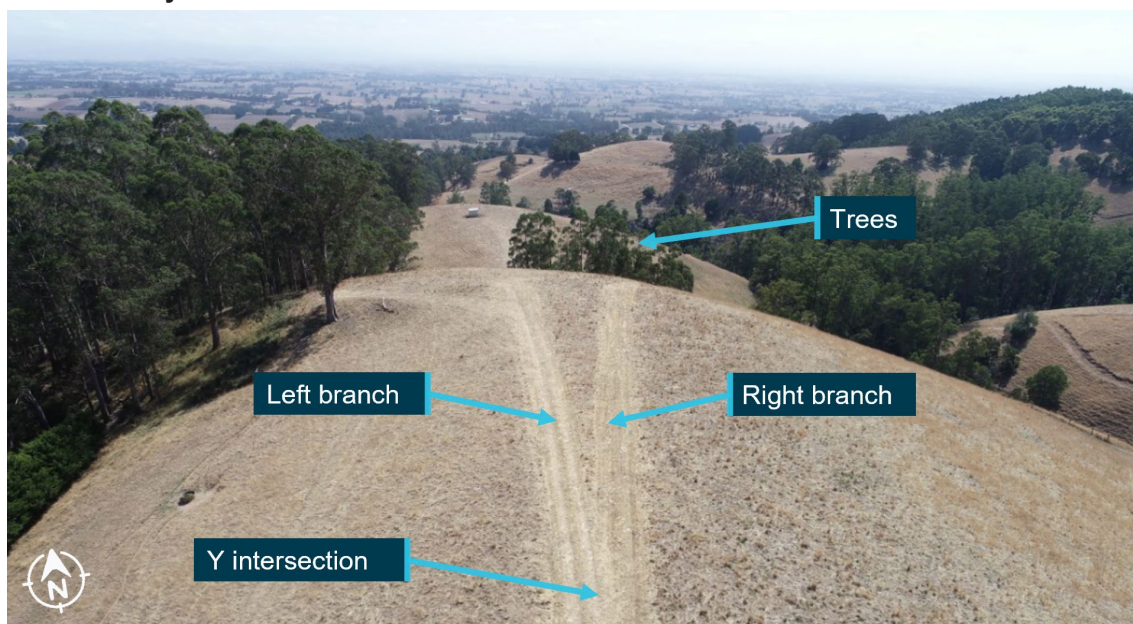
Figure 4: Runway strip ‘Y’ intersection showing the left and right branches with the trees at the runway’s end

Take-offs were always conducted in the same direction due to the more downwards slope. In this direction, the strip followed the natural terrain, with a downwards then upwards slope before dropping steeply towards the stand of trees. The left branch was oriented to the left of the trees and the right branch was oriented directly towards the trees (Figure 4).

The pilot had not operated from this strip for at least 2 years prior to the accident. It was reported that the trees at the end of the strip had grown about 3–10 ft during that time. The pilot was reportedly aware of the hazard presented by the trees, having commented on their growth over the years. In the days prior to the accident, the pilot had communicated their intent to use the right side of the prepared strip for the day's operations. Another of the operator's pilots reported preferring the left branch of the strip in order to avoid the trees. The reasons for the accident pilot's preferred use of the right branch could not be determined.

Although the pilot had conducted take-offs using the Seaview runway strip in previous years, the increased height of trees at the northern end of the strip had reduced safety margins to some extent. The aircraft struck the trees about 16 ft from the top, which meant that even without their estimated 3–10 ft extra height, there would not have been sufficient clearance for a safe take-off.

The investigation was unable to determine why the pilot elected to prepare, and use, a strip orientated directly towards the trees when an alternate take-off option was available.

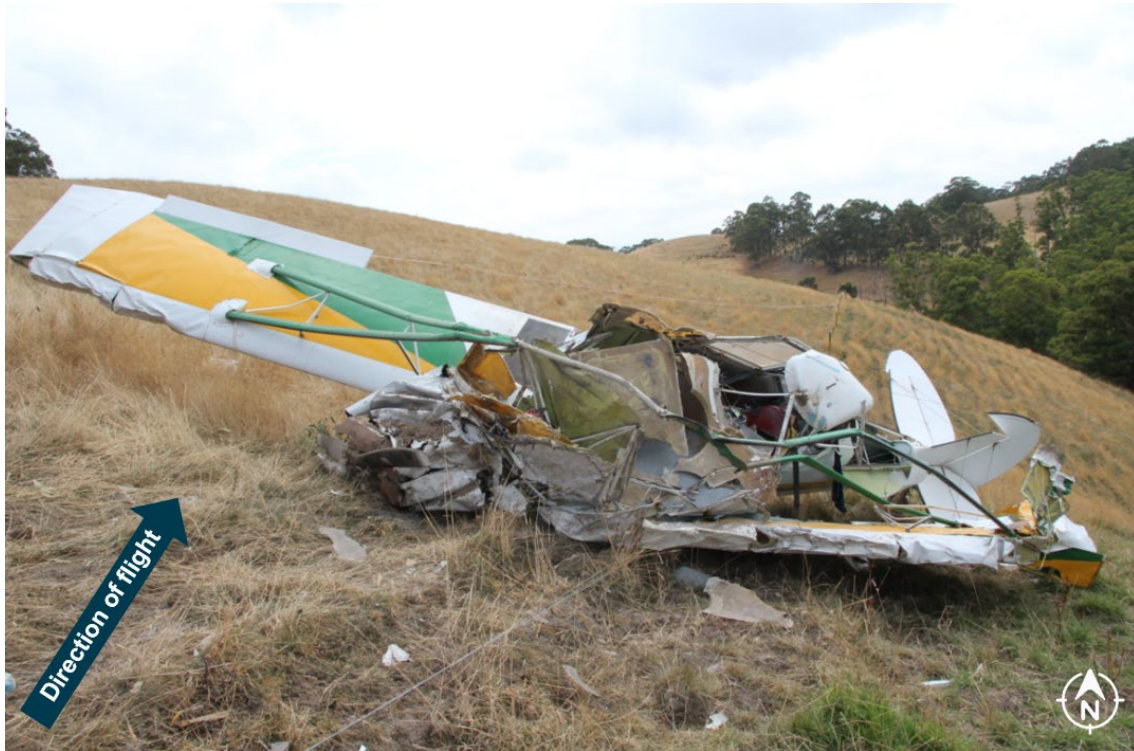
Figure 5: Aircraft wreckage

The hopper door was open and superphosphate had spilled from the hopper with most in the vicinity of the fuselage. Superphosphate was also found in smaller quantities near the initial impact point with the trees and scattered from halfway between the aircraft's point of take-off to the wreckage site. The scattered pellets were consistent with a pilot-initiated release (and not post-impact scatter); however, it could not be determined if the mechanism had been activated in the spread or emergency dump position. The position of the spread/dump lever at the time of impact could not be determined.

Examination of the propeller, along with ground marks, indicated the propeller was rotating under power at the time of impact.

External examination of the engine did not identify any obvious defects. The engine tachometer displayed a needle 'slap mark'⁴ indicating about 2,240 RPM.⁵ The throttle position at the time of impact could not be determined due to disruption of the controls.

There were no evident pre-impact defects with the aircraft structure and flight control continuity was confirmed as far as possible. The flap handle was in the top notch, indicating full flap. The operator's other pilots reported that it was normal practice to apply full flap at the lift-off point, followed by a gradual reduction of flap setting as the aircraft climbed away.
