Collision with terrain involving Robinson R22 Beta II helicopter, VH-HKC

87 km north of Hughenden Aerodrome, Queensland, 11 February 2021

ATSB Transport Safety Report

AO-2021-006

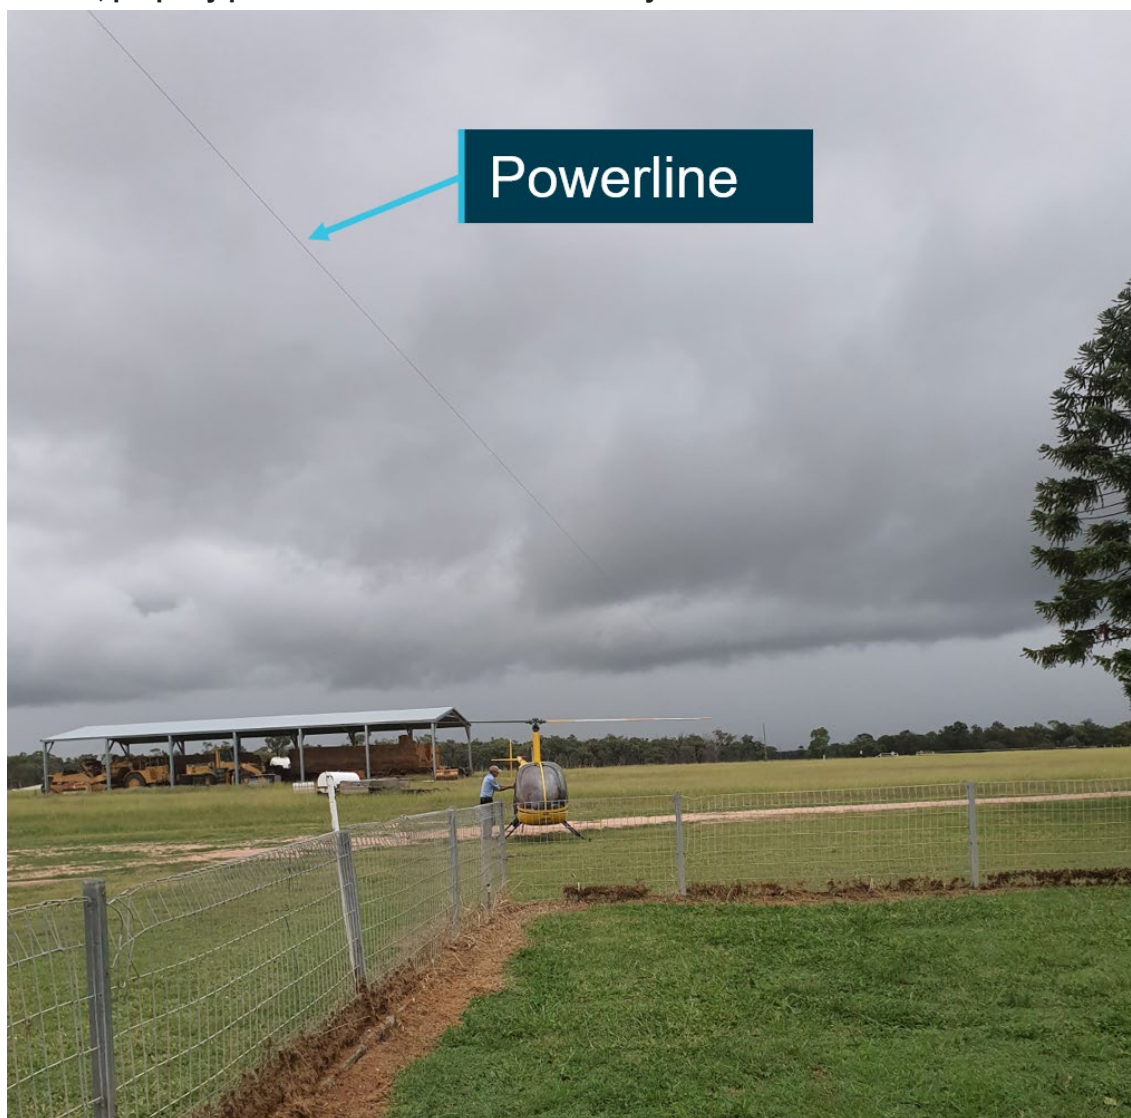
On arrival at Camden Park Station, the pilot flew at low level over the entrance road towards the homestead, landing beneath a powerline (Figure 1). The pilot advised the owner he was lost, looking for Reedy Springs and that the helicopter's low fuel² light was on.

Figure 1: Photo from 1829 EST - VH-HKC and pilot following arrival at Camden Park Station, property powerline indicated and southerly cloud conditions visible

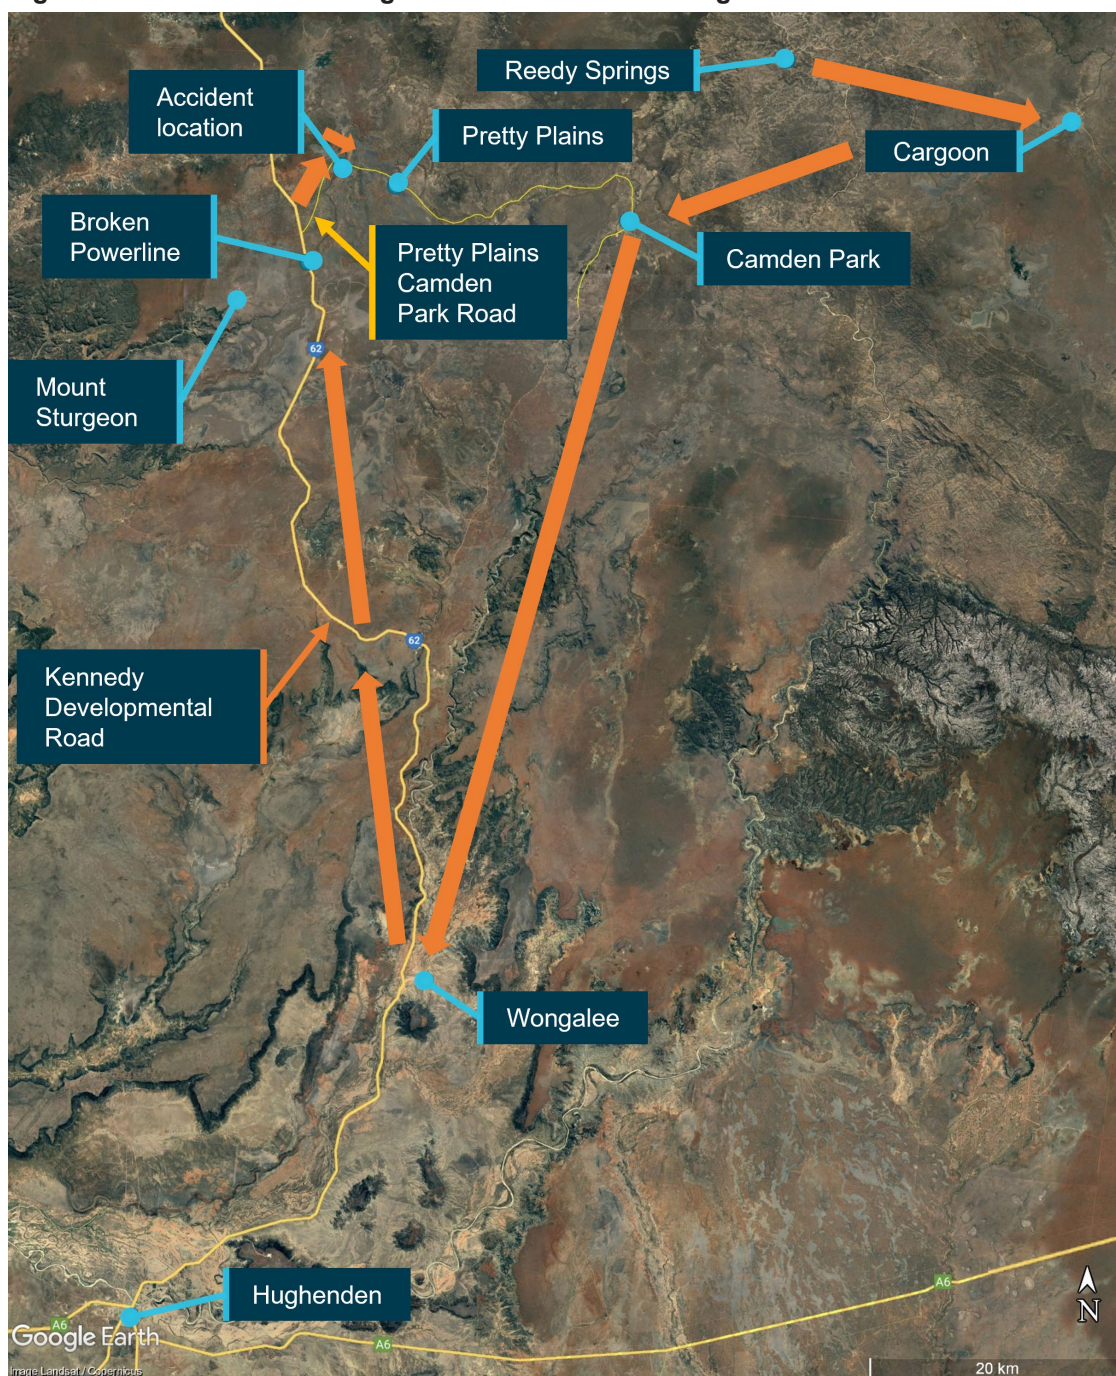
Figure 2: VH-HKC accident flight - known locations and general direction of travel

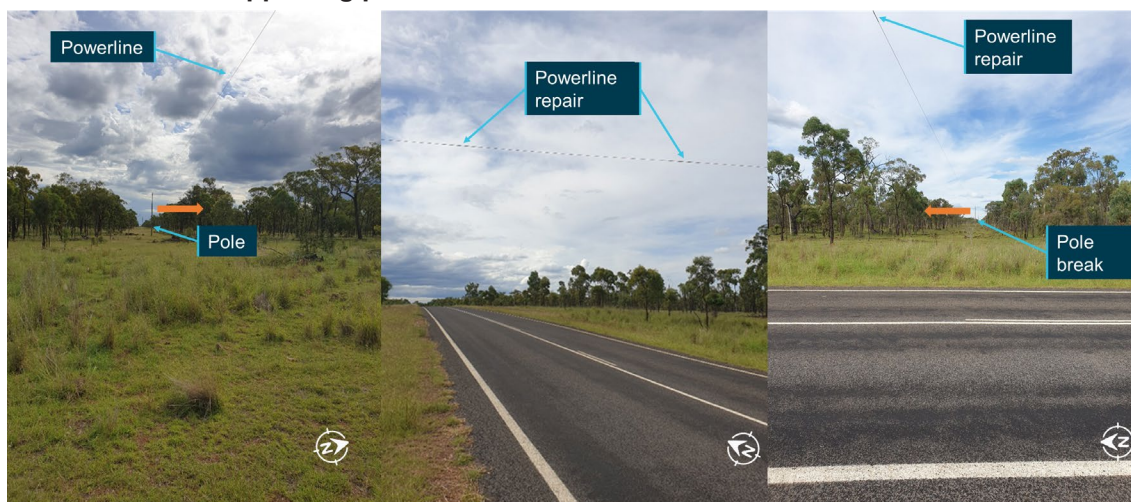
Ergon Energy reported that at about 1954 EST, a high voltage powerline,⁶ strung 6.8 m above the Kennedy Developmental Road (KDR),⁷ 68 km north of Wongalee Station by road, was tripped. The poles supporting the wire on either side of the road were found bent towards the north and inwards with the easterly pole snapped near the base. The 3-strand single wire was broken directly above the road (Figure 3). The break in the line resulted in loss of power to nearby Mount Sturgeon and Pretty Plains Stations. This meant exterior and station lighting in the area was then not available to assist the pilot of VH-HKC.

Based on the nature and location of the wirestrike and accident location it was very likely that the pilot was initially flying above the sealed Kennedy Developmental Road (marked with a centreline and sidelines) then the unsealed Pretty Plains to Camden Park Road and using these roads for navigation to his intended destination. Both of these roads were in a remote rural area and not illuminated by street lighting.

Figure 3: Powerline above the Kennedy Developmental Road showing location of break and direction of supporting pole movement

The timing and physical appearance of the severed powerline on the Kennedy Development Road was consistent with contact with the helicopter. The distance from Wongalee Station to the severed powerline along the Kennedy Development Road was about 68 km, which was consistent with a speed of about 64 kt (119 km/h) had the pilot been following the road. It was likely that in the dark conditions, the pilot navigated by following the road centreline illuminated by the helicopter's landing lights.

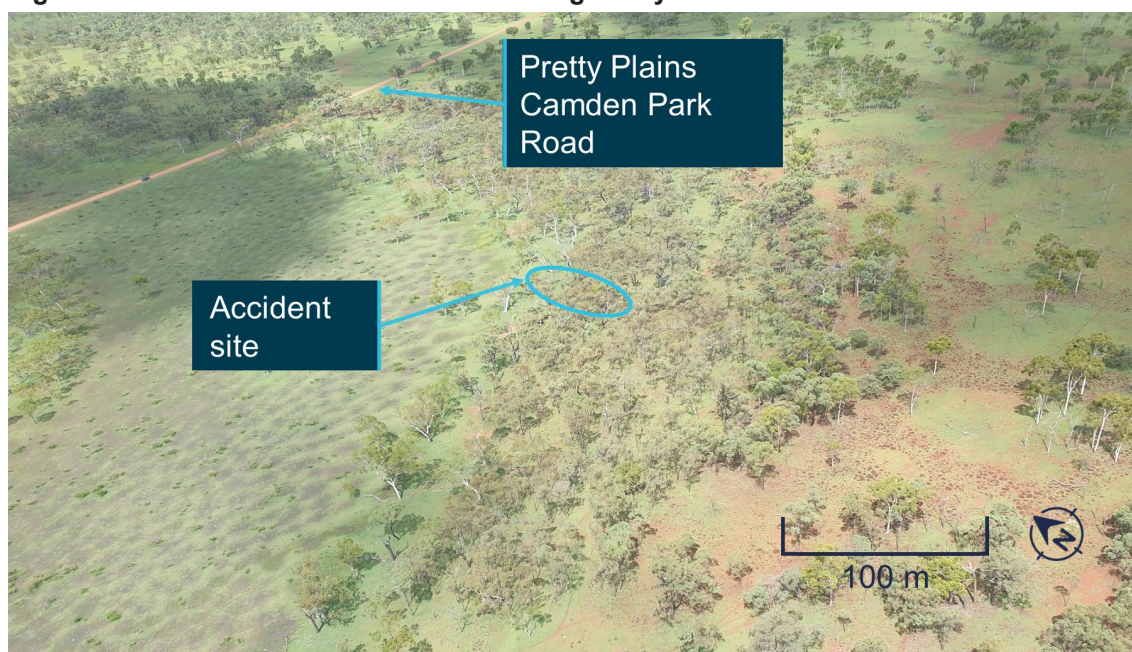
When VH-HKC did not arrive at Pretty Plains or Reedy Springs that evening, search and rescue authorities were alerted. The helicopter was located the following morning, 8 km north-east of the broken powerline and 160 m south of the unsealed Pretty Plains Camden Park Road (Figure 4). This location was 11 km by road from the powerline break and 4.5 km west of the Pretty Plains homestead. The pilot was fatally injured and the helicopter was destroyed.

Figure 4: Aerial view of accident site showing Pretty Plains Camden Park Road

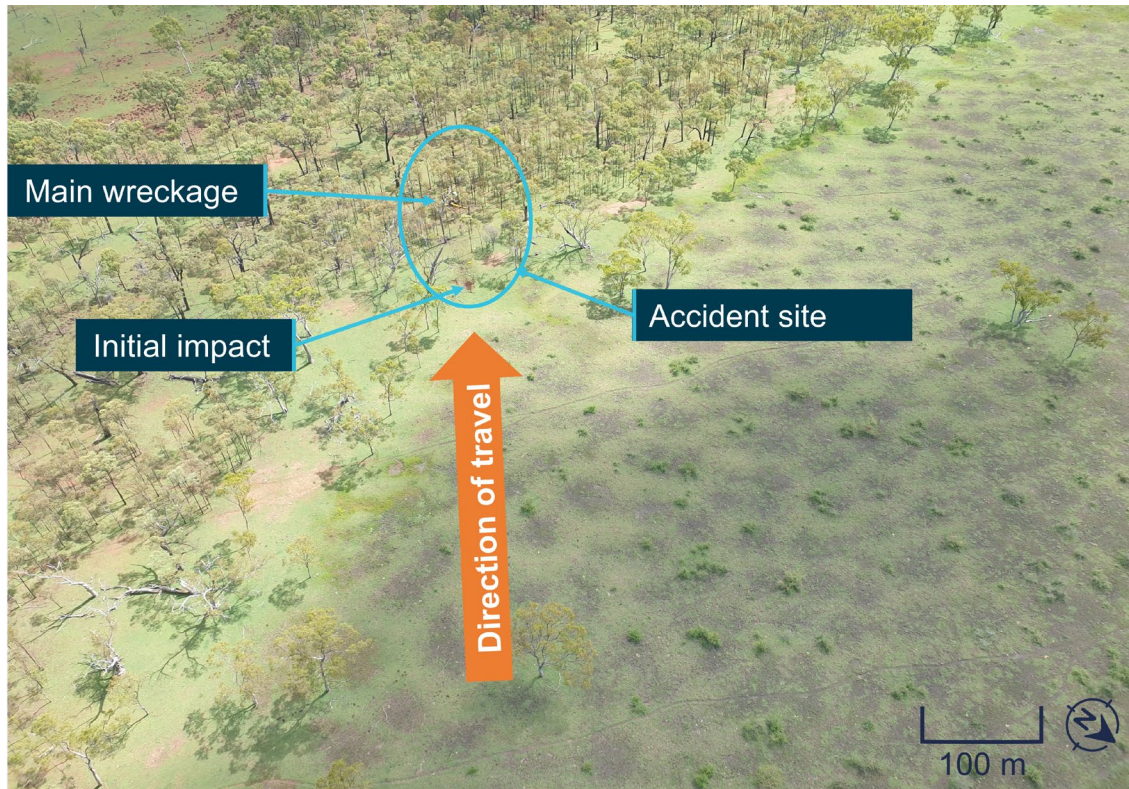
the unsealed Pretty Plains Camden Park Road (Figure 4). The site was 4.5 km west of the Pretty Plains Homestead. The wreckage trail extended in a south-westerly direction of over an area of about 50 m long and 20 m wide (Figure 5).

Figure 5: Overview of VH-HKC accident site

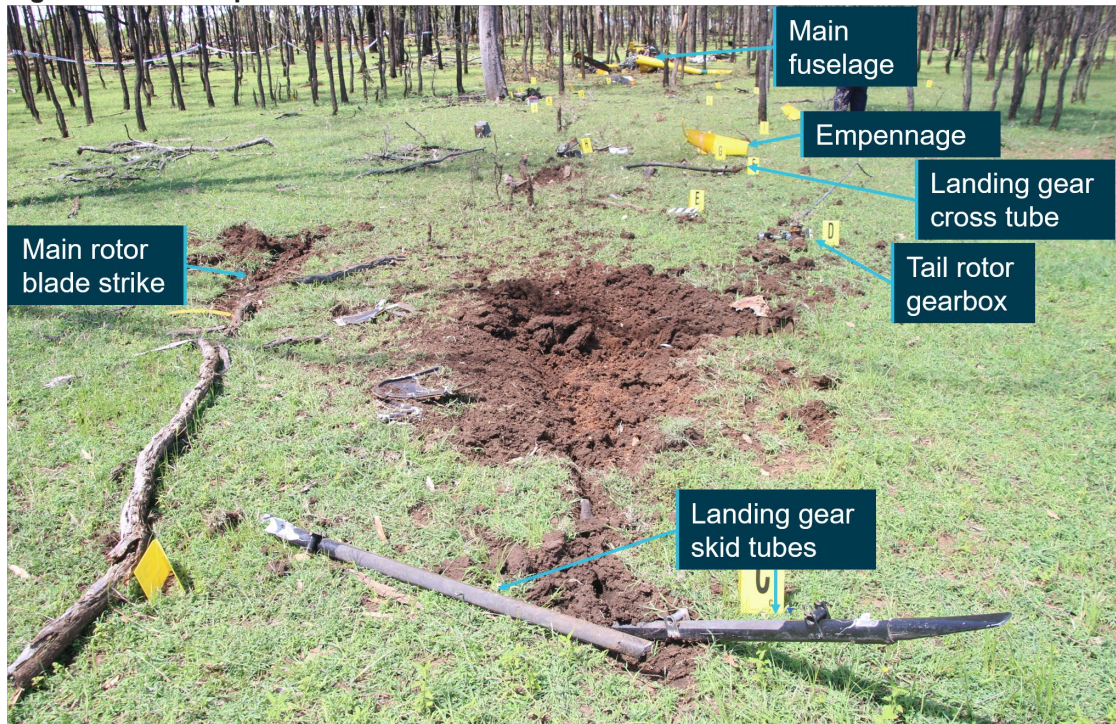
Both landing gear skid tubes were broken off at the initial impact point just prior to the main cabin impact crater evident in the soft ground (Figure 6), with main rotor blade strikes forward and to the left of the area of impact. The impact captured the airspeed indication at 38 kt (70 km/h) and the vertical speed indication at -870 ft/min (-16 km/h). This correlated to a flight path angle of 13 degrees nose-down with a groundspeed of 37 kt (68 km/h).

Figure 6: Initial impact location

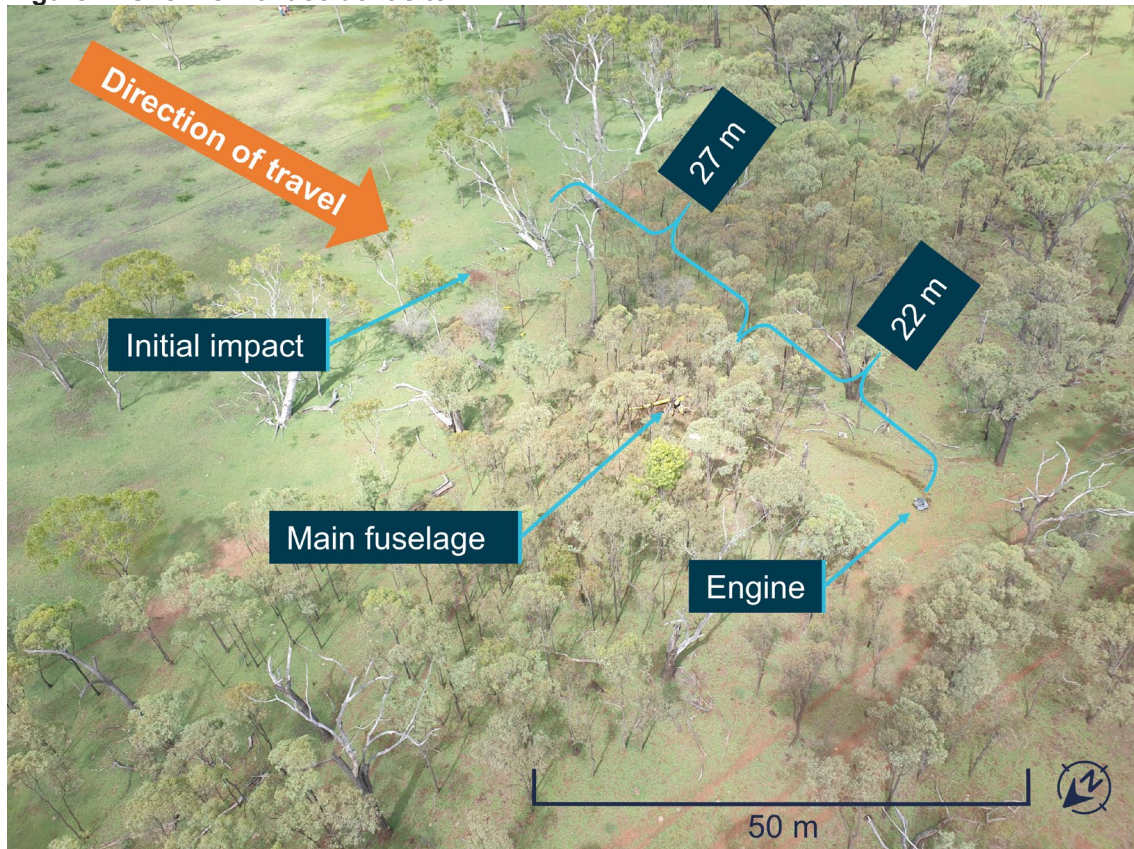
The tail rotor gearbox, blades and empennage were located close to the initial impact. The remainder of the tail boom remained attached to the main fuselage which was 27 m further along the wreckage trail (Figure 6 and Figure 7). The engine was located at the end of the wreckage trail (Figure 7).

Figure 7: Overview of accident site

One main rotor blade separated during the impact sequence; the other blade remained attached to the hub at the main wreckage. Both blades were deformed in a manner indicative of powered rotation on impact. The wreckage trail and damage pattern were consistent with a high-energy nose-down impact, likely in a left skid-low attitude.

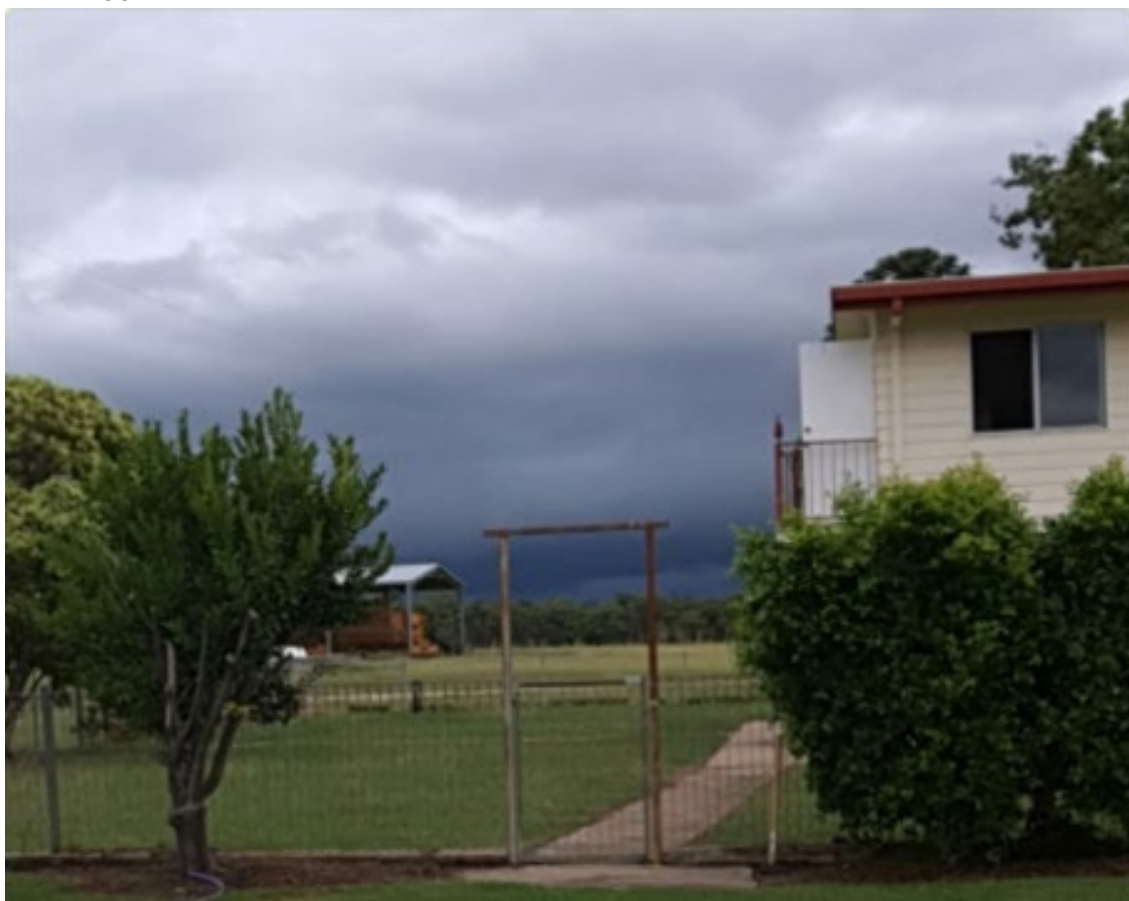
Witnesses at Reedy Springs, Camden Park and Wongalee Stations reported storms and rain in the area during the time of the flights. An image taken at 1756 at Camden Park (Figure 8) captured the prevailing conditions.

Figure 8: Image taken at Camden Park and captioned ‘Another storm is coming’ sent via WhatsApp at 1756 EST about 30 minutes before VH-HKC arrival at Camden Park

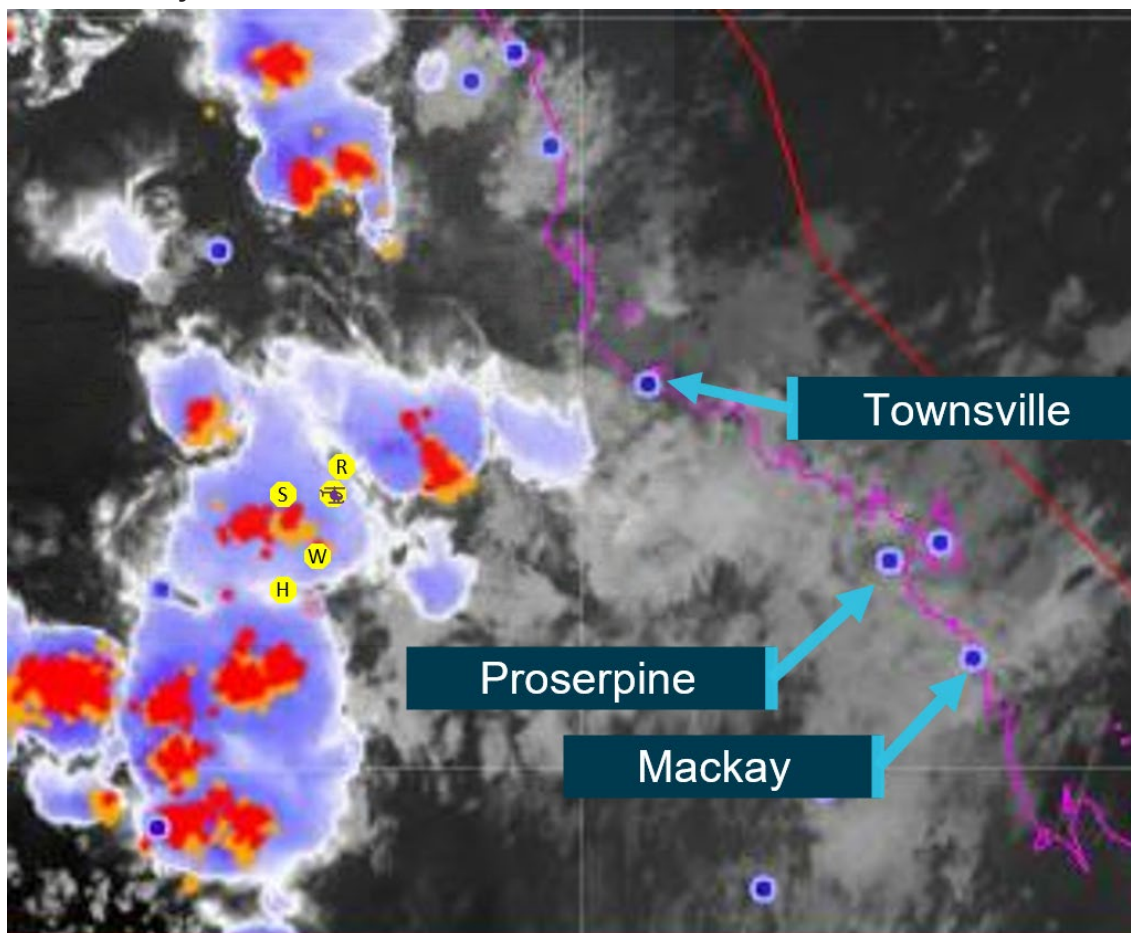
The storm clouds to the south were evident at the time of the pilot's arrival at Camden Park (Figure 1). The pilot reported to at least one witness that they had been avoiding storms. The Bureau of Meteorology satellite infrared imagery shows the presence of clouds and storms in the area of the route taken by the pilot (Figure 9). The white and purple-blue colours in Figure 9

represent a scale of cloud-top temperatures. The colder the cloud-tops, the higher they are.¹⁰ The red and orange patches in Figure 9 were overlaid lightning strike data.¹¹ The image indicated that there was lightning in the discrete storm cells over Northern Queensland in the vicinity of VH-HKC and also showed the purple colour relating to the very high cumulonimbus cloud tops associated with the storms.

Figure 9: Satellite Infrared imagery¹² at 1830 showing extent of clouds and storms in the area visited by VH-HKC

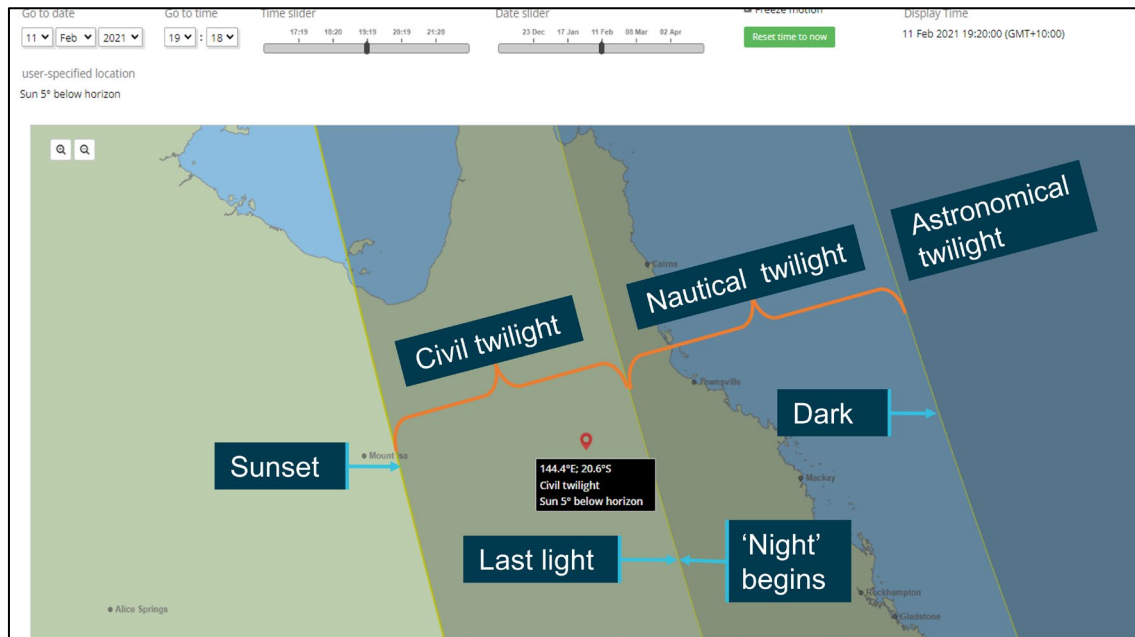
to last light.¹⁶ VH-HKC departed Wongalee at 1920 EST during the period of civil twilight, about 5 minutes prior to last light (Figure 10).

Figure 10: Regions of twilight relative to VH-HKC location at Wongalee Station 1920 EST

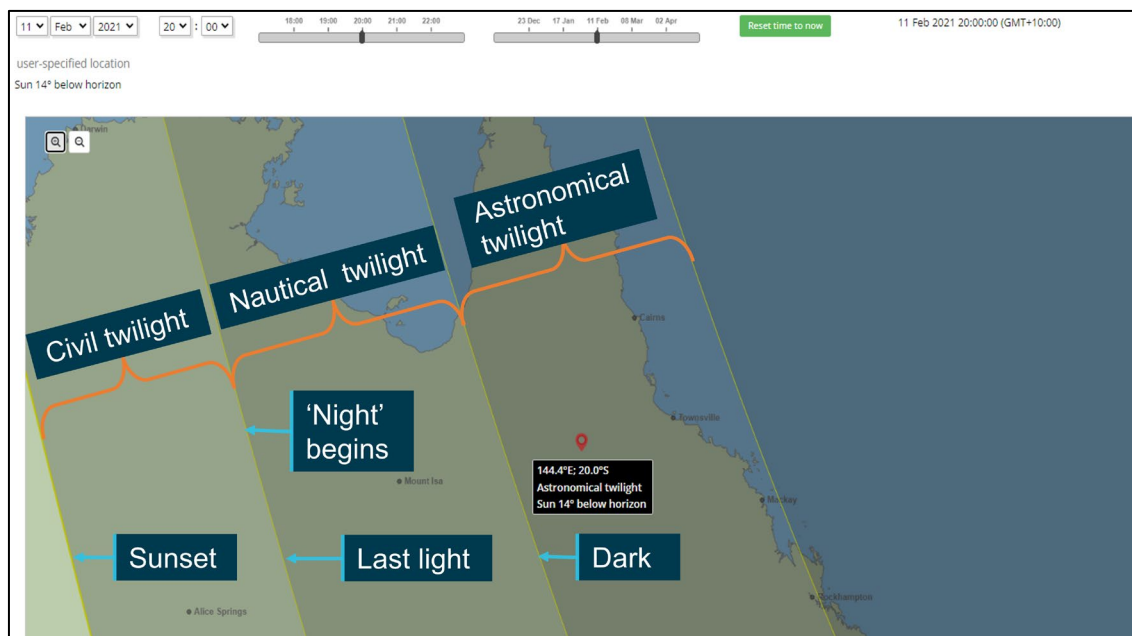
The end of evening nautical twilight¹⁷ was 1951. At this time, it was dark. Both the collision with the powerline on Kennedy Developmental Road and collision with terrain adjacent to the Pretty Plains Camden Park Road occurred in the period of astronomical twilight¹⁸ (Figure 11).

Figure 11: Regions of twilight relative to VH-HKC accident location at 2000 EST

The flight involving the collisions was conducted during astronomical twilight, moonless and in overcast conditions (no starlight) in a remote area with limited terrestrial lighting. This was considered to be a dark night with minimal light available. The collision with the powerline exacerbated the situation by extinguishing the Pretty Plains Station terrestrial lighting in the direction of travel.
