# Wirestrike and collision with terrain, involving Cessna 172, VH-REU

Coonabarabran Aerodrome, New South Wales, on 18 April 2022

## **ATSB Transport Safety Report**

AO-2022-027

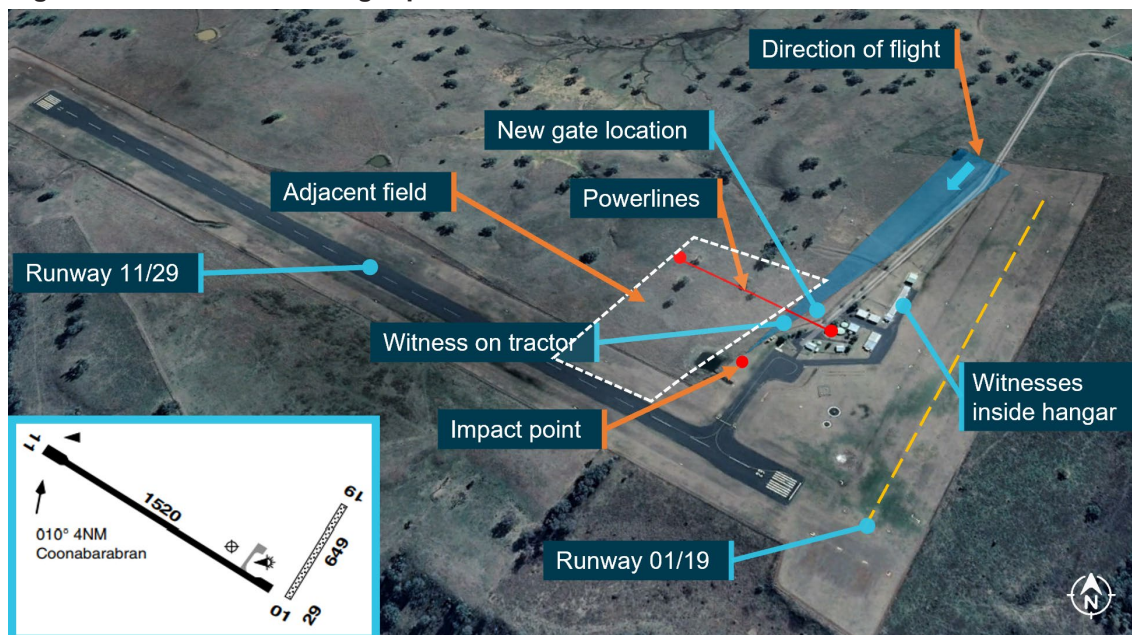
**Figure 1: Aerodrome and flight path overview**

The witness on the tractor recalled seeing the pilot do 2 touch-and-go landings on runway 11, before travelling to the north behind the witness, and banking right back towards the aerodrome. At the time, the witness initially thought that the pilot may have been going to conduct an approach to runway 19, but then realised that this was probably not the case as the aircraft was not turning left, which would have been normal for the approach to runway 19.

*Inset: En Route Supplement Australia (ERSA) chart of Coonabarabran Aerodrome, showing runway lengths in feet.*  
Source: Google Earth, annotated by the ATSB. Inset: Airservices Australia

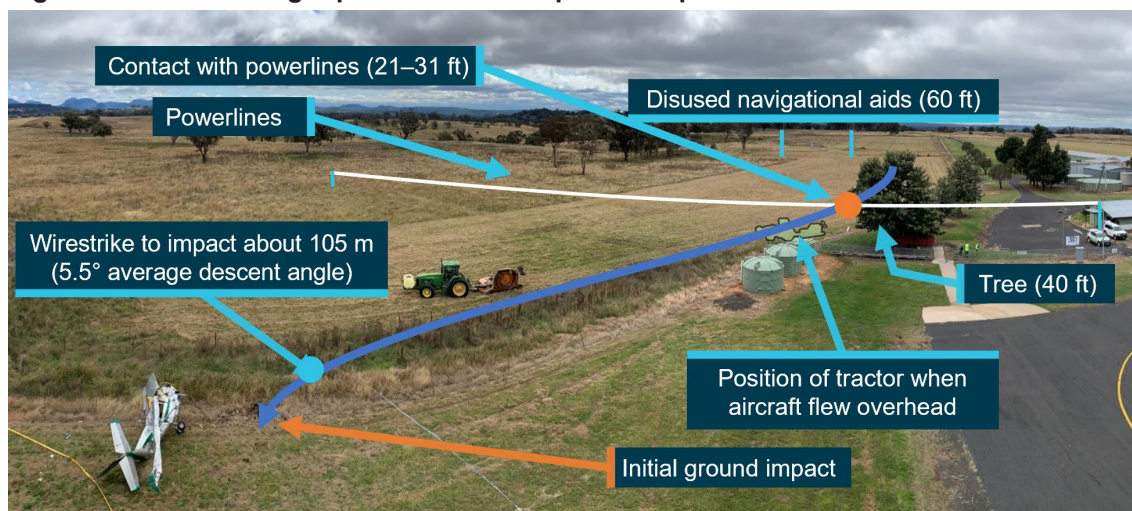
**Figure 2: Estimated flight path based on impact with powerlines and witness account**

The witness on the tractor recalled that the next time they saw the aircraft, it was about 500 m away and was travelling back towards the field at about 70 ft (or about the same height as some unused navigational aids) (Figure 2). At this time, based on the direction and height of the aircraft, the witness thought that the pilot was likely going to fly directly over the tractor. When the witness turned again, the aircraft was directly behind them, flying straight and level. The witness estimated its speed as about 80–85 kt, or fast enough to maintain control of the aircraft but not at top speed. The witness observed the aircraft contact the powerlines just behind and above the tractor and recalled hearing a whistling and crack as the wires travelled over the tractor cab.

*Flight path of VH-REU indicated by blue line.  
Source: ATSB*

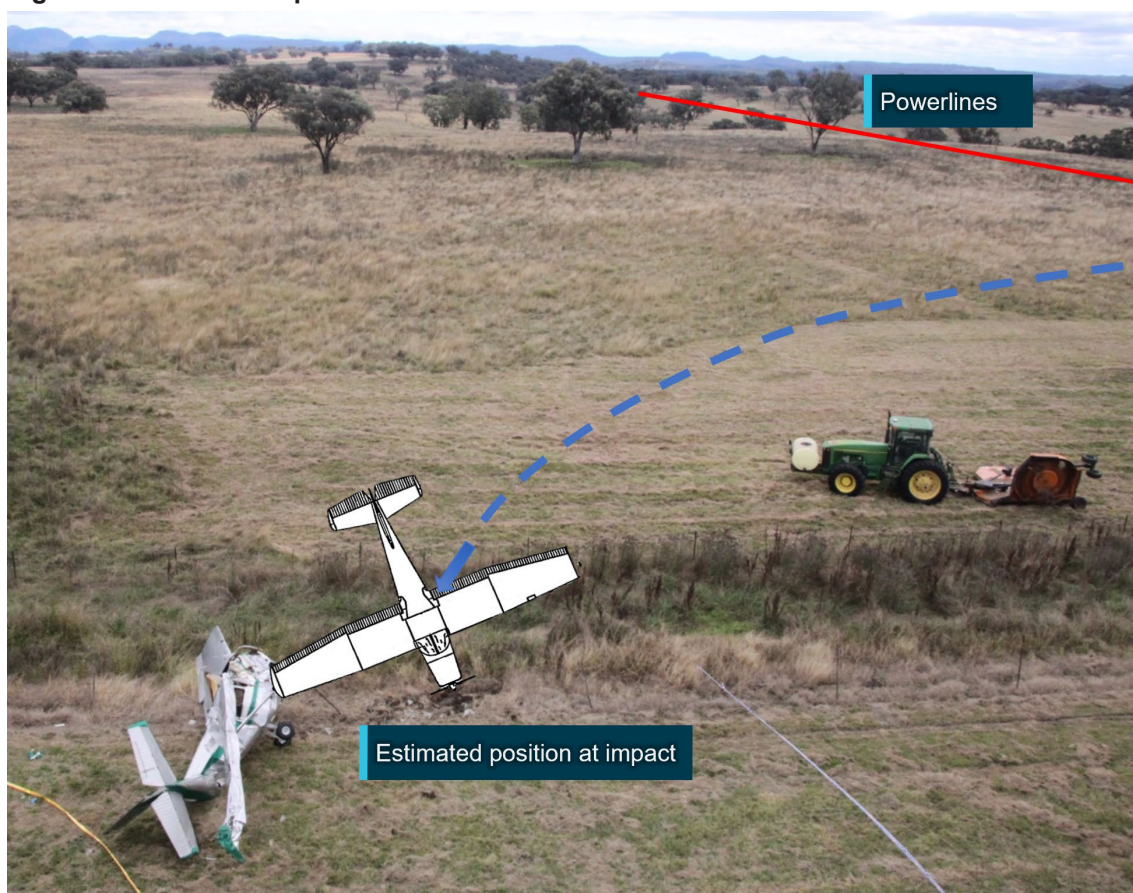
**Figure 3: Estimated impact orientation**

Damage to the aircraft and powerlines indicated that the aircraft had contacted the powerlines and then travelled about 105 m before ground impact. The aircraft impacted the ground about 57° nose-down, skidding to the right, and yawing to the left (Figure 3).

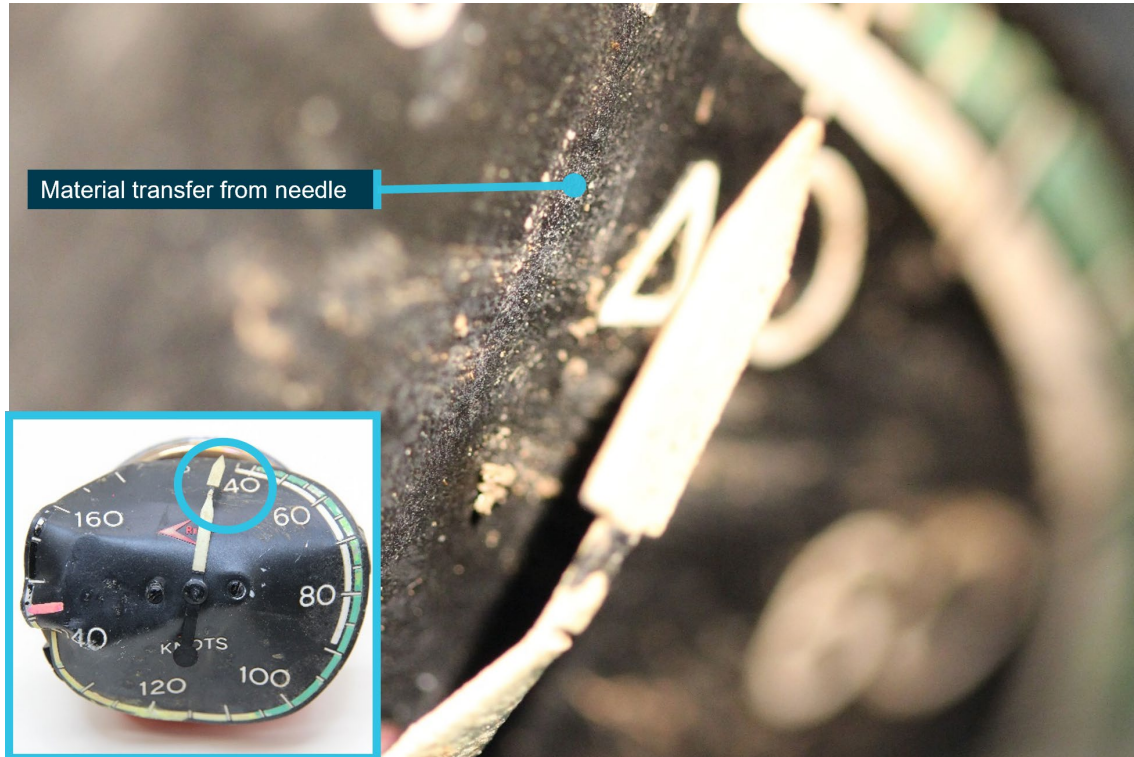
**Figure 4: VH-REU airspeed indicator with material transfer**

Based on a transfer of material from the airspeed indicator needle to its face, the aircraft likely impacted the ground at about 30 kt (or about 55 km/h) (Figure 4).

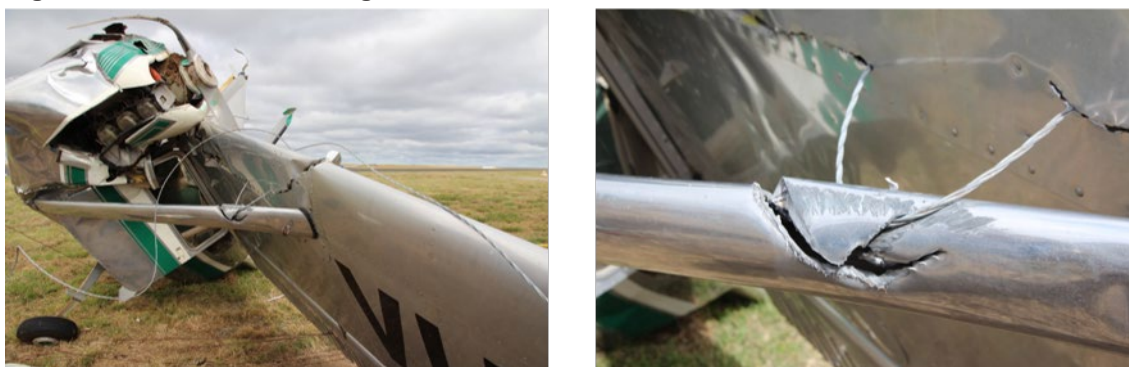
**Figure 5: Powerline, left wing and strut**

- damage to the left wing and strut indicated that the aircraft was likely close to level flight (about 11–12° right wing low) when it contacted the powerlines, with one of the powerlines remaining entangled with the left wing and left wing strut (Figure 5)
- one of the propeller blades had marks likely from contact with the powerlines, and had a significant forward bend and tip curl, which was consistent with the engine producing power when the aircraft impacted the ground (Figure 6)
- the other propeller blade was bent rearwards and had damage consistent with ground impact during the cartwheeling motion of the aircraft
- liveable space in the cabin was maintained
- the seat tracks were in place and the pilot's seat was still attached to the aircraft structure
- the pilot's upper torso restraint (shoulder harness) was found stowed.<sup>3</sup>

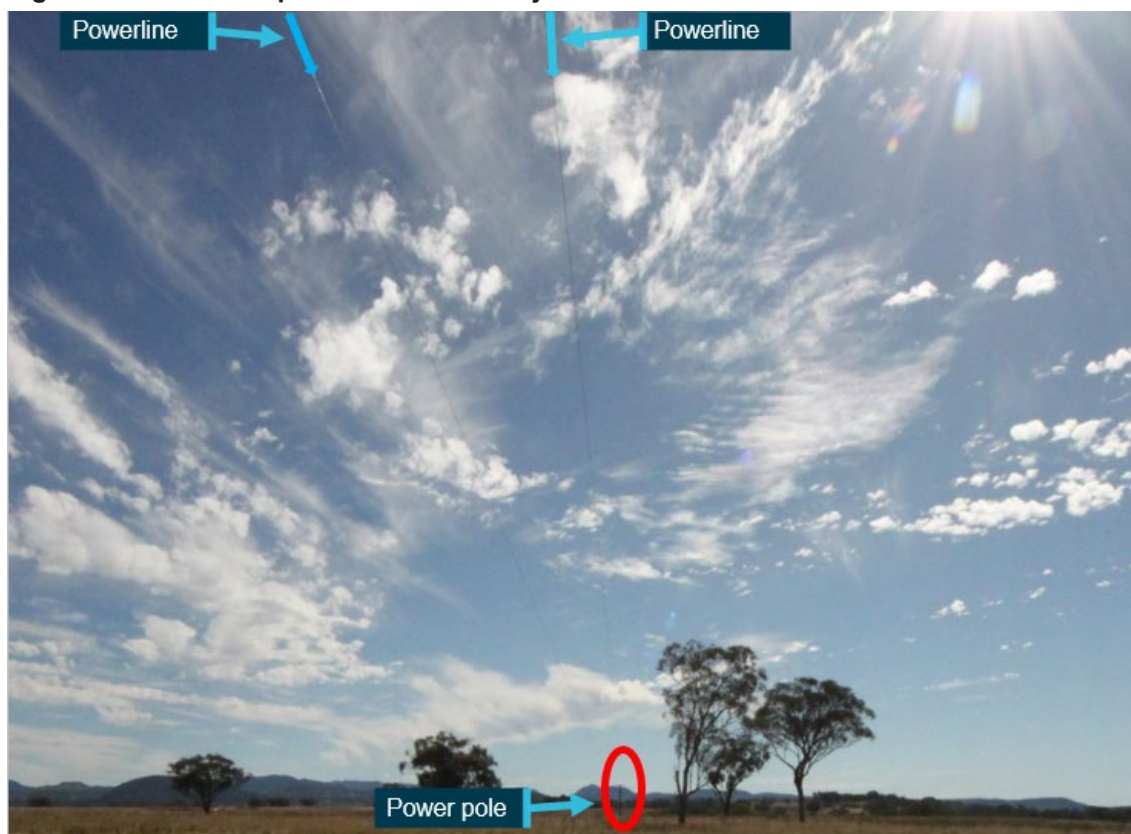
**Figure 7: Reinstalled powerlines in the adjacent field**

The 22-kV powerlines that were struck by the aircraft consisted of a pair of 3-strand galvanised steel wires. The wires spanned across timber poles that were 314 m apart. The powerlines had to be maintained so that the wires had a clearance of 5.5 m from the ground. The powerlines at the aerodrome (including an allowance for catenary) were reportedly compliant with this requirement, and were estimated to be at a height of 21–31 ft (6–9 m) above the ground at the point of impact

The powerlines were not marked and were not required to be marked by Australian Standards (AS) 3891.1 (*Permanent marking of overhead cables and their supporting structures for other than planned low level flying*) or AS 3891.2.4 (*Marking of overhead cables for planned low level flying operations, addressed the requirements for marking overhead cables, including powerlines*).

Figure 7, looking west-north-west, shows reinstalled powerlines above the field after the accident.

Following the wirestrike accident involving VH-REU and in accordance with its company policy, Essential Energy field workers assessed the risk of another wirestrike to the powerlines that crossed the fields north of Coonabarabran Aerodrome. Subsequently, Essential Energy installed aerial markers to these powerlines.
