# Flight below minimum altitude occurrences

40 km south of Cairns Airport, Queensland on 24 and 26 October 2022

## **ATSB Transport Safety Report**

AO-2022-051

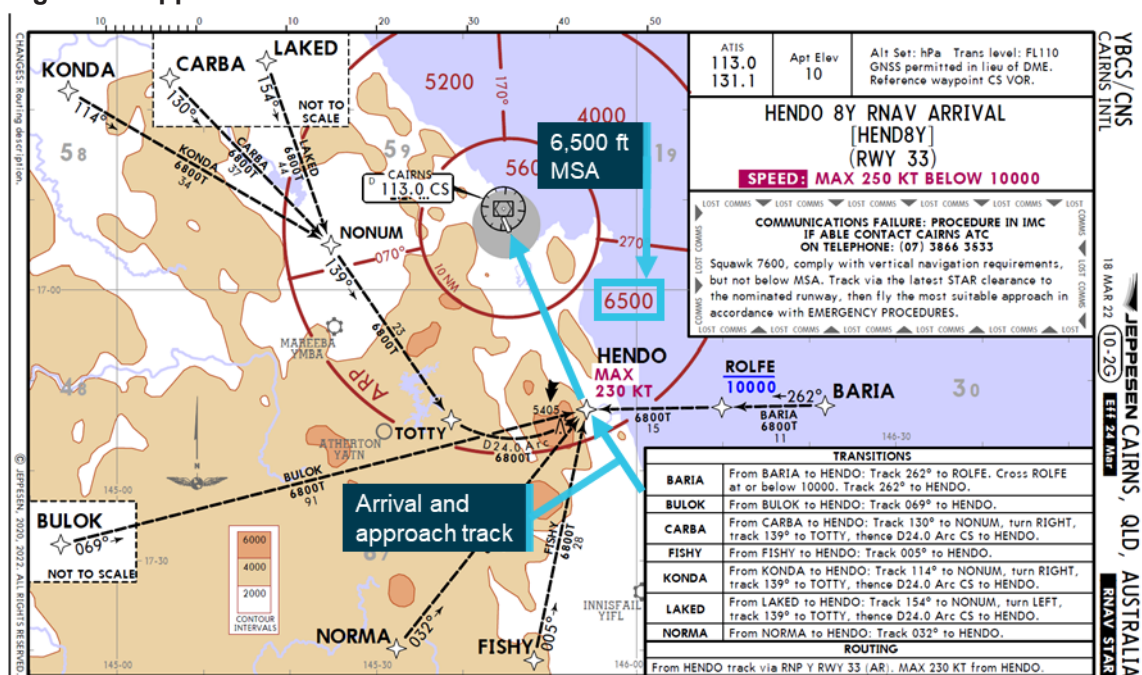
Figure 1: Jeppesen HENDO 8Y standard arrival – VH-VUT

At 1945 local time, the aircraft was cruising in darkness at flight level (FL)<sup>2</sup> 380 about 215 NM to the south of Cairns. At that time, air traffic control (ATC) provided the crew with clearance to conduct the Cairns HENDO 8Y standard arrival (STAR) via the BARIA waypoint<sup>3</sup> transition (Figure 1).

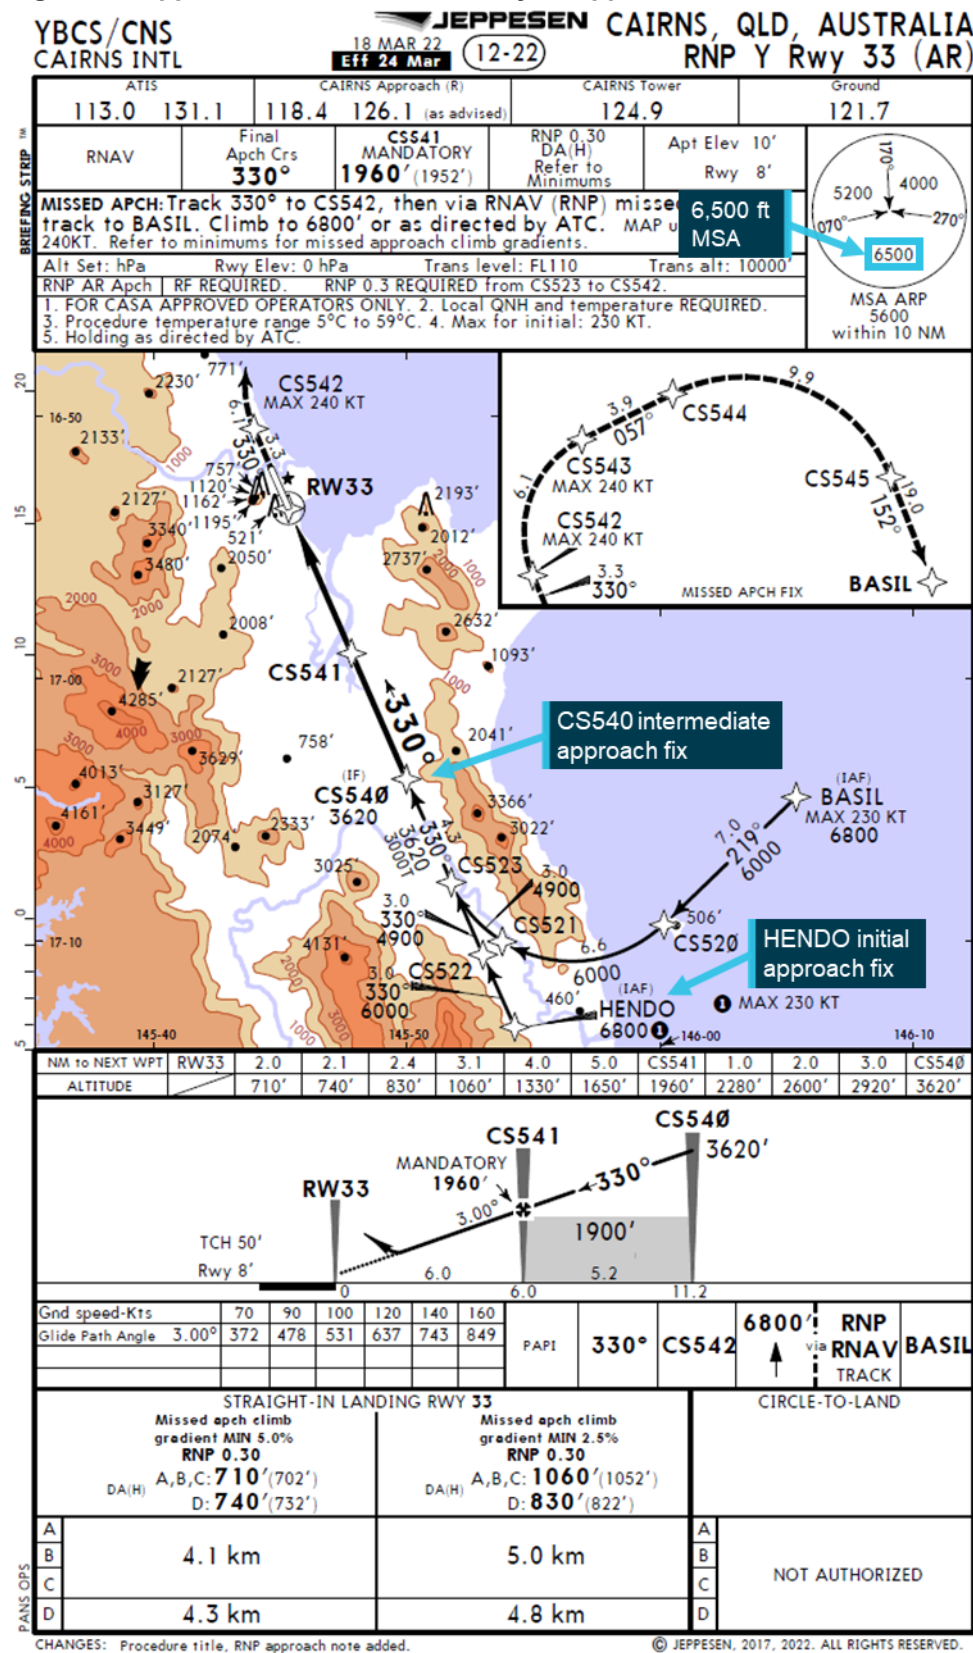
Figure 2: Jeppesen Cairns RNP Y runway 33 approach chart

The approach procedure had two different initial approach fixes (IAF) (Figure 2) with associated paths to a common intermediate fix (IF) at waypoint CS540. From the BASIL IAF, the approach proceeded via CS520, CS521 and CS523, and from the HENDO IAF via CS522 and CS523. In order to load either path into the FMC, the flight crew needed to select one of the two approach transitions (see the section titled *Flight management computer*).

The flight crew did not recognise that an approach transition selection was required and consequently did not select one. As a transition had not been selected, the FMC presented a discontinuity in the entered flight path at the HENDO waypoint (see the section titled *Flight*

*management computer*). The flight crew misidentified the approach IF, CS540, as the IAF and resolved the FMC discontinuity by connecting HENDO to CS540. This selection removed the 6,800 ft descent altitude constraint associated with HENDO in the RNP approach programming.

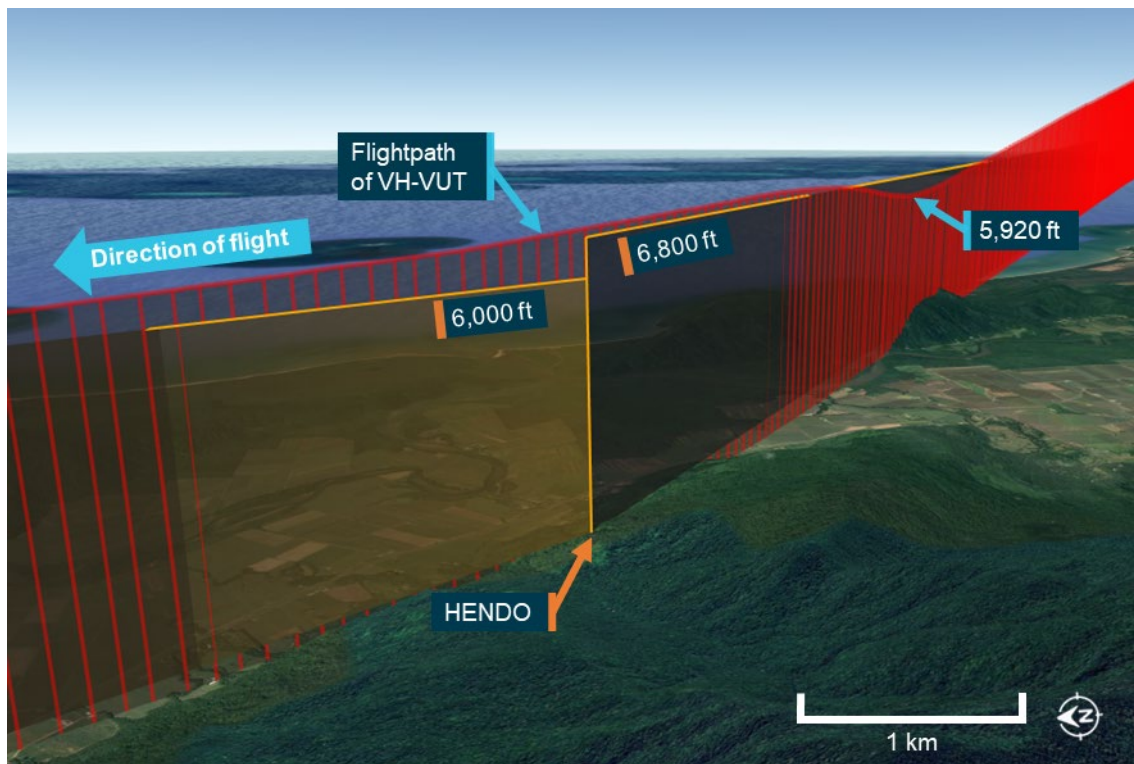
**Figure 3: Flight path of VH-VUT**

At 2011:38, about 7 NM prior to crossing HENDO, the aircraft descended below 6,800 ft (Figure 3) and 9 seconds later descended below the 6,500 ft MSA. Six seconds later, at 2011:53, ATC observed that the aircraft had descended below 6,800 ft and contacted the crew to confirm the aircraft's altitude. The captain then reselected 6,800 ft and manually arrested the descent. ATC then issued a low altitude alert to the crew and advised them to climb immediately. Three seconds later, at 2012:07, the aircraft stopped descending at about 5,920 ft and then commenced a climb. At 2012:28, the aircraft climbed back above 6,800 ft. No ground proximity warning system alerts were generated during the incident.

Virgin Australia updated flight crew operation notice information for Cairns with detailed guidance for the conduct of the HENDO 8Y arrival and RNP Y runway 33 approach. Virgin Australia also provided guidance to all Boeing 737 flight crew for the conduct of arrivals and approaches where the selection of an approach transition was required.

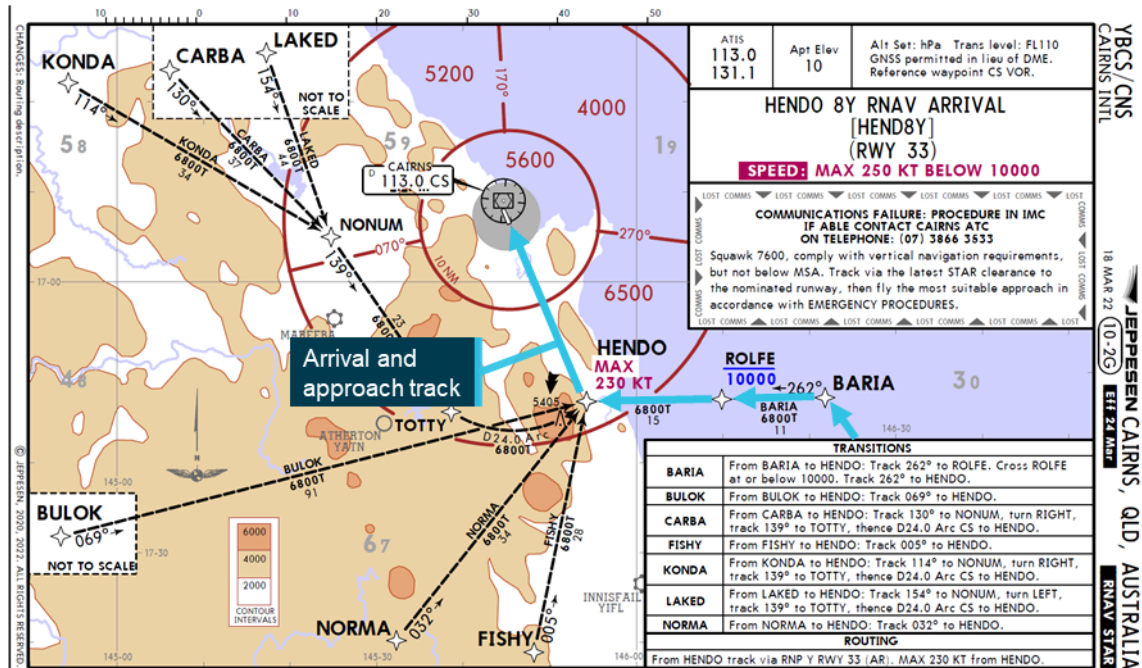
**Figure 4: Jeppesen HENDO 8Y standard arrival – VH-VZA**

At 0739, in daylight, while the aircraft was in cruise at FL 380 about 225 NM to the south of Cairns, ATC provided the crew with clearance to conduct the Cairns HENDO 8Y STAR via the BARIA waypoint transition (Figure 4).

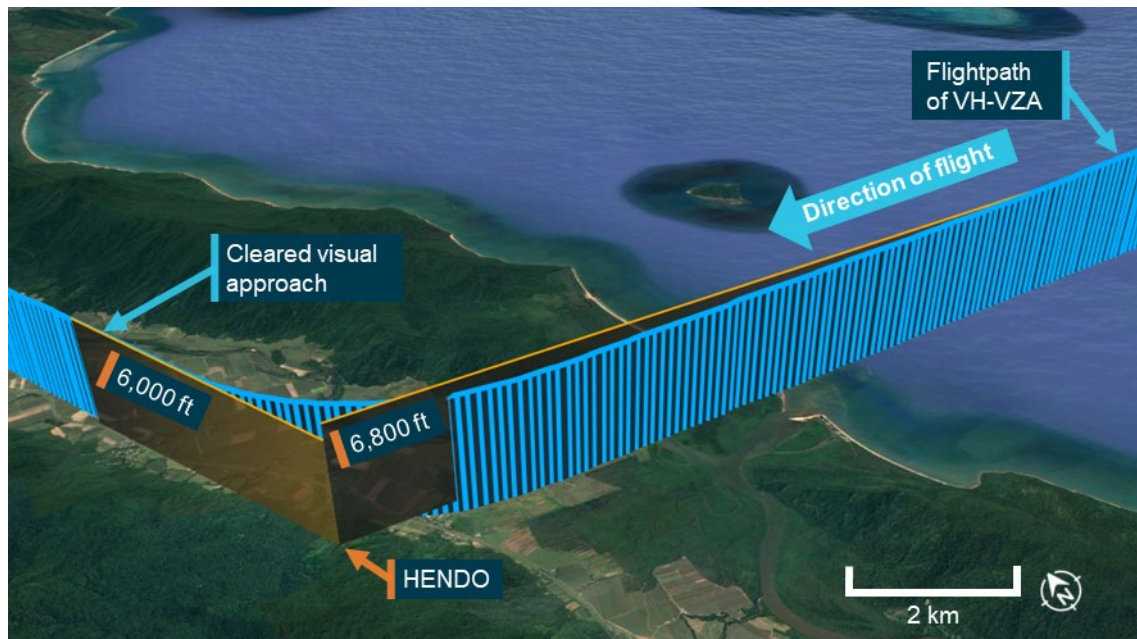
**Figure 5: Flight path of VH-VZA**

At 0810:42, when the aircraft was about 7 NM east of HENDO, the captain selected 5,500 ft in the autopilot mode control panel and the aircraft descended below 6,800 ft, and 34 seconds later below the 6,500 ft MSA.

The aircraft passed HENDO at 0811:56 at an altitude of about 6,125 ft (Figure 5). Eleven seconds later, ATC contacted the crew to confirm that the aircraft had passed HENDO at the correct altitude. ATC then confirmed with the crew that the flight was operating in visual conditions and provided clearance for a visual approach. The aircraft landed at Cairns without further incident.

Qantas issued an internal notice to flight crew providing guidance for the conduct of arrivals and approaches where the selection of an approach transition was required.

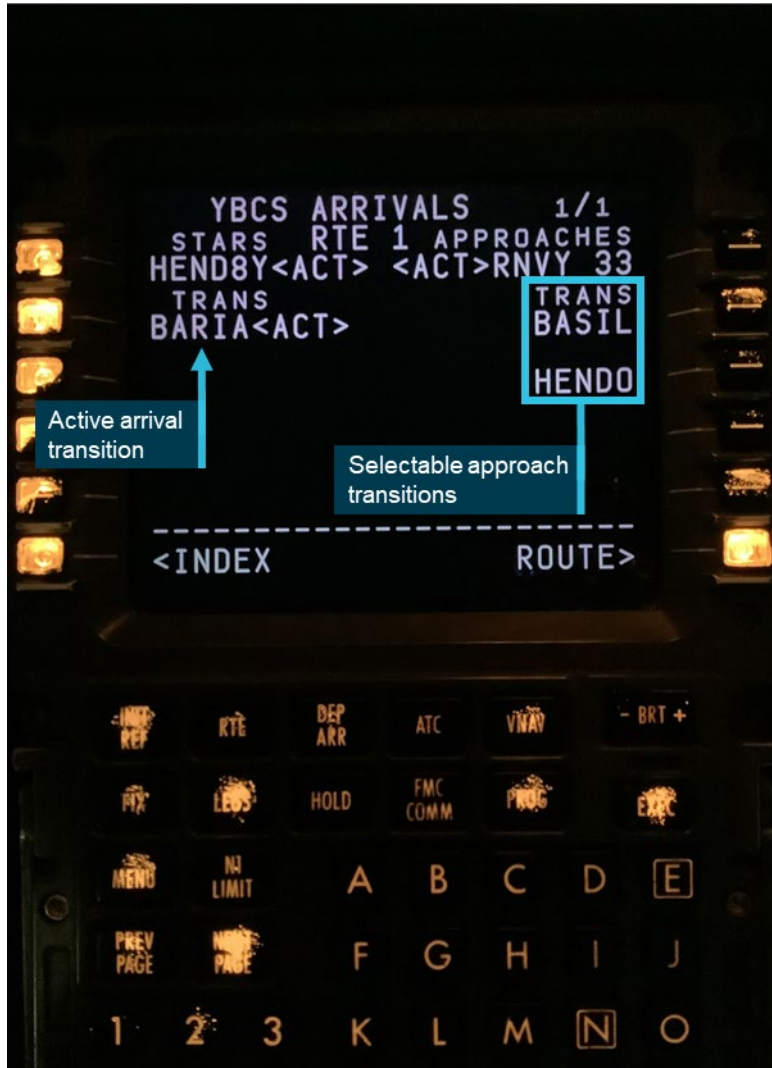
Figure 6: Flight management computer approach transitions

The approach procedure (Figure 2) had two different IAFs with associated paths to a common IF (CS540), from BASIL through waypoints CS520, CS521 and CS523, or from the HENDO through CS522 and CS523. Therefore, the flight crew needed to select one of the two approach transitions (Figure 6). If a transition was not selected, the segment of the approach from the IAF to the IF would not be loaded (the component of the instrument approach from the common IF onwards was automatically loaded).

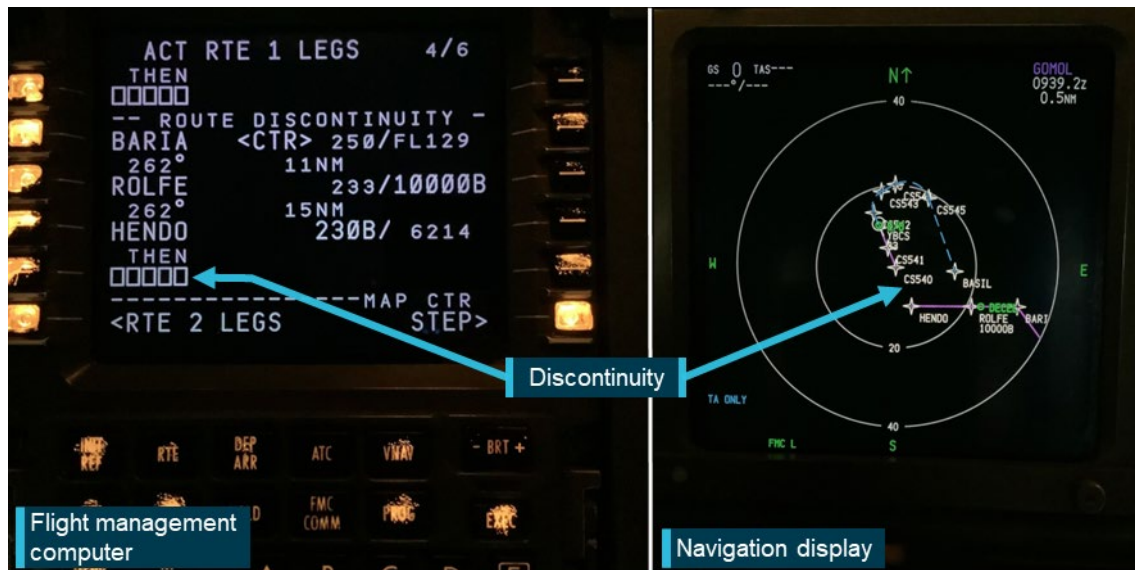
**Figure 7: Flight management computer (left) and navigation display (right) showing the discontinuity**

As the crews did not select an approach transition, a discontinuity (Figure 7) was created at the HENDO waypoint associated with the HENDO 8Y STAR. Both crews resolved this discontinuity by connecting HENDO to CS540. This selection removed the 6,800 ft descent altitude constraint associated with HENDO in the RNP approach programming. The segment minimum safe altitudes associated with waypoints CS522 (6,000 ft) and CS523 (4,900 ft) were also removed.
