# Partial power loss and collision with terrain involving Dynaero MCR-01 VLA, VH-SIP

near Serpentine Airfield, Western Australia, on 28 December 2020

## **ATSB Transport Safety Report**

AO-2020-065

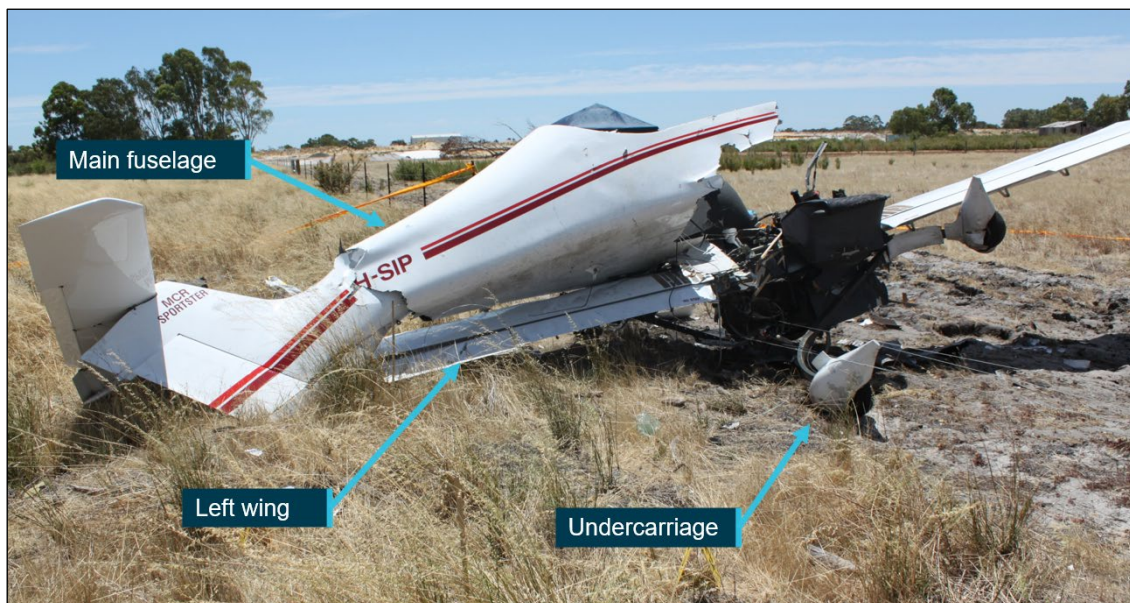
**Figure 3: Accident site**

No pre-impact defects were identified with flight controls or aircraft structure. The fuel tank, located between the cockpit and engine compartment, had ruptured and a quantity of fuel had leaked into the soil. There was no pre- or post-accident fire.

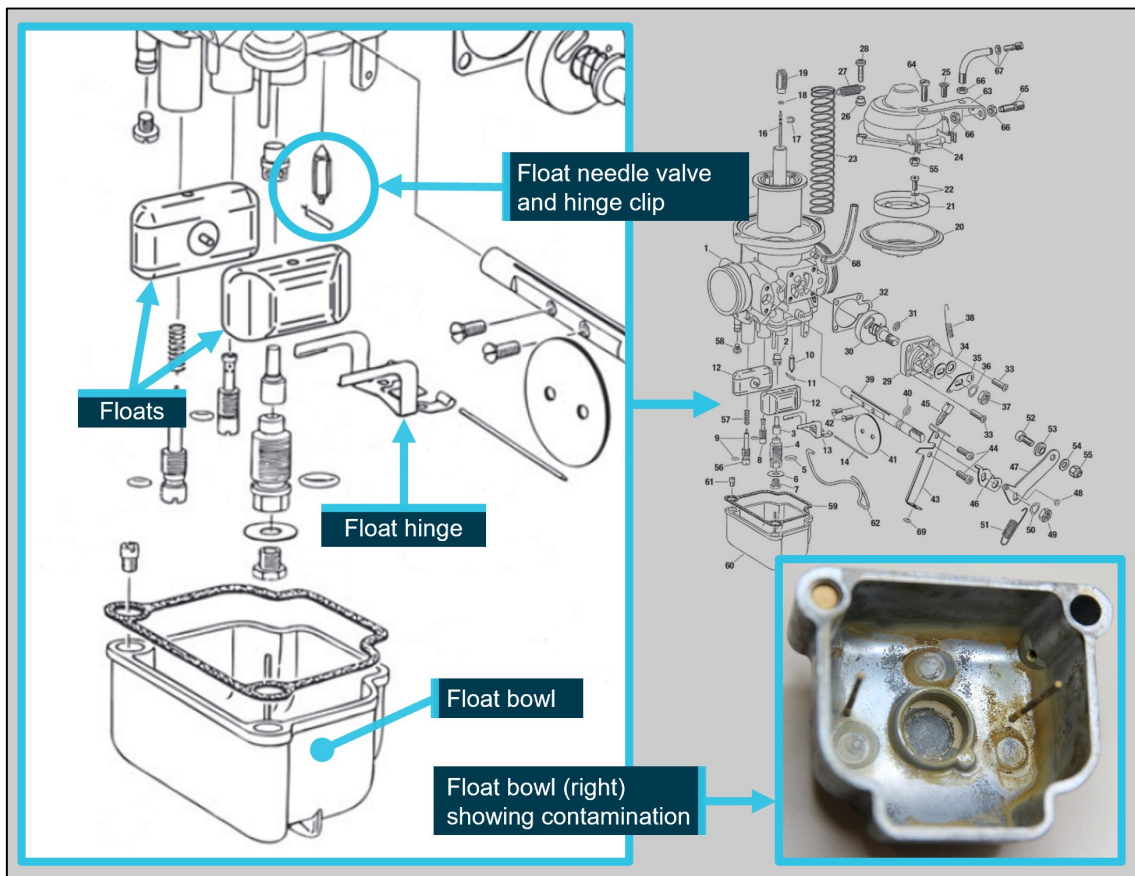
**Figure B 1: Carburettor components**

Review of the engine systems found that the left carburettor was missing a clip that attached the float needle valve to the float hinge bracket (Figure B 1 and Figure B 2). During multiple tests under controlled conditions, the left carburettor flooded<sup>8</sup> repeatedly. It was later determined that this was likely due to the presence of significant amounts of corrosion on the float needle valve, its seat, and a deposit on the on the valve tip (Figure B 3).

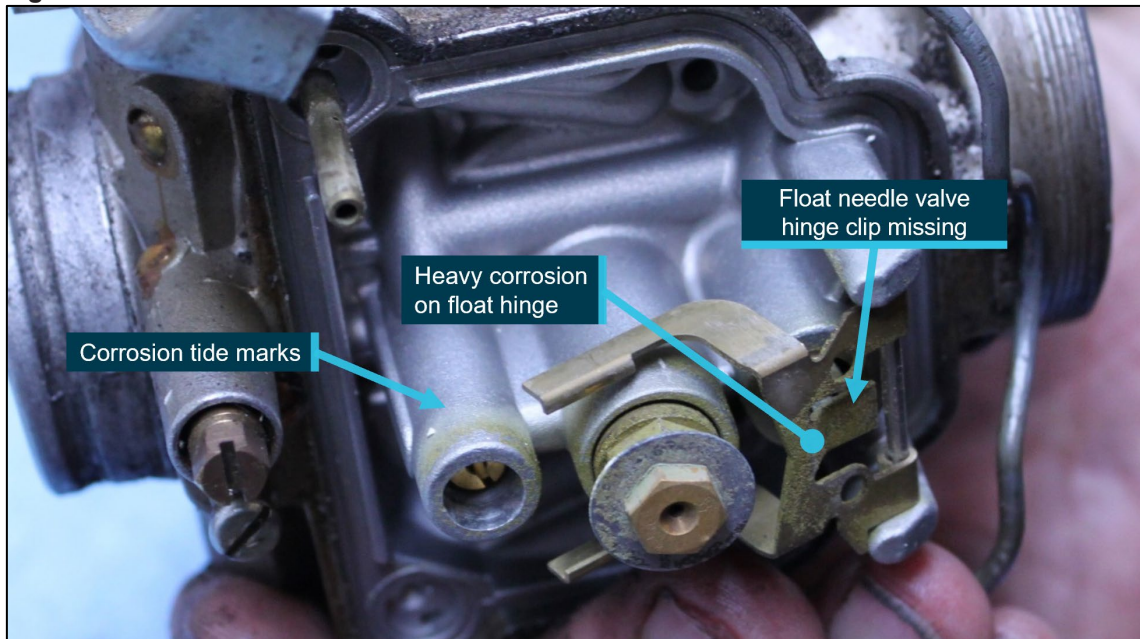
**Figure B 2: VH-SIP left carburettor condition**

ATSB technical analysis found that the contamination on the left carburettor float needle valve showed that it was corrosion, and the deposit on the valve tip was a carbon-based material. The contamination in the bowls of both carburettors was considered a likely corrosion by-product from the bowls.

The engine manufacturer advised the ATSB that faultless function of the engine could not be guaranteed if contaminants were found in the carburettor bowls. Corrosion on the float needle valve, and the absence of the clip that attaches the float needle valve to the float hinge bracket further increased the risk that the engine would not satisfactorily perform. The engine manufacturer also advised that the deposit on the left carburettor float needle valve could cause flooding and engine rough running at low power settings.

Service bulletins from the manufacturer recommended that if any contamination was found within the carburettor bowl, that the entire fuel system must be inspected and cleaned.

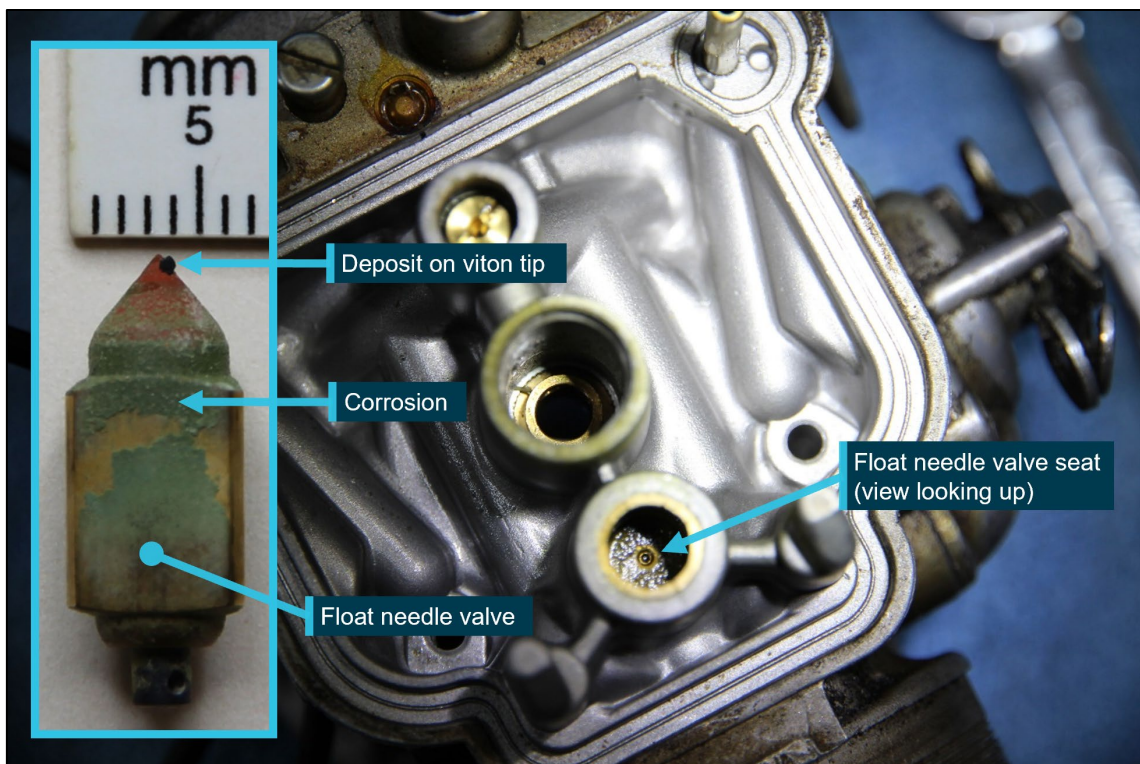
**Figure B 3: VH-SIP left carburettor float needle valve and seat**

The flooding that was observed during multiple tests of the left carburettor, was the result of significant contamination on its float needle valve and seat. Given the amount of contamination, the left carburettor was likely flooding prior to the accident, and as carburettor flooding is known to result in fuel odour, would have been the likely source of the reported fuel smell.

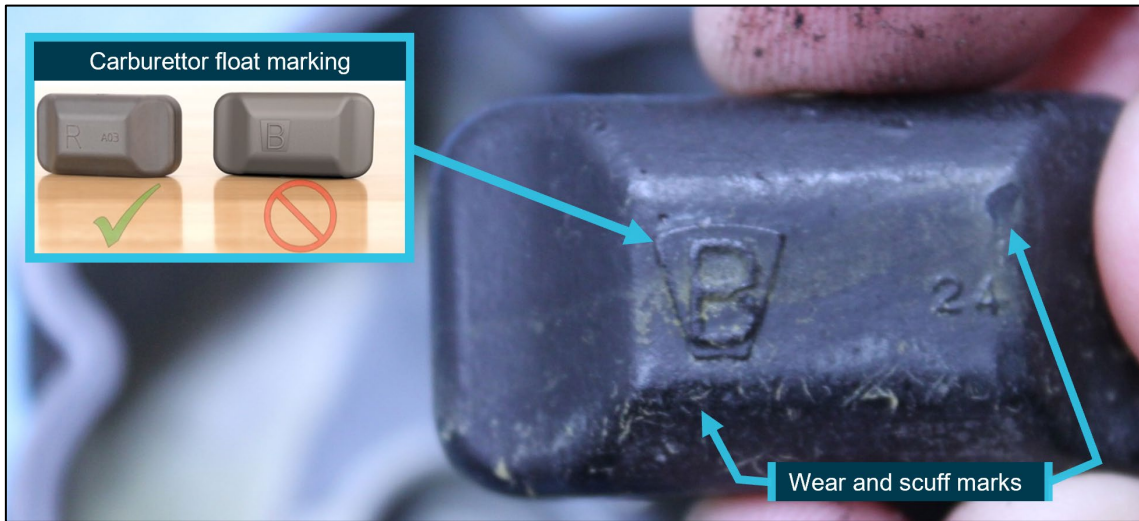
**Figure B 4: Left carburettor float condition**

Additionally, both carburettor float bowls were contaminated. The floats fitted to both carburettors were the original type (Figure B 4), which were required to be replaced as part of a mandatory service bulletin. Pre-service bulletin floats could lose buoyancy and increase the likelihood of carburettor flooding, also characterised by the presence of fuel odour.
