Cabin depressurisation involving Airbus A330, VH-EBK

235 NM (435 km) south-west of Adelaide, South Australia on 5 February 2021

ATSB Transport Safety Report

AO-2021-005

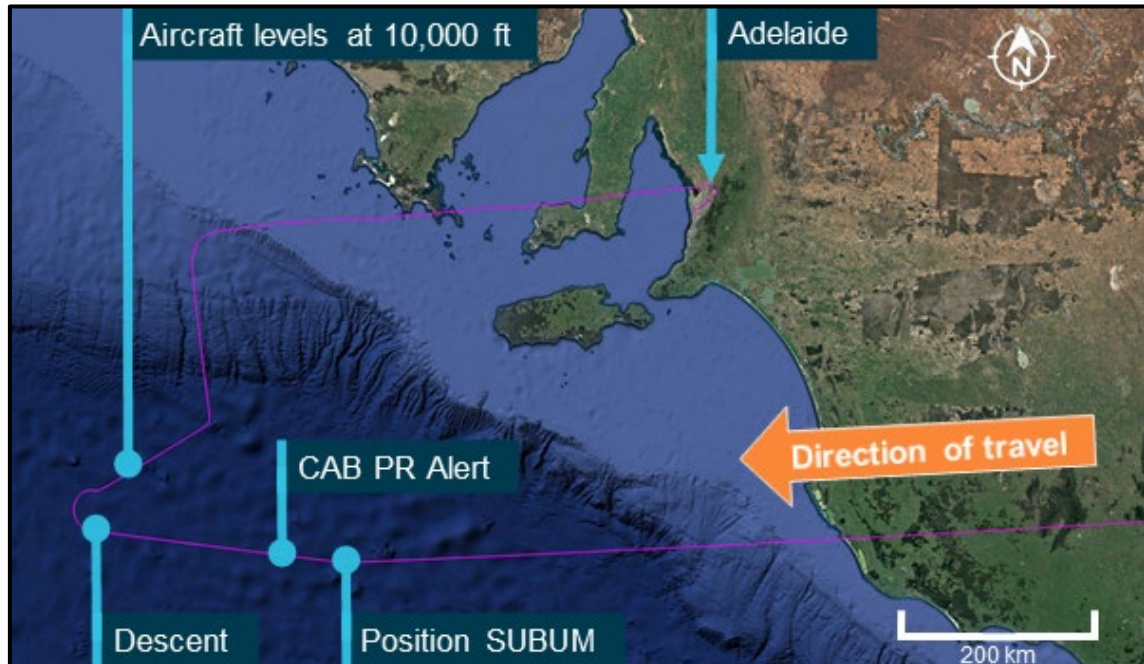
Figure 1: VH-EBK track and principal events

Melbourne air traffic control (ATC) was flight following⁷ the aircraft through the controller-pilot data link communications⁸ however, the first officer called Brisbane ATC using high frequency band radio communications to advise the technical issue. A PAN PAN⁹ was declared on that frequency. Brisbane ATC was also notified of the need to descend due to the aircraft's pressurisation issue, and the intention to divert. During these communications, at 0105, the aircraft commenced a descent from FL 400 and turned towards Adelaide (Figure 1). Brisbane ATC acknowledged the PAN call at 0106.

About 2 minutes after commencing the descent, the flight crew identified that the cabin pressurisation data presented on the SD page had changed. The cabin altitude was now red (to highlight that it had exceeded 9,550 ft) and now indicating about 12,400 ft, while the other pressurisation indications were indicative of the cabin depressurising. The flight crew immediately responded by commencing an emergency descent. At 0108, the first officer transmitted a MAYDAY¹⁰ call, which was acknowledged by Brisbane ATC.

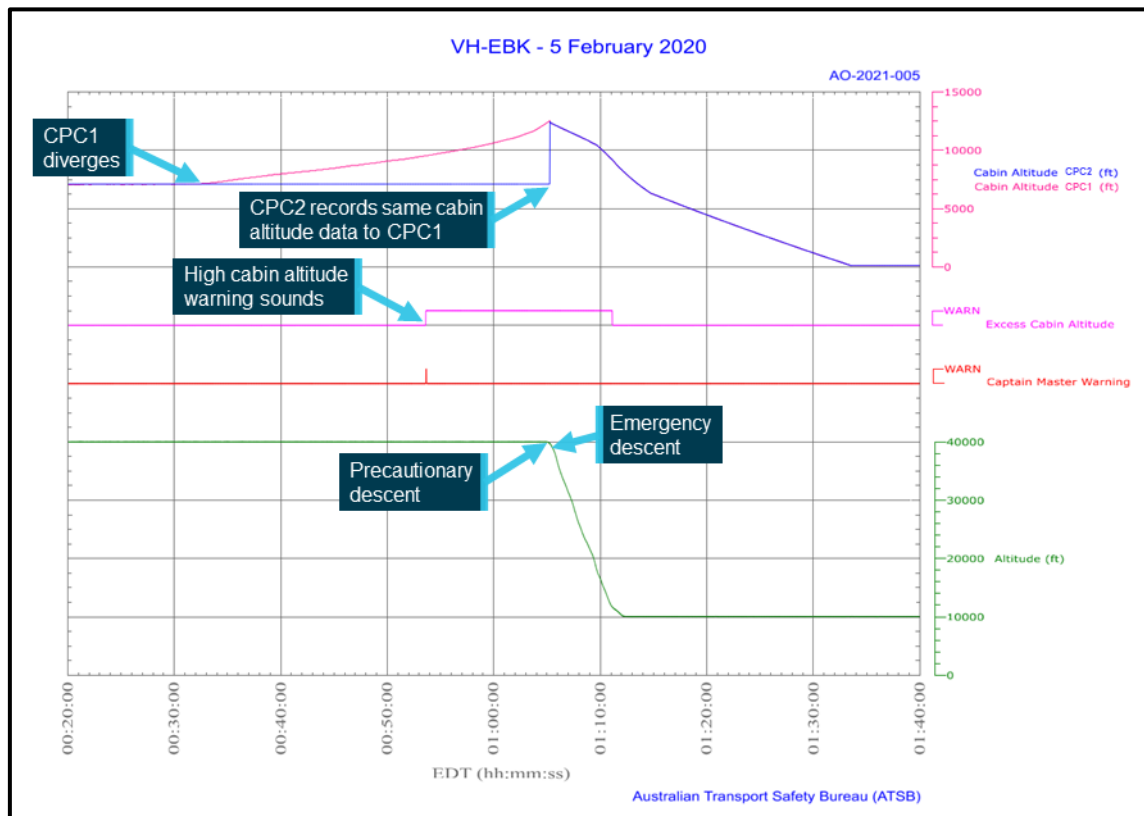
Figure 7: VH-EBK flight data

The aircraft was equipped with a quick access recorder (QAR) and flight data recorder (FDR). Figure 7 shows flight data for certain recorded parameters at the time of the incident.

The examination also found that during the flight, at 0032, when the cabin altitude was about 7,100 ft, the CPC2 cabin pressure sensor value appeared to 'freeze', but it continued to produce credible data. The faulty pressure sensor affected control of the outflow valves, and over time, this resulted in a loss of cabin pressure. It was not until about 0105, shortly after the precautionary descent was initiated, that the intermittent pressure sensor fault resulted in its output data exceeding any of the CPC's internal fault detection criteria. At this time, the intermittent fault disappeared, and the pressure sensor started measuring the actual cabin pressure (12,500 ft cabin altitude). According to Nord-Micro, the sharp discontinuity in the pressure sensor value probably exceeded the fault detection criteria, triggering CPC2 to use the CPC1 pressure sensor data for cabin pressure control.
