Mid-air collision between hot air balloons, VH-FSR and VH-OOP

6 km south-east of Alice Springs Airport, Northern Territory on 18 July 2022

ATSB Transport Safety Report

AO-2022-037

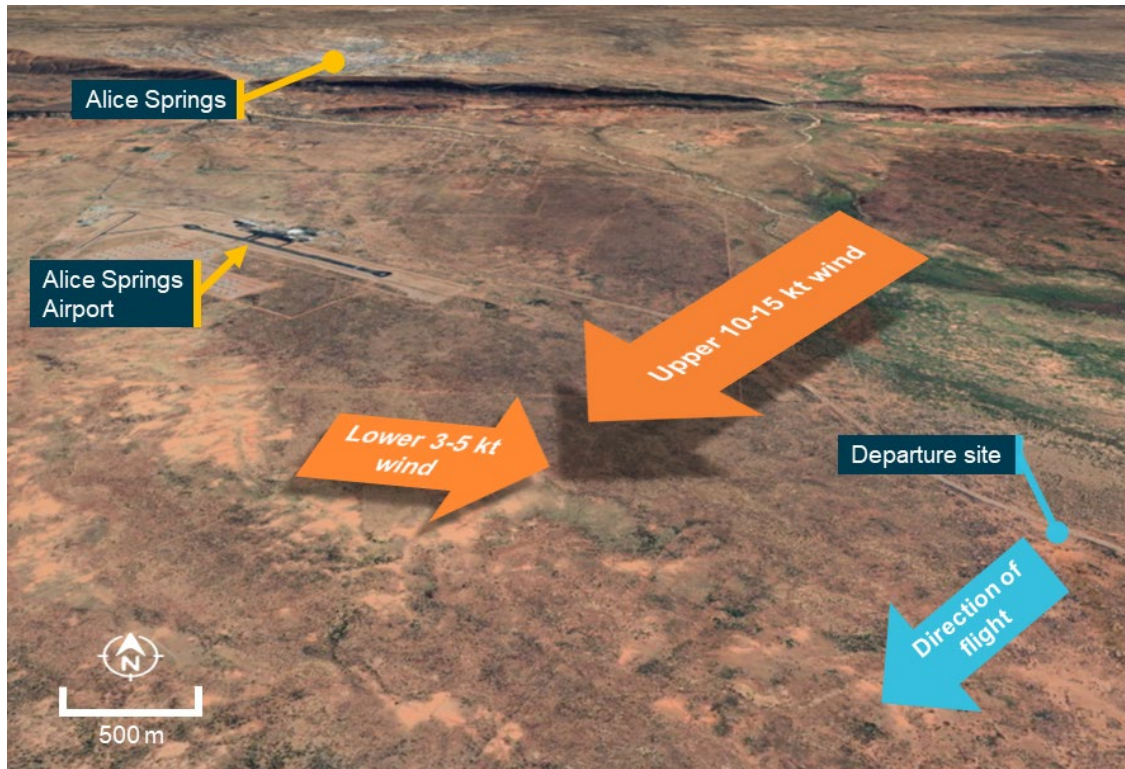
Figure 1: Departure site and prevailing winds

Before departing, the pilots released a pilot balloon² to determine wind conditions. The pilots observed that up to about 200 ft above ground level (AGL) a 3-5 kt westerly wind prevailed. Above this was a 100 ft thick layer of calm air. Extending above the calm layer was a north-easterly wind of about 10-15 kt (Figure 1). The pilots also noted that cloud and visibility conditions were clear.

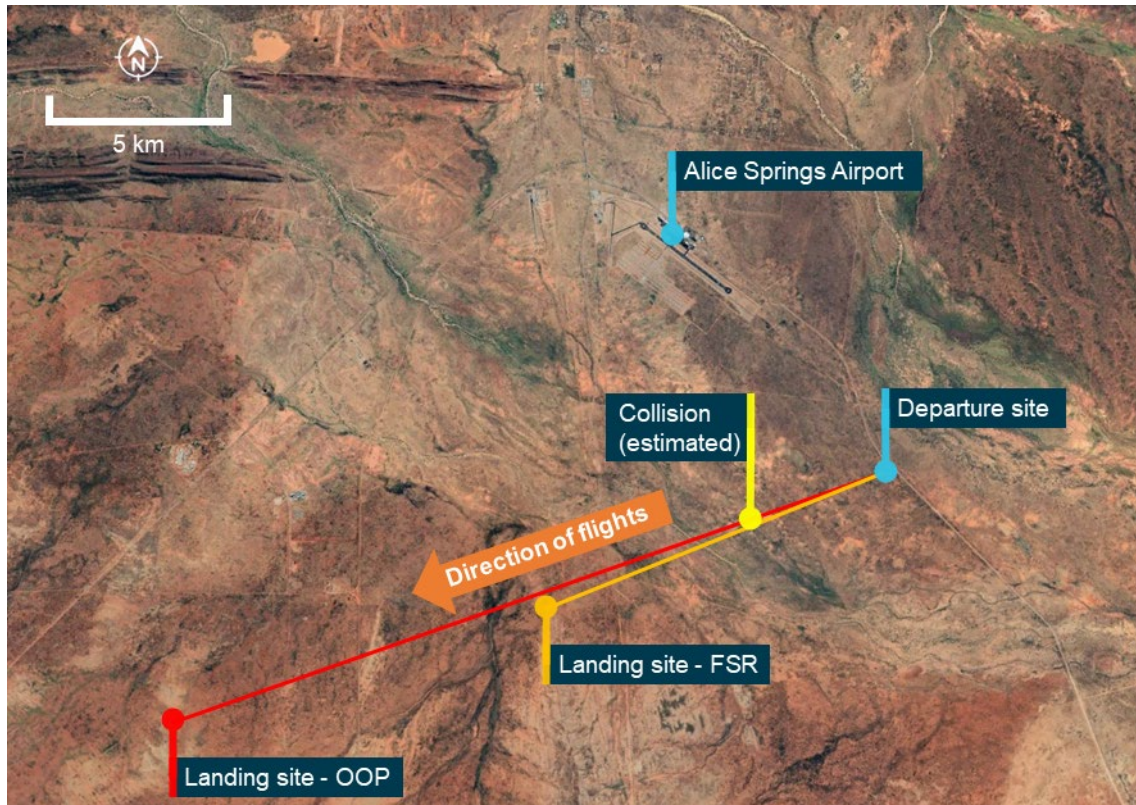
Figure 2: Overview of flights

About 40 seconds before the eventual collision, the pilot of OOP observed FSR closing and recognised the potential for contact (Figure 2), so called the pilot of FSR 4 times using a UHF radio. During that time, the pilot of FSR was focussed on managing the descent and misinterpreted these broadcasts as communications between other balloons that were operating in the area and therefore did not reply.

While flying at about 900 ft above ground level (AGL) in 10-15 kt winds, the pilot of hot air balloon VH-FSR (FSR) decided to descend to slow the balloon's progress. The pilot of FSR observed VH-OOP (OOP), which was flying at about 100 ft AGL and about 1,150 m ahead within a layer of slow wind. However, the pilot of FSR misjudged the height of OOP and believed it to be flying higher in the same faster moving air stream that FSR was operating in. Based on that assessment, the pilot of FSR believed that sufficient separation would be maintained as FSR descended to a position behind OOP at a similar altitude. However, this misjudgement resulted in FSR converging toward OOP as it descended.
