Mid-air collision involving Eurocopter EC130B4, VH-XH9, and Eurocopter EC130B4, VH-XKQ

Main Beach, Gold Coast, Queensland on 2 January 2023

AO-2023-001

Preliminary – 7 March 2023

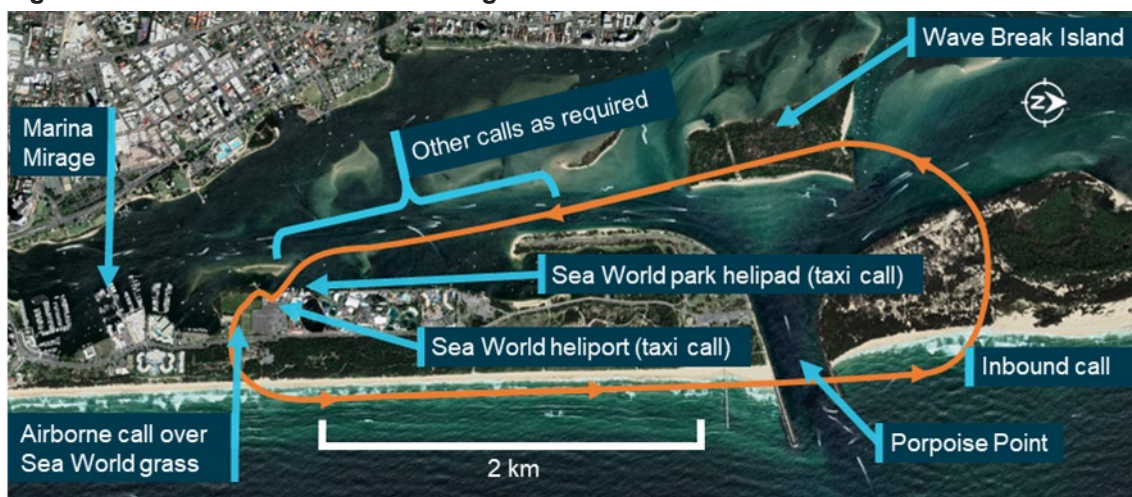
Figure 1: Standard 5-minute scenic flight route and radio calls

At about 1351:40, XH9 departed pad 3 at the operator's heliport for a 5-minute scenic flight, with the pilot and 5 passengers on board. The 5-minute scenic flight climbed over an area known locally as 'Sea World grass' before tracking northbound coastal over water at 500 ft. Figure 1 shows the standard route and radio calls for the operator's 5-minute flights.

At about 1353:40, the pilot of XH9 made an inbound radio call from near Porpoise Point stating their position, height of 500 ft and intention to track to Sea World via the Broadwater by making a left turn.

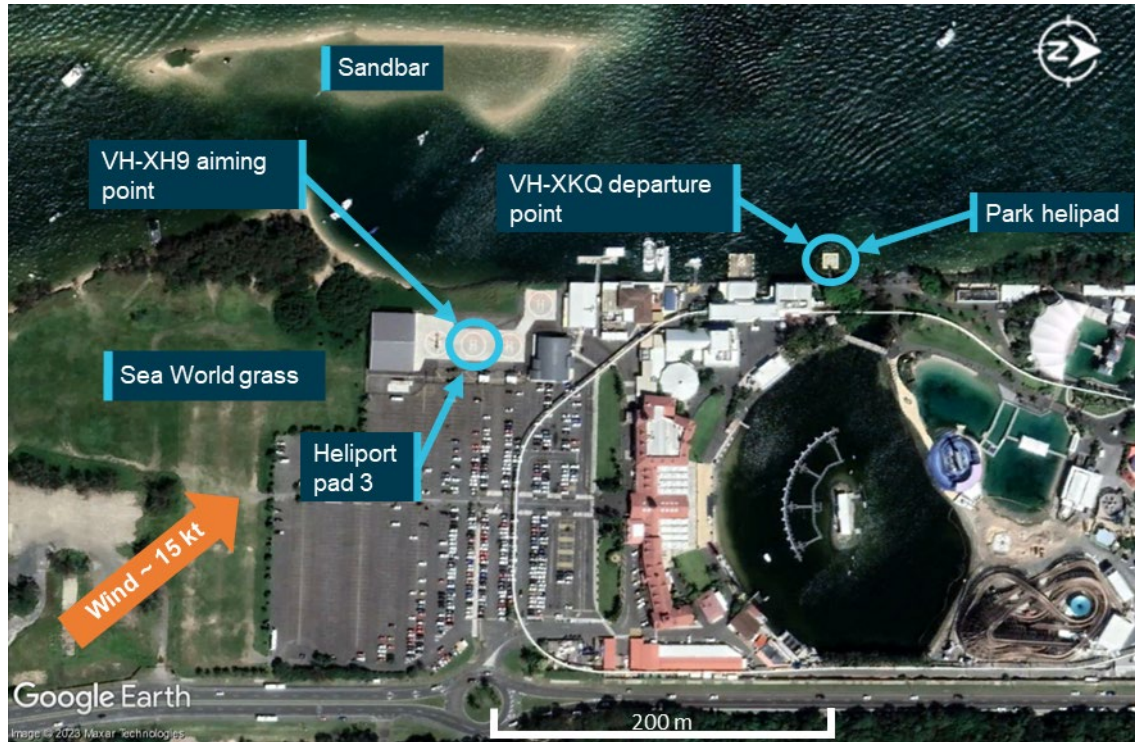
Figure 2: Helipad configuration at Sea World on 2 January 2023

Concurrently, at a separate helipad within the theme park (park helipad), 2 ground crew were loading passengers into XKQ in preparation for departure (Figure 2). The flight was also planned

The ground crew assisted passengers into XKQ, fastened the passengers' seatbelts and helped with the passengers' headsets. The ground crew reported that they completed a final visual check of the helicopter, which included checking all the doors were closed and ensuring the surrounding area was free from hazards, and signalled to the pilot that XKQ was ready for departure. They then went to prepare passengers and information for the next flight. The ground crew later reported that they had not seen any other aircraft before giving the signal for the pilot to depart.

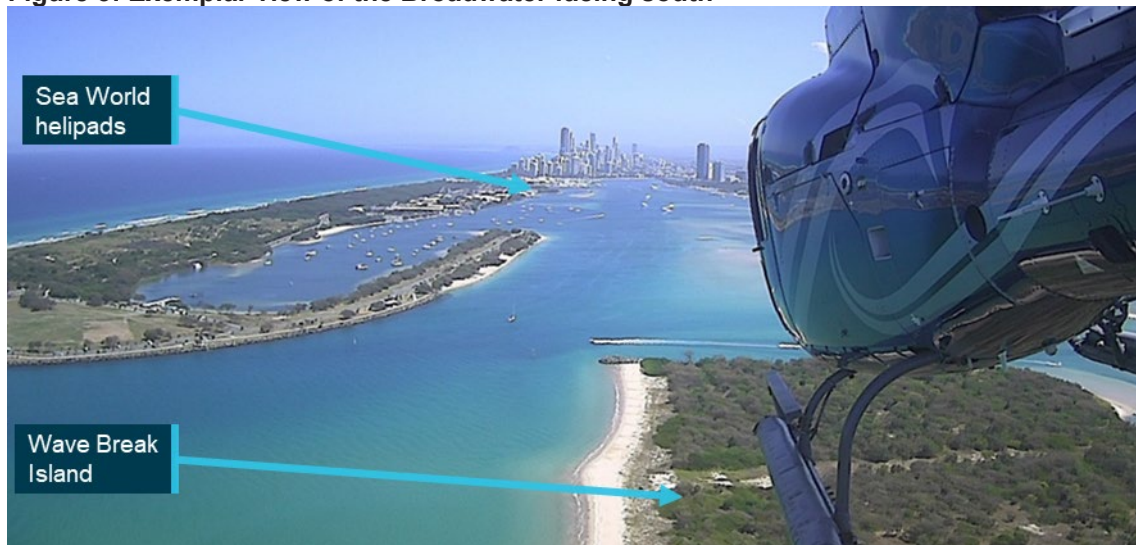
Figure 3: Exemplar view of the Broadwater facing south

On the return leg of the scenic flight in XH9, the track southbound along the Broadwater provided a clear view of the helipads at Sea World (Figure 3). The pilot of XH9 stated that, while transiting the Broadwater, they saw passengers being loaded into XKQ and the doors of XKQ closing. The pilot of XH9 recalled that their assessment at the time was that they would be clear of XKQ and that it would pass behind them.

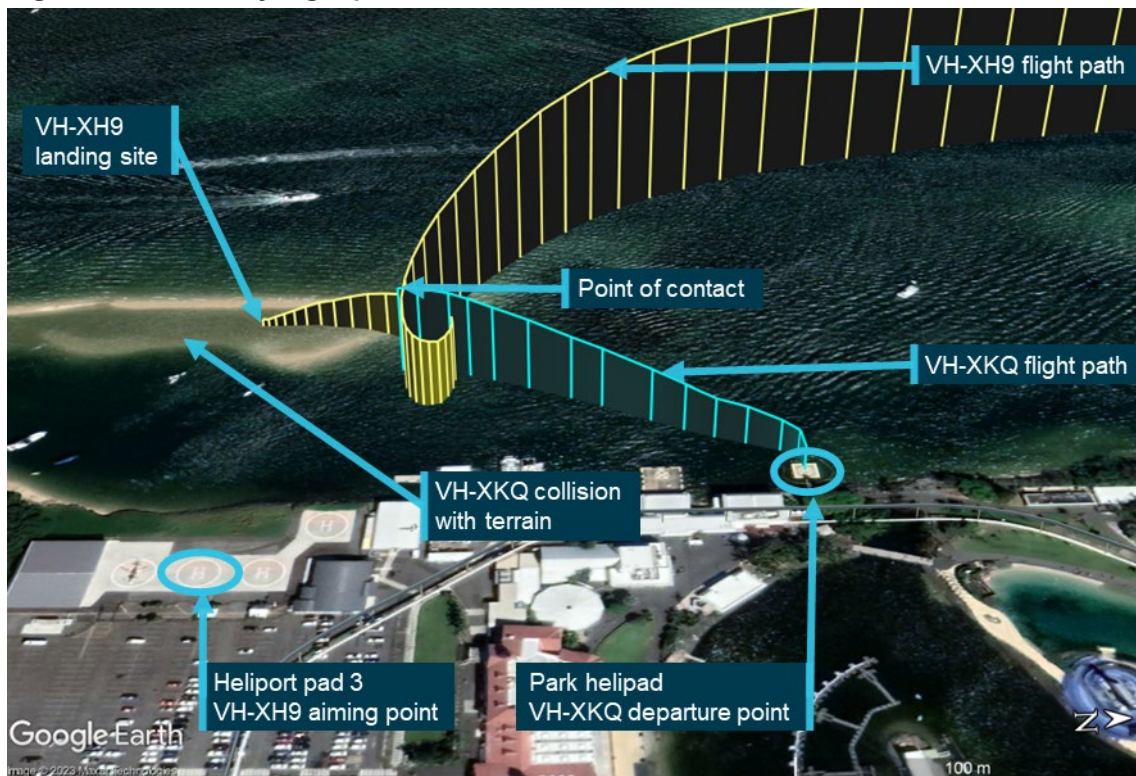
Figure 4: Preliminary flight path reconstruction of VH-XH9 and VH-XKQ

At 1355:42, the pilot of XKQ commenced their scenic flight and was climbing over water in the direction of the sandbar near the helipad (Figure 4). The pilot of XH9 reported that they did not hear a taxi call over the radio from the pilot of XKQ. This does not necessarily mean that a taxi call was not made and this topic will be subject to detailed analysis by the ATSB investigation. The pilot of XH9 also reported that they did not see XKQ depart from the park helipad.

At about 1355:47, the pilot of XH9 turned left onto a final approach path for pad 3. The pilot of XH9 reported that at this time they were focussed on the landing site, and on managing rotor downwash to avoid a pleasure craft crossing their approach path.

At 1356:05, 23 seconds into XKQ's flight, at a height of about 130 ft, the helicopters collided (Figure 4 above).

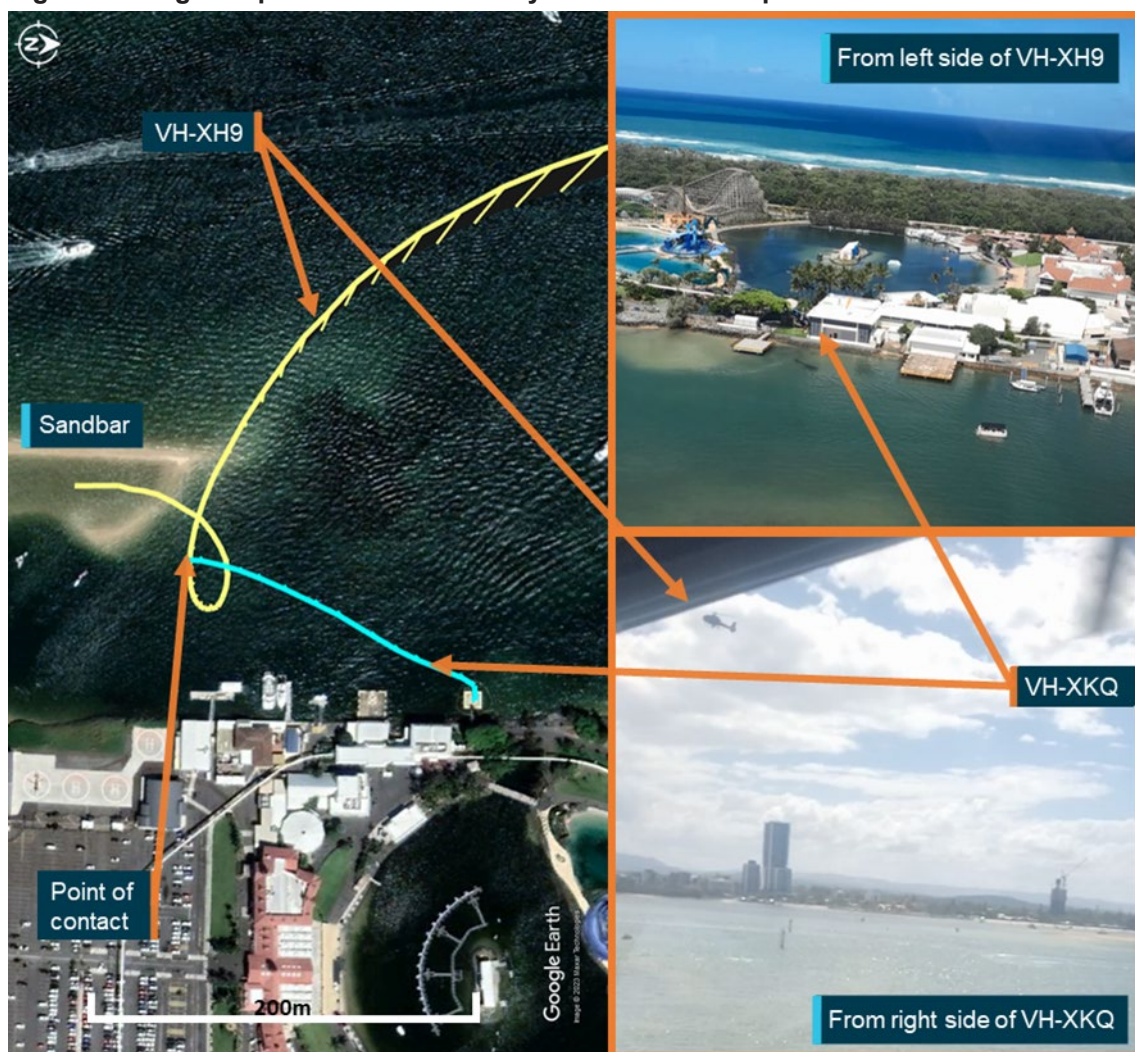
Figure 5: Images captured simultaneously from each helicopter at about 1355:55

Video footage taken by passengers in both helicopters on mobile phones contained images of the other helicopter (Figure 5). This does not mean that the helicopters were visible to either pilot from their positions in the helicopter, or even the passenger filming, and this aspect will be subject to detailed analysis by the ATSB investigation.

At about 1355:59, 2 passengers on board XH9 sighted XKQ. Understanding the helicopter would only get closer, at least one passenger attempted verbal guidance to the pilot. As the verbal guidance did not work, and anticipating a potential collision, one passenger physically alerted the pilot. The pilot of XH9 later recalled being alerted to the other helicopter by a passenger, but the pilot did not see XKQ approaching prior to the collision.

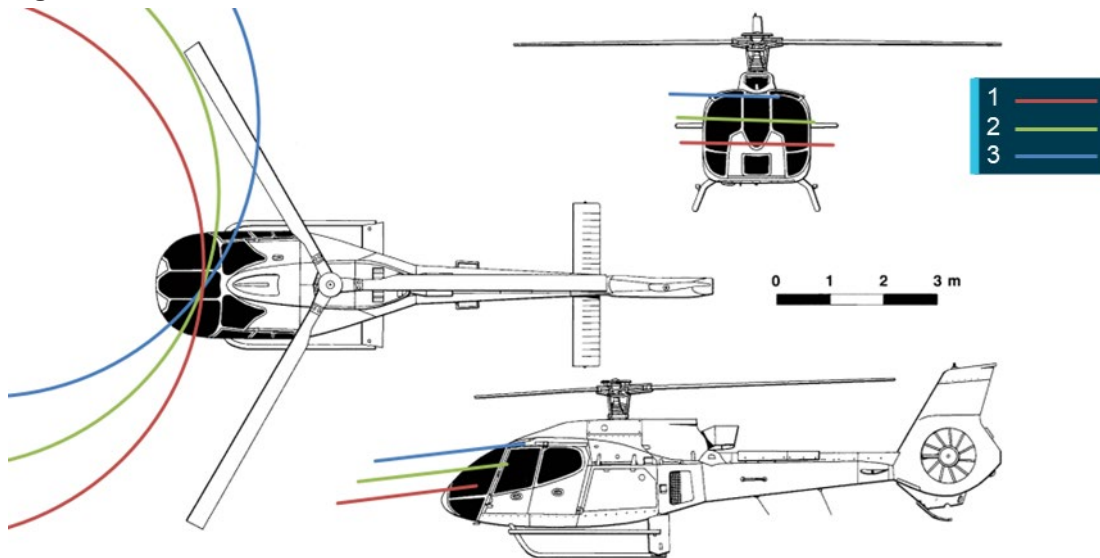
Figure 6: Indicative main rotor strikes to cabin of VH-XH9

The main rotor blades of XKQ entered the forward cabin of XH9 (Figure 6). XKQ broke apart in mid-air and impacted shallow water next to the sandbar. The pilot and 3 passengers were fatally injured, and 3 passengers were seriously injured. The helicopter was destroyed.

Helicopter XH9 had significant damage to the forward cabin, instrument console, and main rotor blades. The impact turned XH9 to the left, and the pilot continued with the momentum of that

Damage to the nose of XH9 indicated that the main rotor blades of XKQ passed through the front of the cabin of XH9, severing several windshield and door frames. The windshield panels and

several instruments in the pedestal were destroyed. The main rotor blades of XH9 showed damage and skin delamination, likely due to contact with debris passing through the main rotor system.

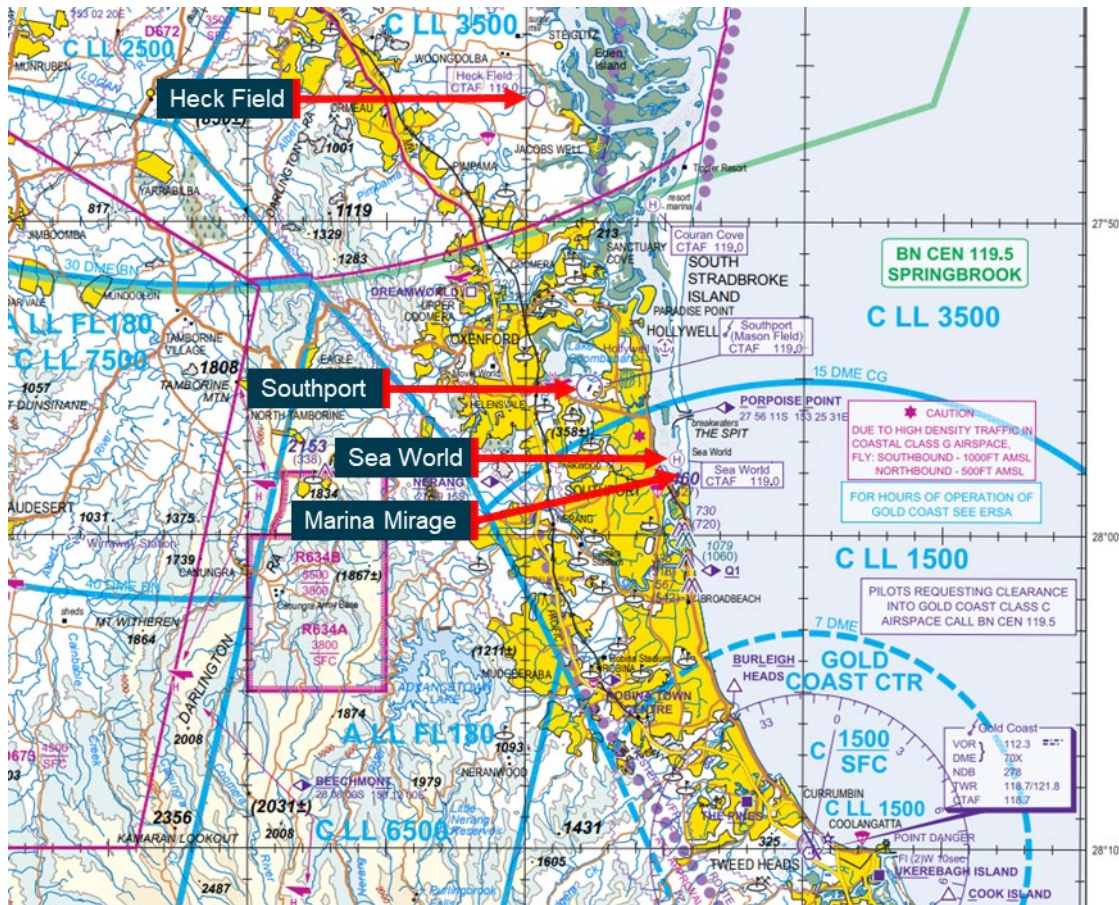
Figure 7: Gold Coast Visual Terminal Chart extract

The airspace above the helipads is uncontrolled (Class G airspace) to a height of 1,500 ft (Figure 7). Communication between aircraft in the area takes place on a common traffic advisory frequency (CTAF). The same VHF frequency (119.0) services Southport Aerodrome, about 9 km to the north-west, and Heck Field Aerodrome, about 27 km north-north-west. A CTAF has no defined boundary, however a pilot inbound for a CTAF must make an inbound call by about 10 NM (18.5 km) from the landing site.
