# In-flight break-up, Robinson R44 Raven I helicopter, VH-NBY

3 km north of Broome Airport, Western Australia on 4 July 2020

## **ATSB Transport Safety Report**

AO-2020-033

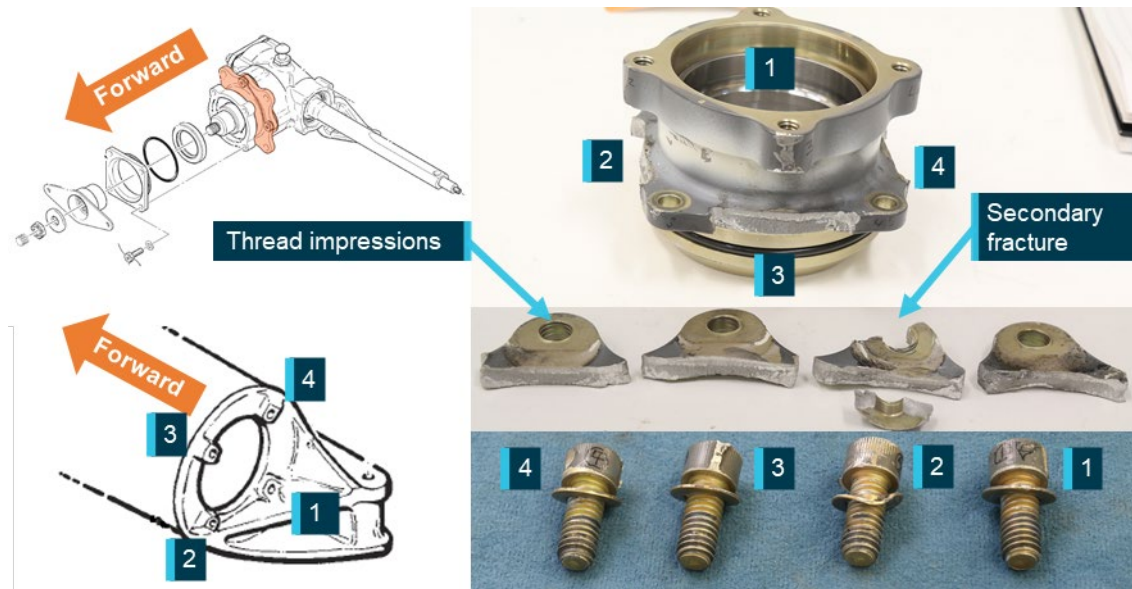
**Figure 16: Tail rotor input cartridge**

any of the lugs that might suggest that the input cartridge had contained a metallurgical defect (pre-existing cracking) that would otherwise have led to an increase in net section stresses from operational loads.

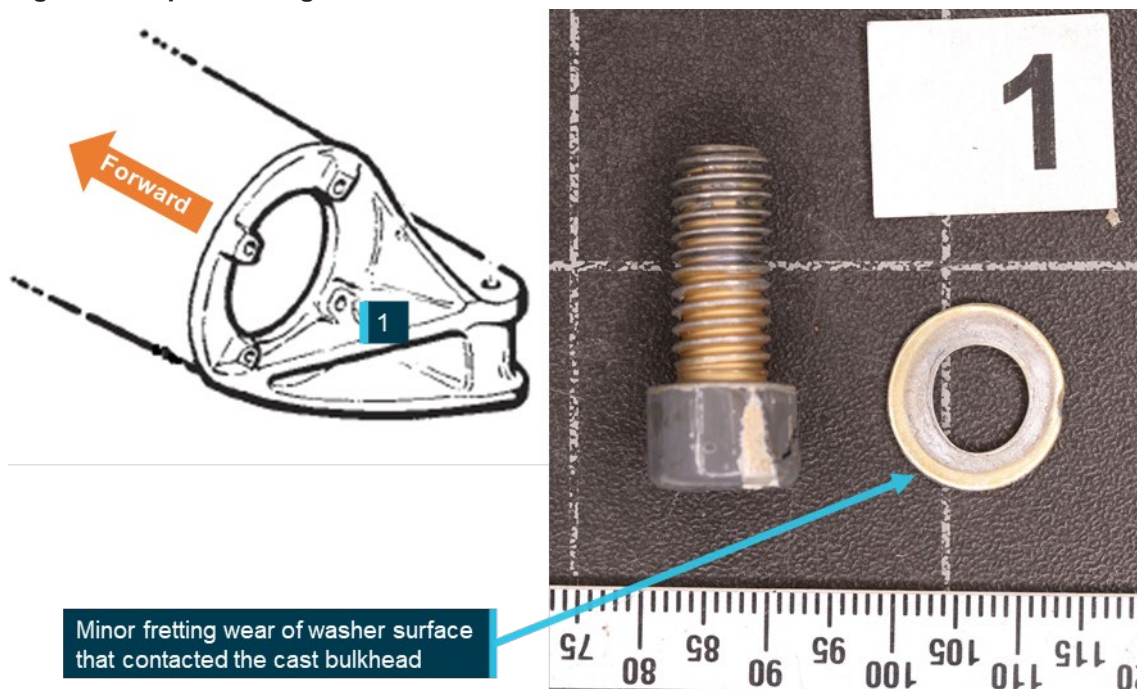
**Figure 17: Input cartridge attachment bolt**

Some evidence of micro movement of the fitted components was found on the washer surface facing the cast bulkhead at location 1 (Figure 17). Here, minor fretting and elongation of the washer was observed.

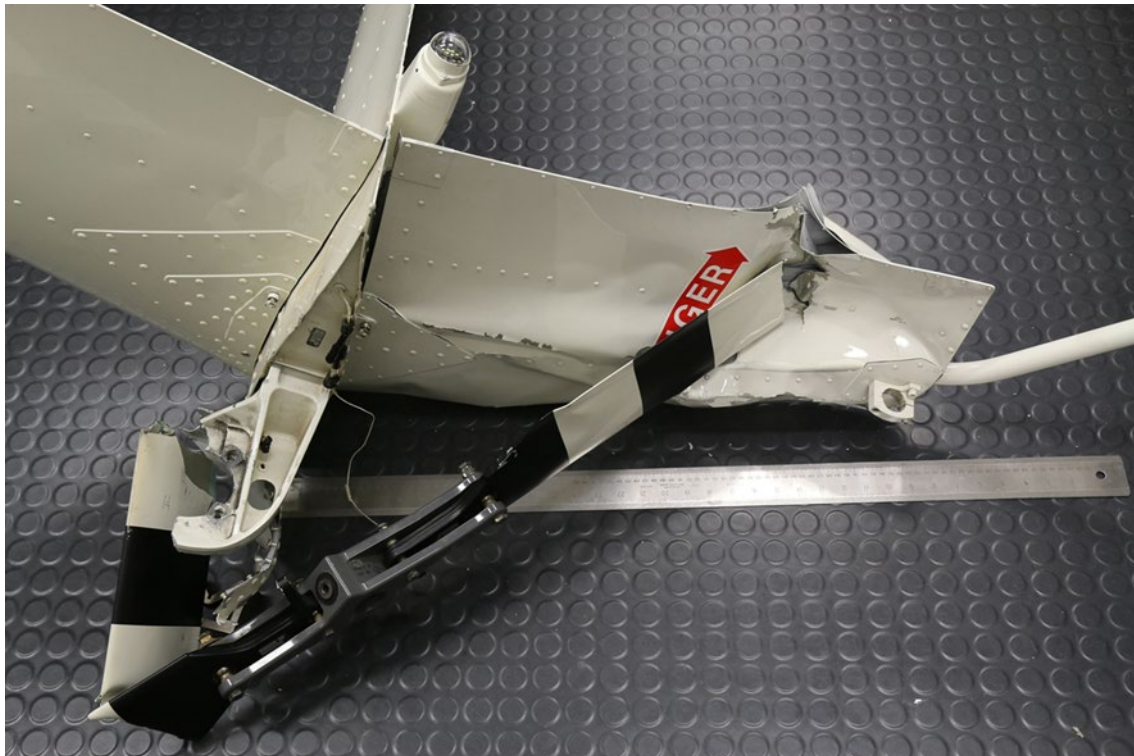
**Figure 22: Tail rotor contact with lower vertical fin**

Analysis of the break-up sequence identified that the TRGB was almost certainly separated from the end of the tail cone at the time of tail rotor blade contact with the tail cone, and with the lower vertical fin.

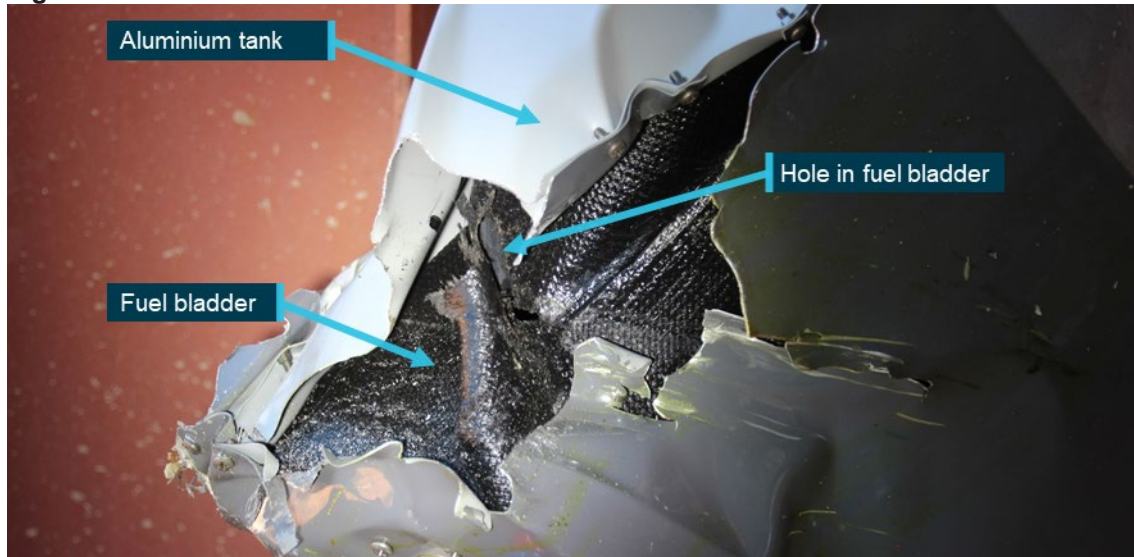
**Figure 27: Fuel bladder tear**

The puncture allowed the release of fuel, but at a low rate (Figure 27). An unknown quantity of fuel leaked from the bladder and attending fire services contained the spill. About 30 L of fuel remained in the helicopter. Given the previously-observed rupturing of aluminium fuel tanks during significant impact, without the fuel bladders, the risk of a post-crash fire would probably have been significantly higher.

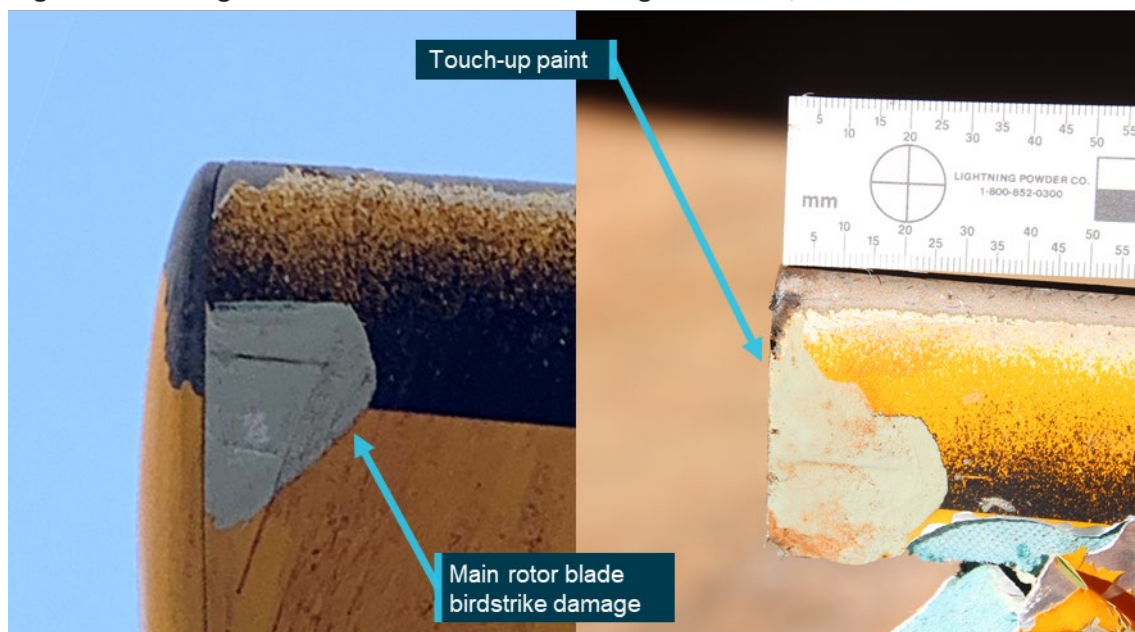
**Figure 29: Damage to VH-NBY main rotor following bird strike, and blade at accident site**

The main rotor blade tip was painted at some point after this event. There is no mention of inspection or repair in any of the helicopter logbooks or maintenance releases.

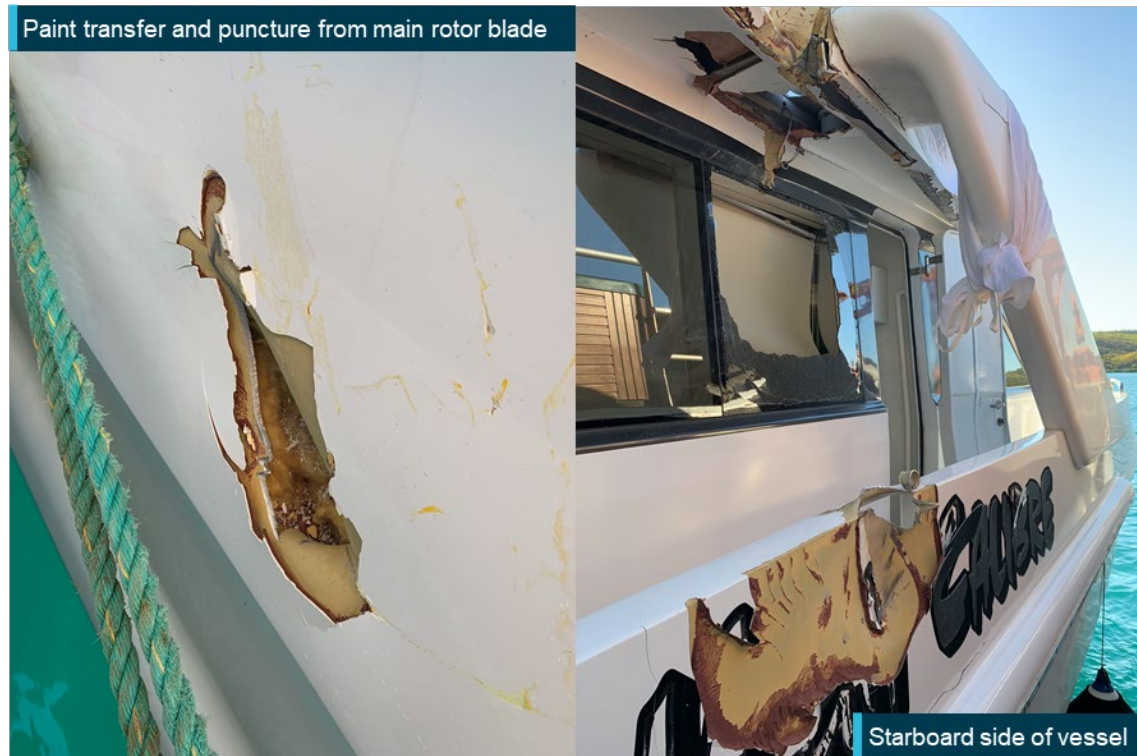
**Figure 32: Damage to High Calibre**

The front left occupant had serious injury, the owner sat front right, had severe bruising, and the rear right passenger had minor injuries. The helicopter was destroyed. The Civil Aviation Safety Authority confirmed the loss of VH-ZGY with an insurance agent, and the helicopter was not recovered. High Calibre had significant damage and the hull was penetrated above the water line. High Calibre was repaired in a remote location 10 days later.

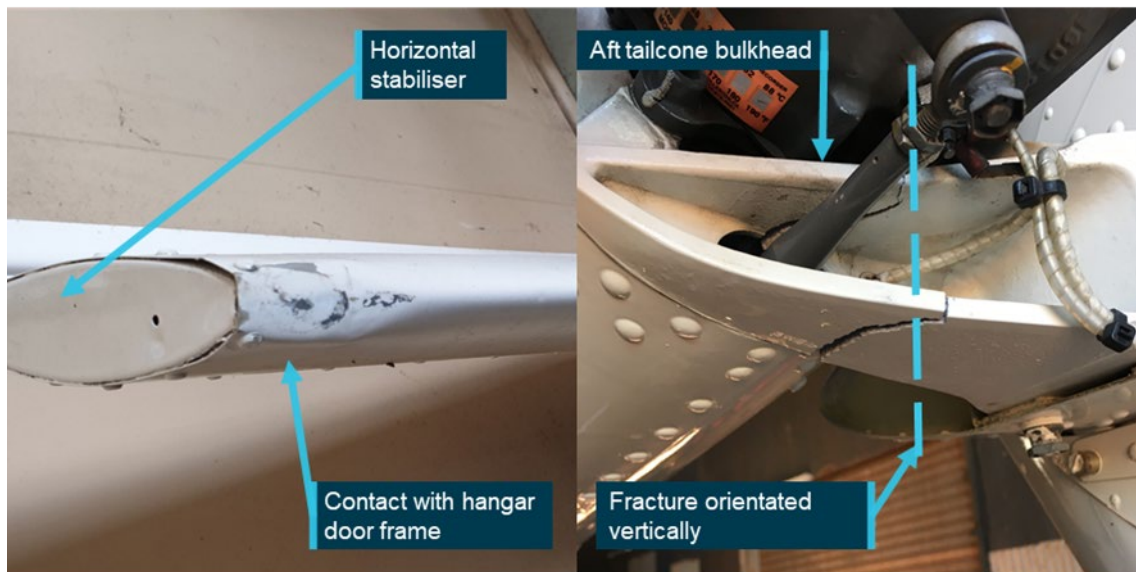
**Figure 33: Ground handling damage to an R44**

These failures were a known issue and the manufacturer had published service letters for each type on 11 March 2020.
