# Rotor drive system failure and collision with terrain involving a Robinson Helicopter Company R22, VH-YMU

44 km south of McArthur River Mine Airport, Northern Territory on 16 August 2020

## **ATSB Transport Safety Report**

AO-2020-043

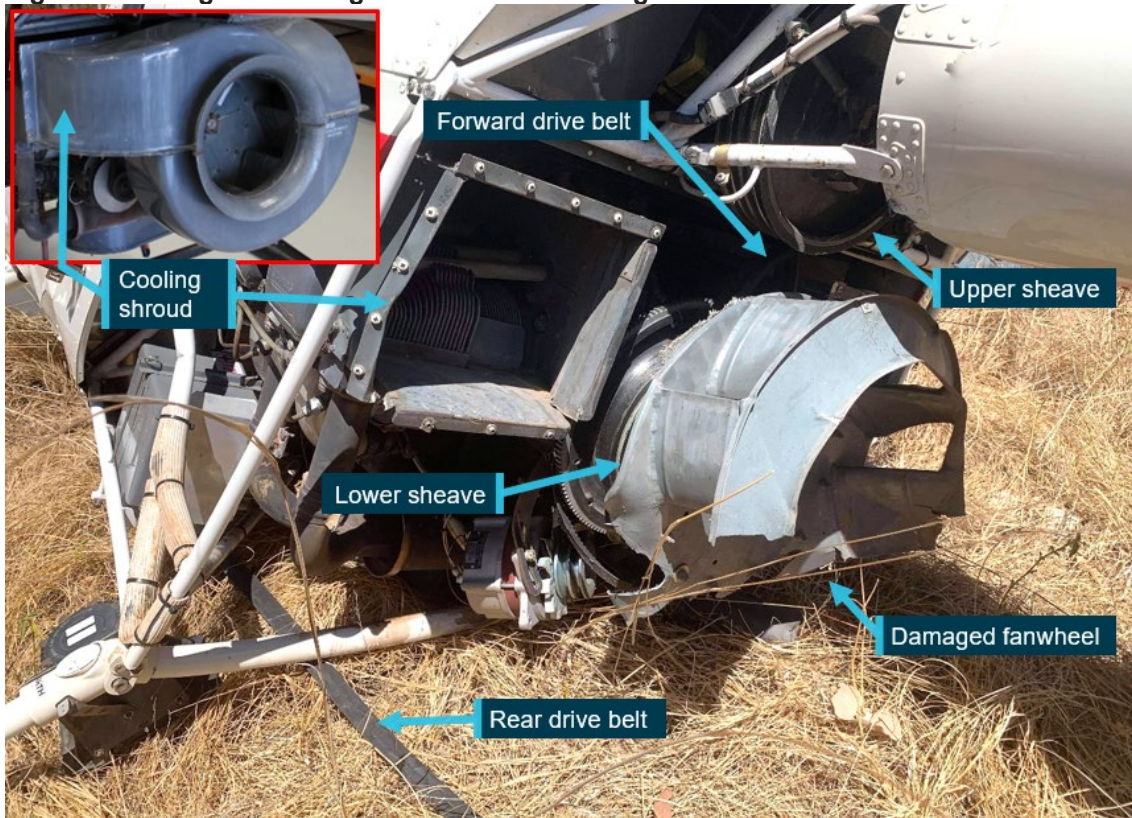
**Figure 1: Damage to cooling fanwheel and missing shroud**

The fibreglass cooling shroud showed evidence of slice and penetration damage and had been separated from the rear of the engine in flight. This damage was most likely a result of fanwheel segments separating from the cooling fan while the fanwheel was rotating.

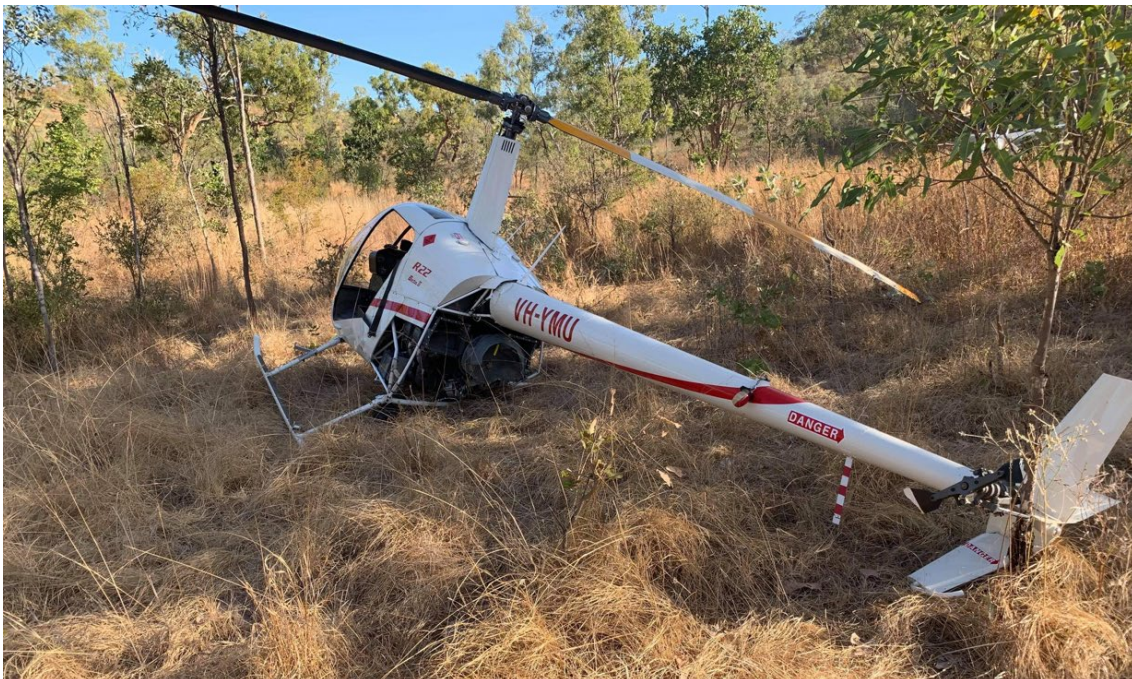
**Figure 2: VH-YMU accident site**

Additionally, the skid landing gear was splayed outward, and the pilot seat base had collapsed mainly on the right rear side. The forward tail rotor drive flex coupling was significantly damaged, most likely due to contact from the failing fanwheel or the tail cone attachment lower frame. The tail rotor blades had fractured and the lower vertical stabiliser was bent to the left. Both main rotor blades had minor impact damage, most likely due to contact with the surrounding trees.

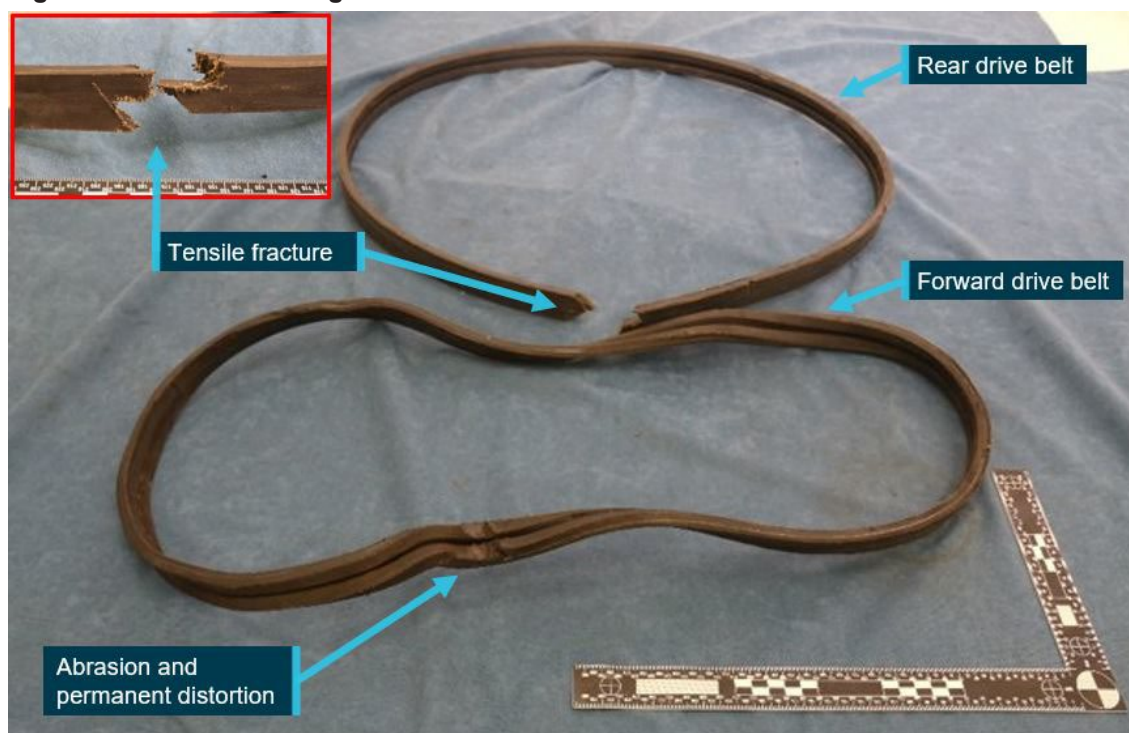
The forward drive belt had sustained consequential damage from contact with the rotating drive system components, as evidenced by abraded rubber deposits on the forward face of the upper sheave and on the clutch shaft. Measurement of the rear drive belt identified that it had a 25 mm greater overall circumference than the forward drive belt, indicating that the rear drive belt had stretched during the ground impact and then failed in tensile overstress (Figure 5). The circumference of the forward drive belt was consistent with that of a new Revision-Z belt and the cross-sectional profile of both belts did not show any evidence of excessive wear.

**Figure 5: Drive belt damage**

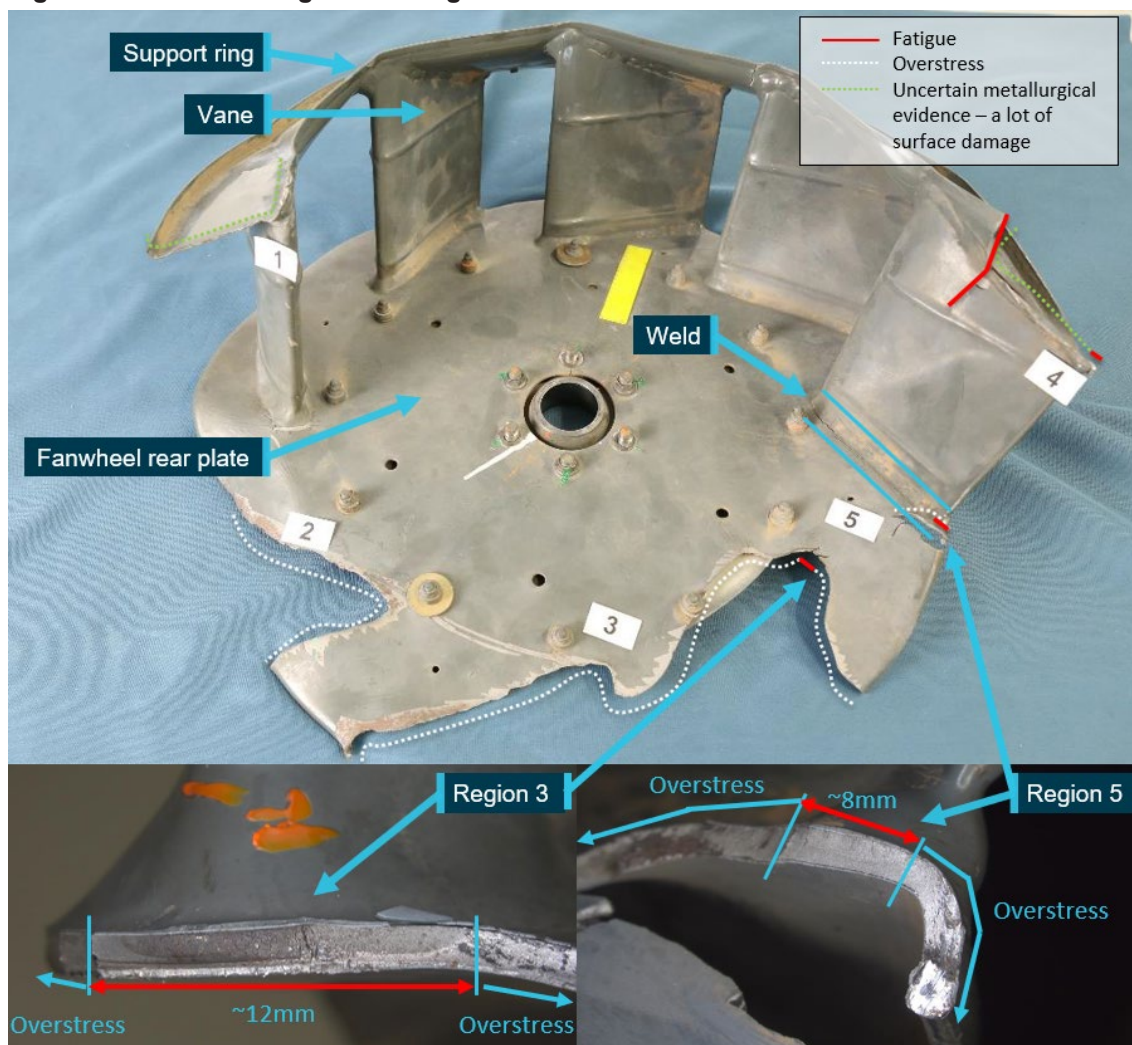
The ATSBs metallurgical examination identified the presence of discrete pre-existing fatigue cracks on the fracture surfaces of the fanwheel where the cooling vanes had been welded. The formation of corrosion product on some of those crack surfaces indicated that those fatigue cracks had been present for a significant period. The fanwheel fracture surfaces, beyond the regions of fatigue, showed evidence of gross tearing that was consistent with overstress of the structure.

A detailed examination of the fanwheel fracture surfaces identified regions of fatigue cracking located on the weldment of the fan vanes. These were located at the rear of one vane (Region 5) and forward of the next vane (Region 3), where the vane was welded to the fanwheel rear plate. The fatigue cracks were measured at approximately 8 and 12 mm, respectively. The vane section containing the 12 mm crack had separated from the fanwheel along with another vane and displayed rapid ductile tensile tearing of the fracture surface (Figure 6).

**Figure 6: Fanwheel fatigue cracking**

The vane support ring also had an area of fatigue cracking (Region 4) measuring approximately 45 mm. There was a degree of corrosion formation on the surfaces that suggested the cracking had been there for a significant period. There was insufficient metallurgical evidence on the fracture surfaces of the vane support ring to conclude definitively whether this region was damaged by fatigue that then could have led to a structural weakening of the fanwheel.

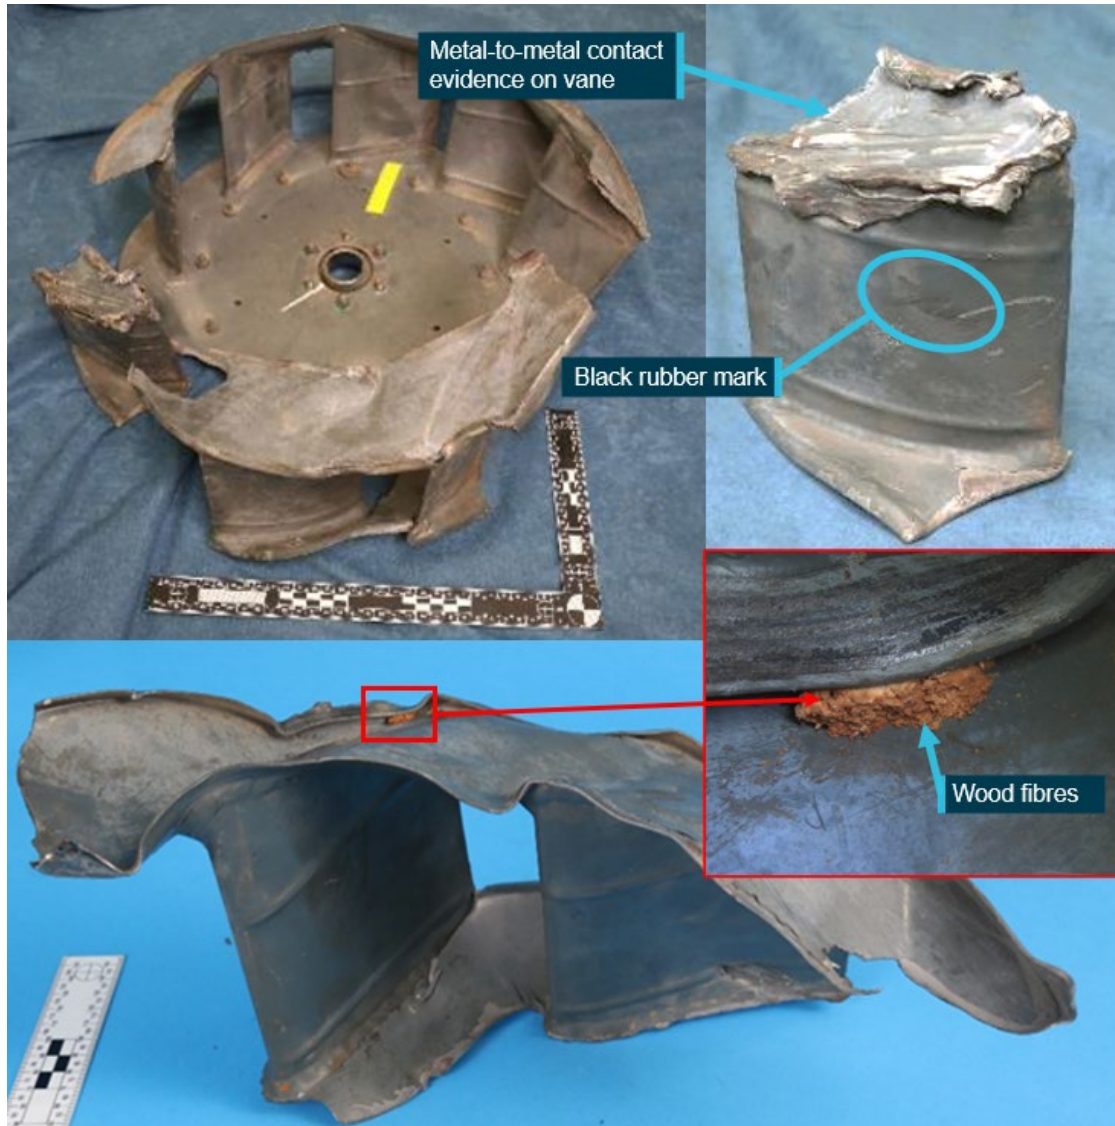
The metallurgical examination of the fanwheel identified evidence of pre-existing fatigue cracks in the welded region of 2 vanes, and in the outer support ring structure. Two segments of fanwheel had liberated from the assembly. One segment had 1 vane with evidence of severe metal-to-metal contact during the rotation of the fanwheel, and a black witness mark, which was most likely rubber transfer due to contact with the drive belt/s. The other was a segment of 2 vanes with wood fibres entrapped in the structure.

When considering the hypothesis for an in-flight break-up of the fanwheel to have occurred, ATSB's examination of the single vane that had released from the fanwheel showed extensive rotational contact and scoring damage from metal-to-metal contact. That damage conflicted with the metallurgical evidence and was an indicator of a potential in-flight release and subsequent contact of that part with nearby rotating drivetrain componentry.

The larger segment of the fanwheel that had also released (containing the two vanes) was extensively deformed and contained entrapped wood fibres that was consistent with that portion striking a tree. There was an absence of wood fibres on all other parts of the fanwheel. It is likely that this section of fanwheel contacted a tree after it had broken from the fanwheel, prior to ground impact (Figure 7).

**Figure 7: Fragmented cooling fanwheel and liberated fragments: a vane section sustained severe metal-to-metal contact and a larger section contained entrapped wood fibres**
