# In-flight break-up, Stolp Acroduster II SA-750, VH-YEL

16 km north-east of Caboolture airfield, Queensland, on 18 August 2021

**ATSB Transport Safety Report**

AO-2021-032

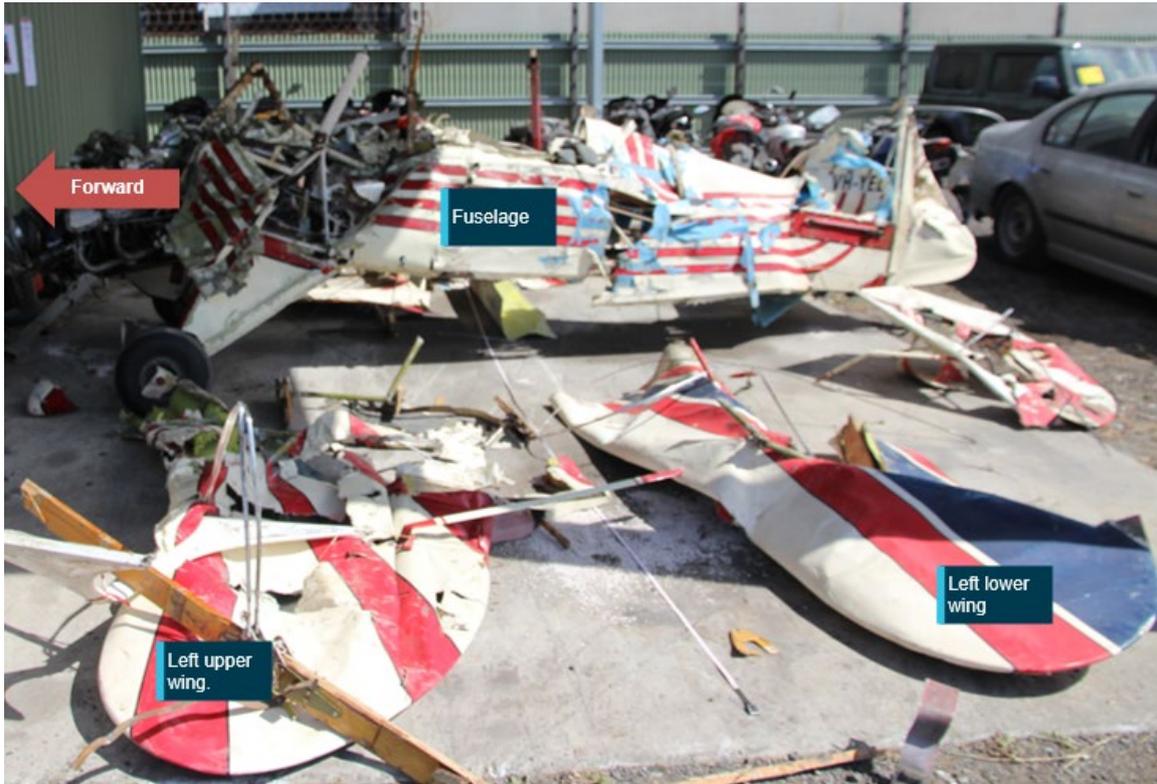
Figure 6: VH-YEL as recovered and partially reassembled

The main wreckage was recovered by barge at the changing of the tide and was transported to a secure storage facility for examination by the ATSB (Figure 6). Reconstruction of the sections of recovered aircraft identified that:

- the majority of the parts were accounted for with the exception of the right interplane strut
- the aircraft flight controls had no pre-impact defects
- the fuselage, wings, flying and landing wires had no pre-impact defects
- the forward cabane strut upper wing attachment point eye bolts to the centre-wing structure had fractured and displayed evidence of pre-existing fatigue cracking
- there was no evidence of propeller rotation at impact, however, the engine most likely stopped from fuel starvation during the in-flight break-up sequence.

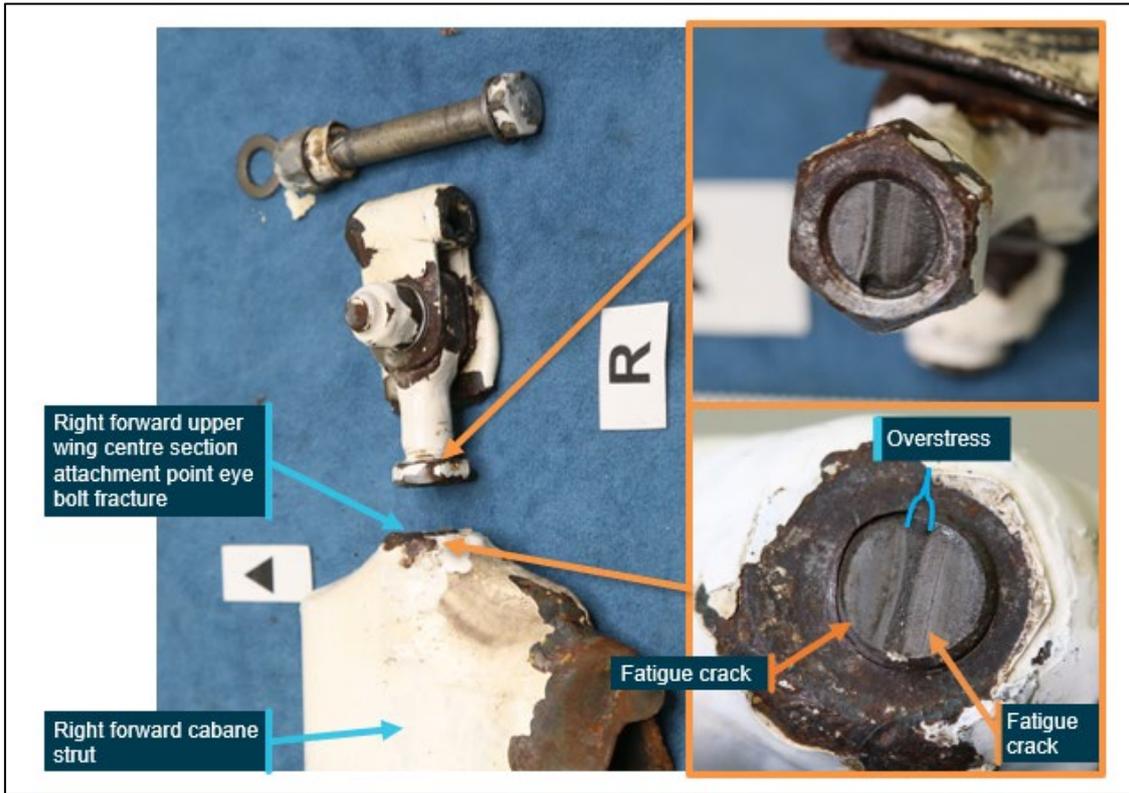
**Figure 7: Right eye bolt, cabane strut and fracture surface**

- There was uniaxial fatigue cracks in a fore/aft direction through 85% of the right eye bolt threaded cross section with the remaining material fractured in overload (Figure 7).

The location of the crack on the right forward cabane strut eye bolt was directly under the securing nut, making it impossible to identify the fatigue crack without disassembling the attachment point and removal of the eye bolt. The location of the crack on the left forward cabane strut was directly above the securing nut and would have been difficult to identify while it was forming in the threaded section without disassembly and removal of the eye bolt from the cabane strut.

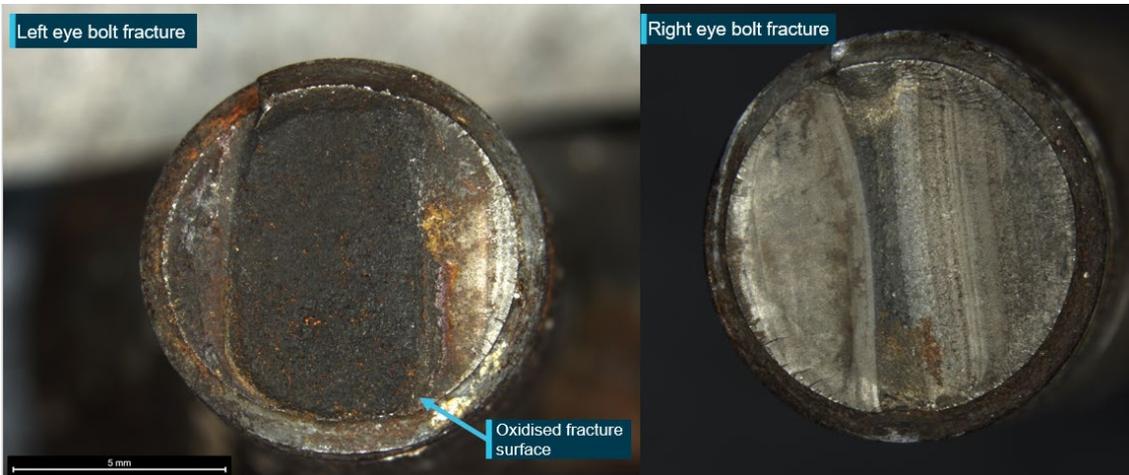
**Figure 8: Corrosion level differences between left and right eye bolt fracture surfaces**

- There was several areas of additional micro-cracking present in the threaded portion of the forward eye bolts.
- The left eye bolt fracture surfaces had significant corrosion when compared to the right eye bolt fracture surfaces. This indicated that the left eye bolt had completely fractured some time before the accident flight (Figure 8).

The aircraft wreckage was distributed over 2.4 km, with the centre wing section found about 500 m away from the main wreckage. The ATSB's metallurgical examination of the forward left and right upper wing centre section attachment eye bolts (eye bolts) from VH-YEL did not identify any manufacturing defects or anomalies outside of the limited design specifications provided. However, the ATSB's inspection found areas of significant pre-existing fatigue cracking in the threaded portions of the eye bolts. There was also significant corrosion on the fracture surfaces of the left eye bolt, when compared to the right eye bolt. This indicated the left eye bolt had failed some time before the accident flight.

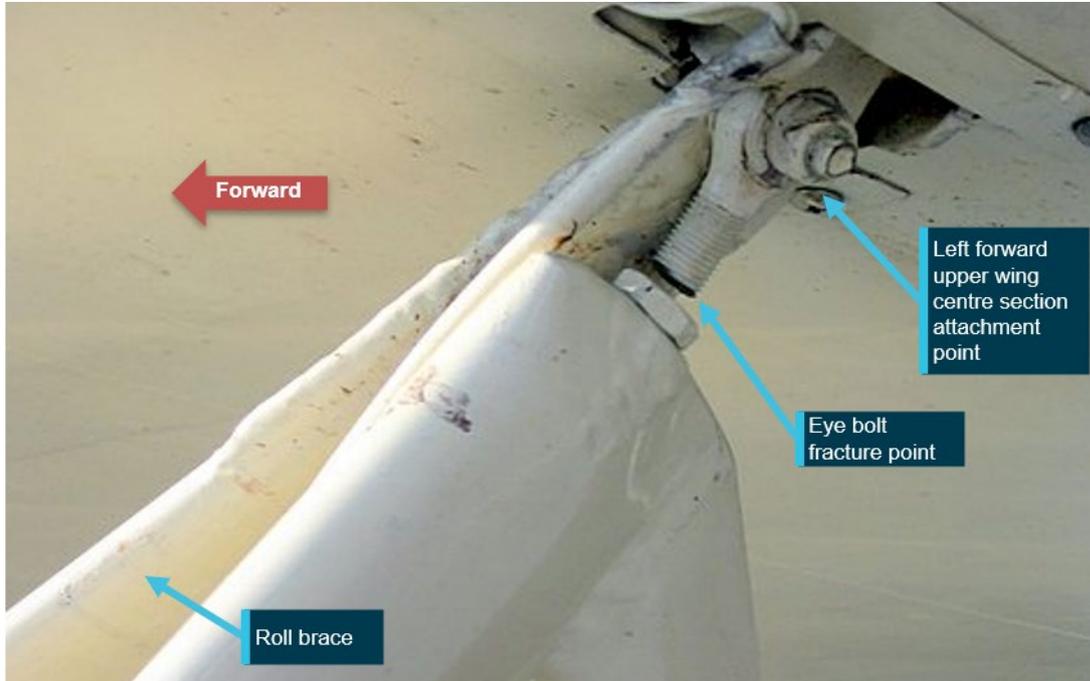
**Figure 9: Previous Acroduster SA-750 with fractured wing attachment eye bolt**

A subject matter expert familiar with the early design and development of the aircraft type indicated that there has been a history of cabane strut eye bolt cracking in the same area of the threaded section as occurred with VH-YEL. They provided the ATSB with an image taken 2 decades before this incident of an Acroduster SA-750 where a left forward upper wing cabane

strut eye bolt fractured completely through its threaded section. That fracture was in the same location as VH-YEL. The left roll brace was the only remaining structure providing support to that section of the wing (Figure 9). It could not be determined how long prior, or for how many hours the aircraft had flown with the failed eye bolt.

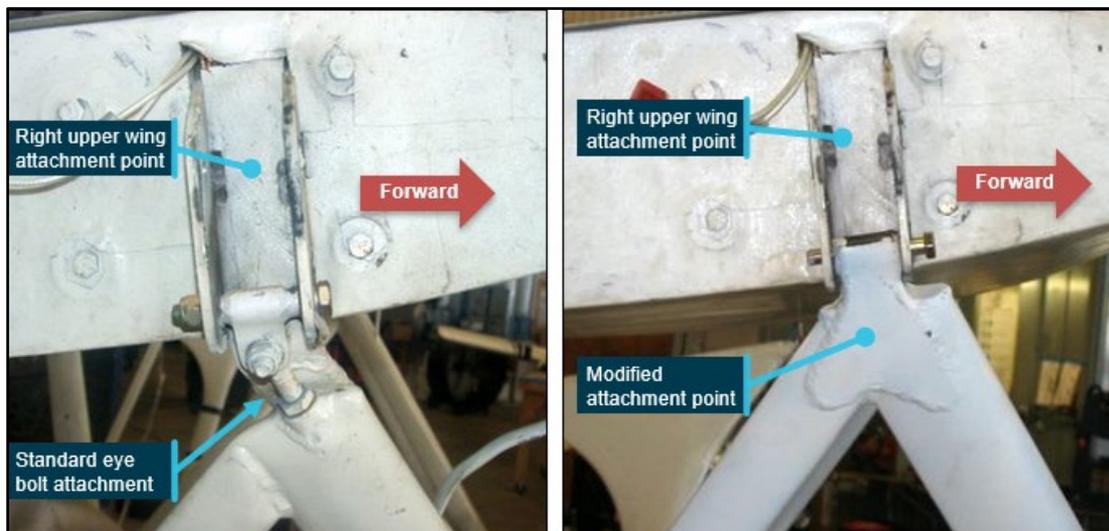
The ATSB was further advised that some owners of Acroduster aircraft made modifications to the upper wing attachment points. The modification removed the eye bolts and replaced them with a welded structure, which attached directly to the upper wing attachment point, effectively strengthening the attachment points (Figure 10). The ATSB notes that the modification shown was not approved by the aircraft design owner and had been added by experimental amateur-built owners. Advice on such modifications should be sort from a suitably qualified aeronautical engineer on any design changes undertaken.

**Figure 10: Right-side upper wing centre section attachment point with a standard eye bolt attachment (left) and a modified attachment (right)**

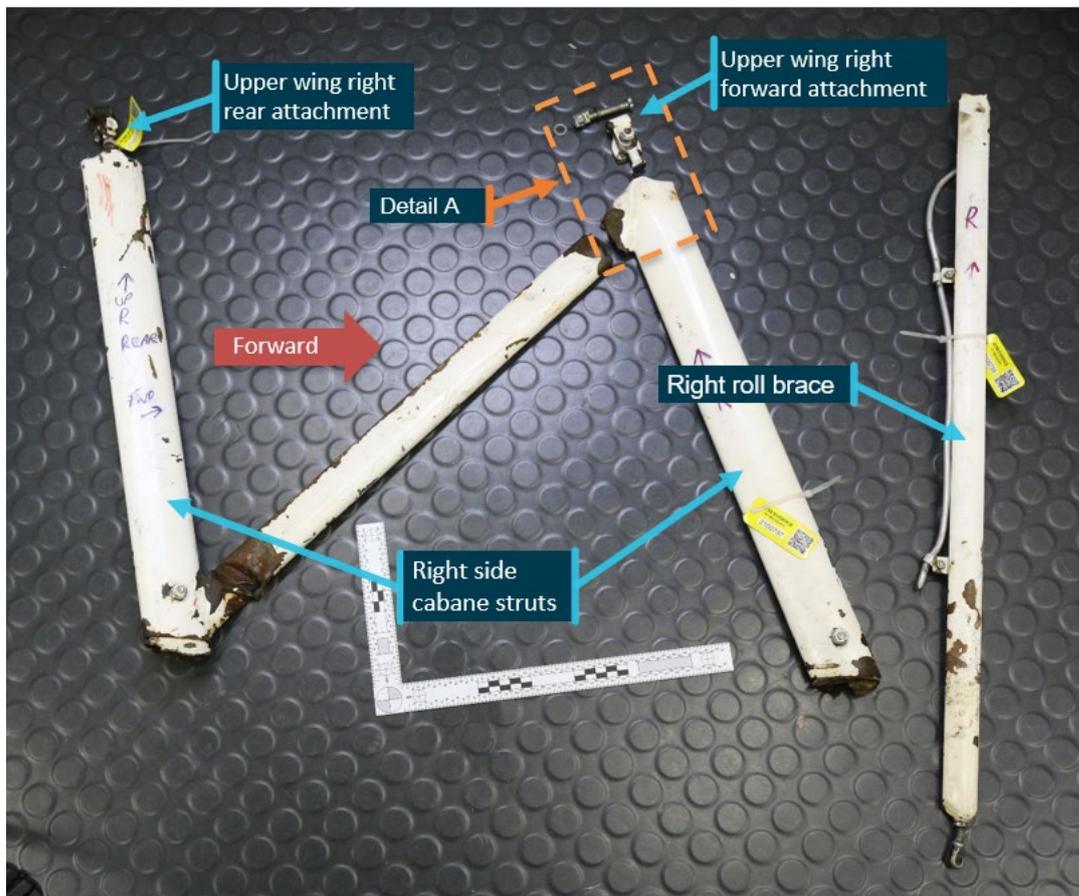
**Figure A1: Right cabane struts, roll brace and upper wing attachment points**

Figure A1 shows the right cabane struts and roll brace. The area notated as Detail A (also see Figure A2) shows the fractured upper wing attachment point.

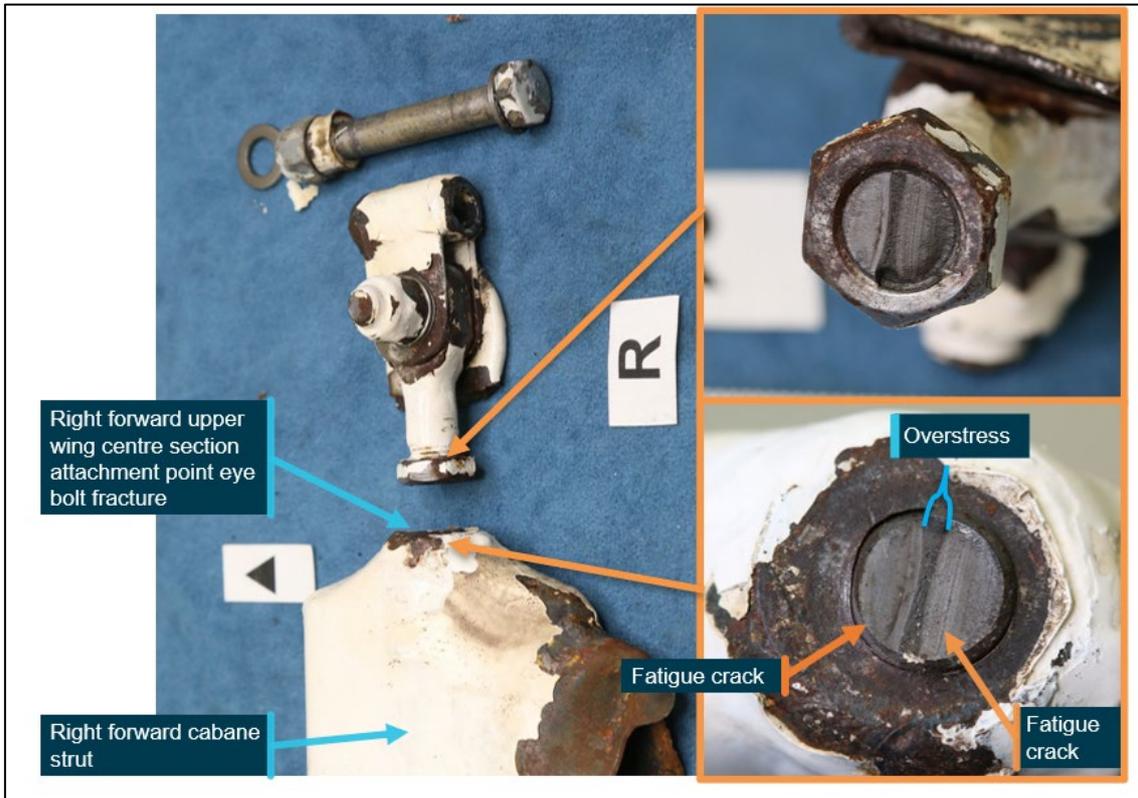
The ATSB's laboratory examination confirmed that fatigue cracks had developed in the forward eye bolts for both the left and right cabane struts. The examination determined that the cracking had initiated in the thread root region along the threaded shank of each bolt. Distinctly opposing features on the fracture surfaces indicated that the stresses leading to crack growth were likely from fore/aft uniaxial bending of each bolt during service.

The fatigue cracking had extended through approximately 85% of the right eye bolt and about 35% of the left eye bolt cross-section prior to ductile overstress fracture. (Figure A2 and A3).

**Figure A2: Right cabane strut forward upper wing attachment eye bolt showing evidence of significant fatigue cracking through the threaded portion (Detail A from Figure A1)**

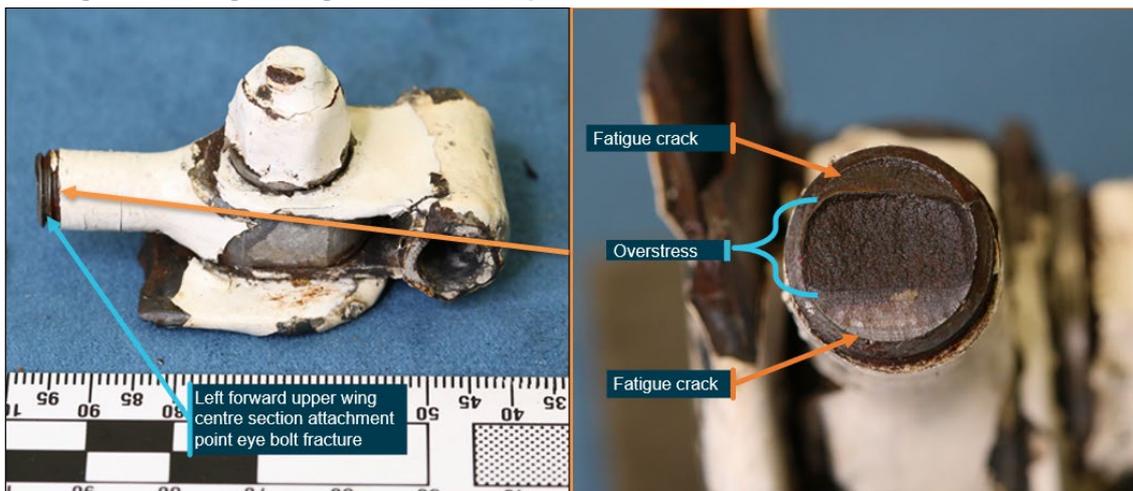
**Figure A3: Left cabane strut forward upper wing attachment eye bolt showing evidence of fatigue cracking through the threaded portion**

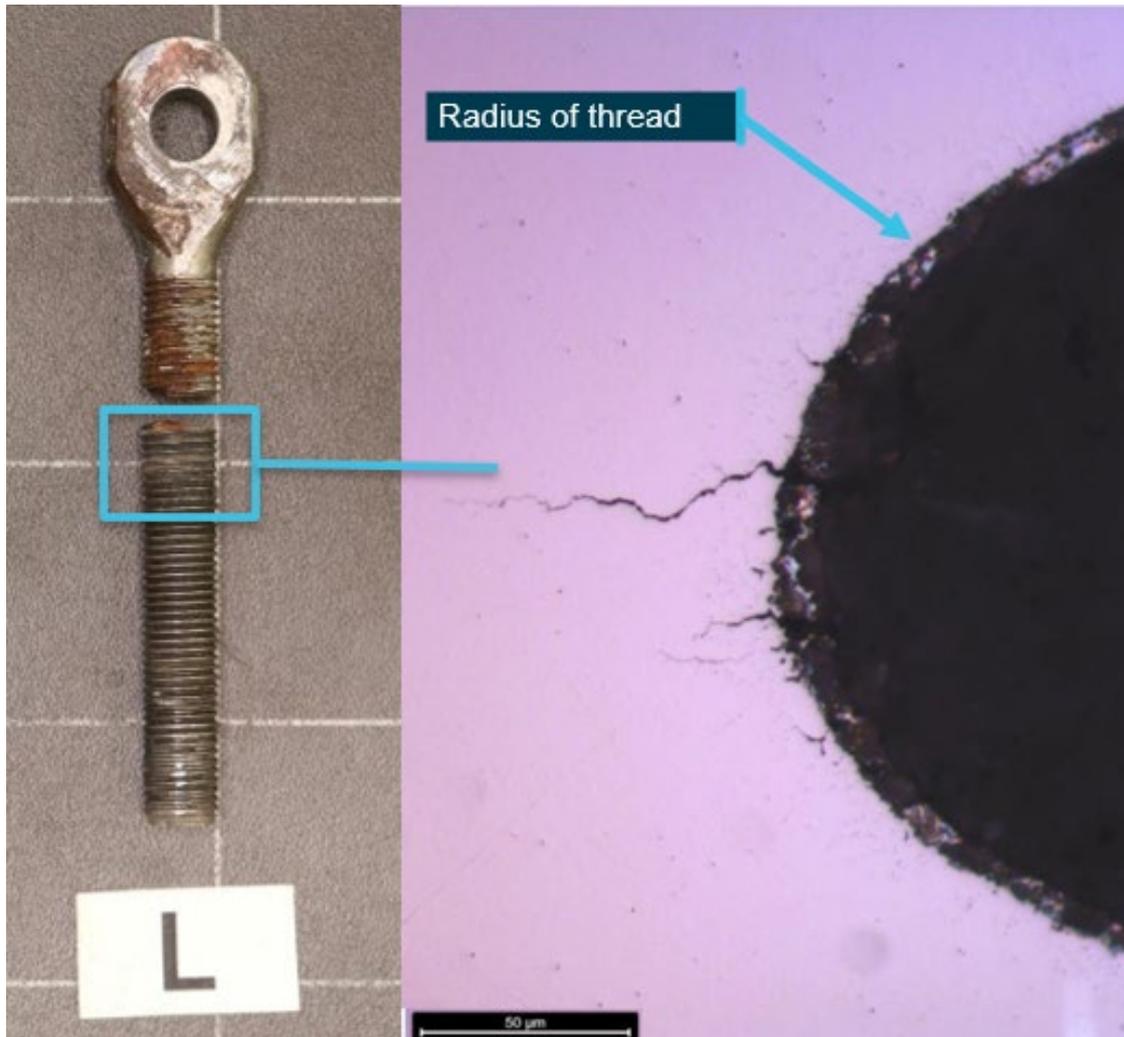
The scanning electron microscope examination also identified the presence of additional microcracking in the thread root region of each bolt that extended further along the shank. The extent of cracking was later confirmed by metallurgical sectioning of the left eye bolt whereby numerous smaller penetrating cracks had developed along the bolt shank threads (Figure A4).

**Figure A4: The fractured left eye bolt and a corresponding metallurgical cross-section that shows additional microcracking had developed within the threads of the bolt shank**

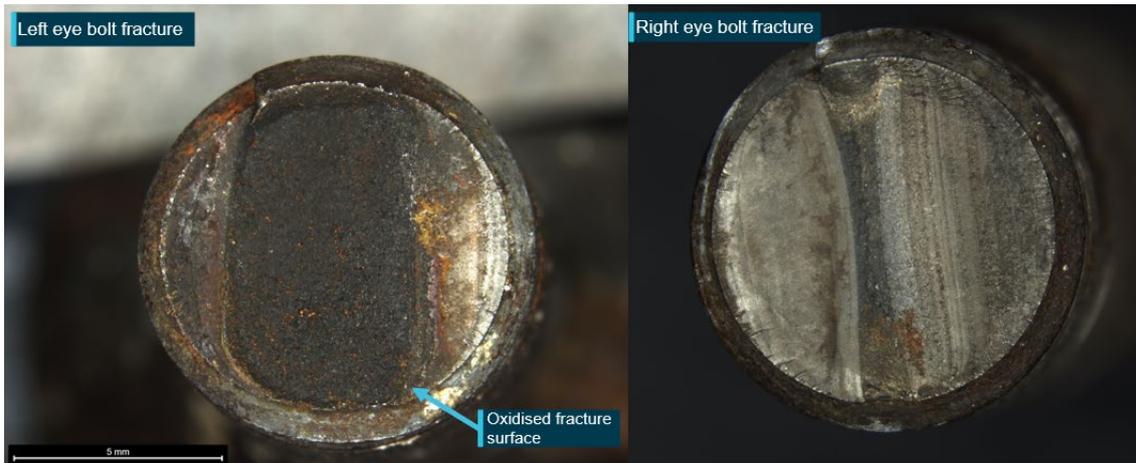
An optical comparison between the fracture surfaces of the left and right eye bolts identified notable differences between each bolt. The left eye bolt had significantly more corrosion and associated oxidation of the majority of the fracture surface, when compared with right eye bolt (Figure A5). That physical difference provided evidence to identify that the left eye bolt had likely been the first to fracture, followed sometime later by fracture of the right eye bolt.

**Figure A5: Eye bolt fracture surfaces showing the difference in the level of corrosion between the left and right eye bolt**

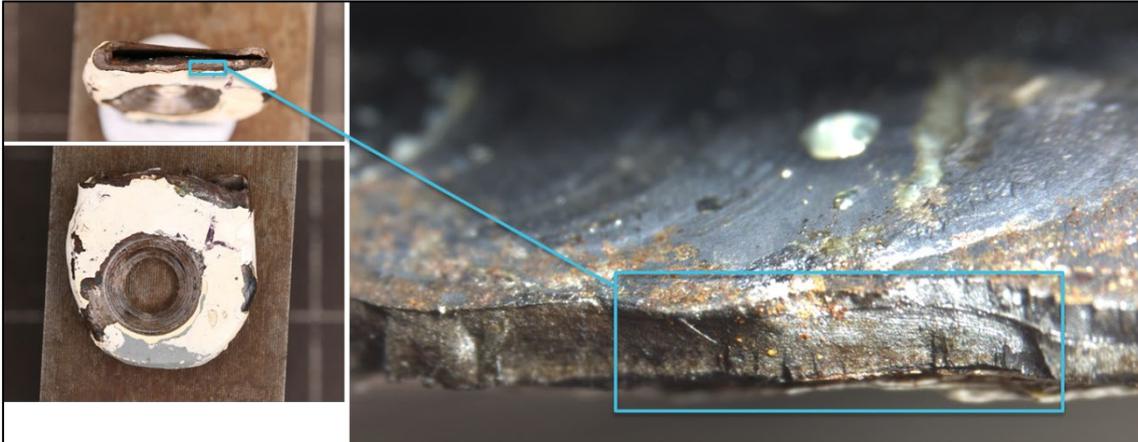
Visual examination of both roll braces that had been attached to their respective cabane strut showed that they had fractured at the upper connection to the trunnion joint. Each fracture location was coincident with the position of the upper cabane strut eye bolts. ATSB's laboratory examination identified that the left roll brace had fractured with about 60% of its cross-section showing features consistent with fatigue (such as crack progression markers and a flat surface profile) (**Figure A6**). The remainder of the fracture was one of ductile overstress.

**Figure A6: Optical examination of the roll brace from the left cabane strut showed indications of pre-existing fatigue in the welded region**
