# Engine failure and collision with terrain involving S.E.D.E. Morane-Saulnier MS.893A, VH-UQI

22 km south-west of Archerfield Airport, Queensland, on 6 November 2020

## **ATSB Transport Safety Report**

AO-2020-060

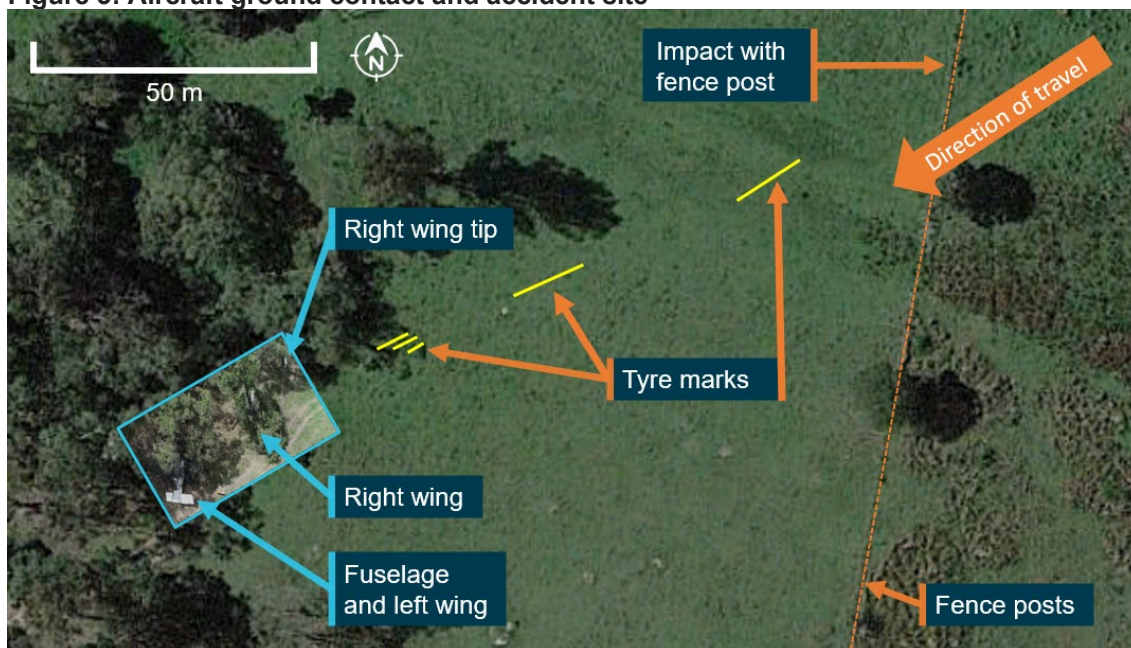
**Figure 3: Aircraft ground contact and accident site**

The accident site was located about 22 km south-west of Archerfield Airport. The main wreckage was situated in trees at the south-west end of a sparsely vegetated paddock, which was oriented in a north-east / south-west direction and was about 400 m in length with a relatively clear approach from obstacles due to sparse vegetation. The first impact point was with a fence post, followed by intermittent wheel marks in the grass, indicating that the aircraft had bounced multiple times during the landing. The distance from initial impact with the fence to the main wreckage was about 170 m (Figure 3).

The right-wing tip struck trees about 2 m above the ground and separated from the wing. The right wing then impacted another tree, between the wing root and midway along the wing, then separated from the fuselage. This impact pivoted the aircraft 90° to the right. The fuselage and left wing travelled a further 10 m before coming to rest. The forward left side of the aircraft impacted a large tree, resulting in the engine, firewall and nose gear separating from the fuselage.

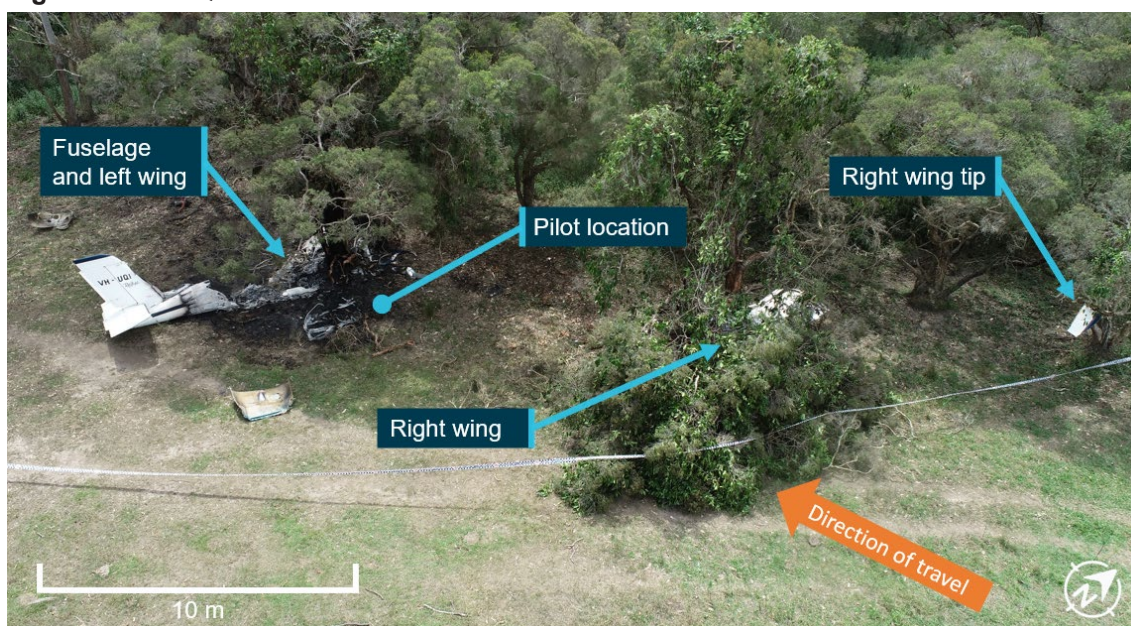
**Figure 4: VH-UQI accident site**

The engine, fuselage and left wing were exposed to a post-impact fire, and the empennage section remained largely unburnt (Figure 4). Examination of the aircraft structure and flight controls did not identify any pre-impact defects. The flaps were determined to be in the full down position at impact.

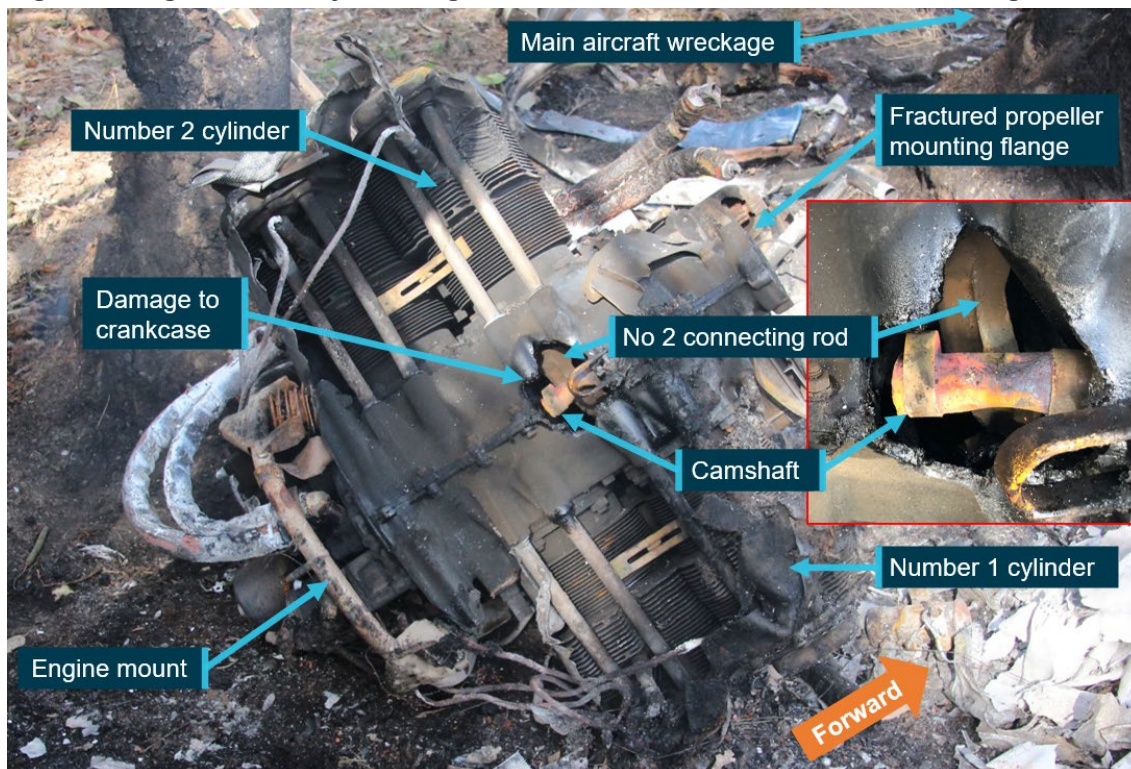
**Figure 5: Engine assembly showing a hole in the crank case and internal damage**

On-site examination of the engine identified a large hole in the top of the crankcase, between the number 1 and 2 cylinders. Visible through the hole was the fractured camshaft and number 2 piston connecting rod (Figure 5).

A smaller hole was noted on the underside of the crankcase, adjacent the number 1 cylinder and forward of the number 2 cylinder. The propeller and its mounting flange on the crankshaft had fractured in overload level with the front of the crankcase and was not affected by fire.

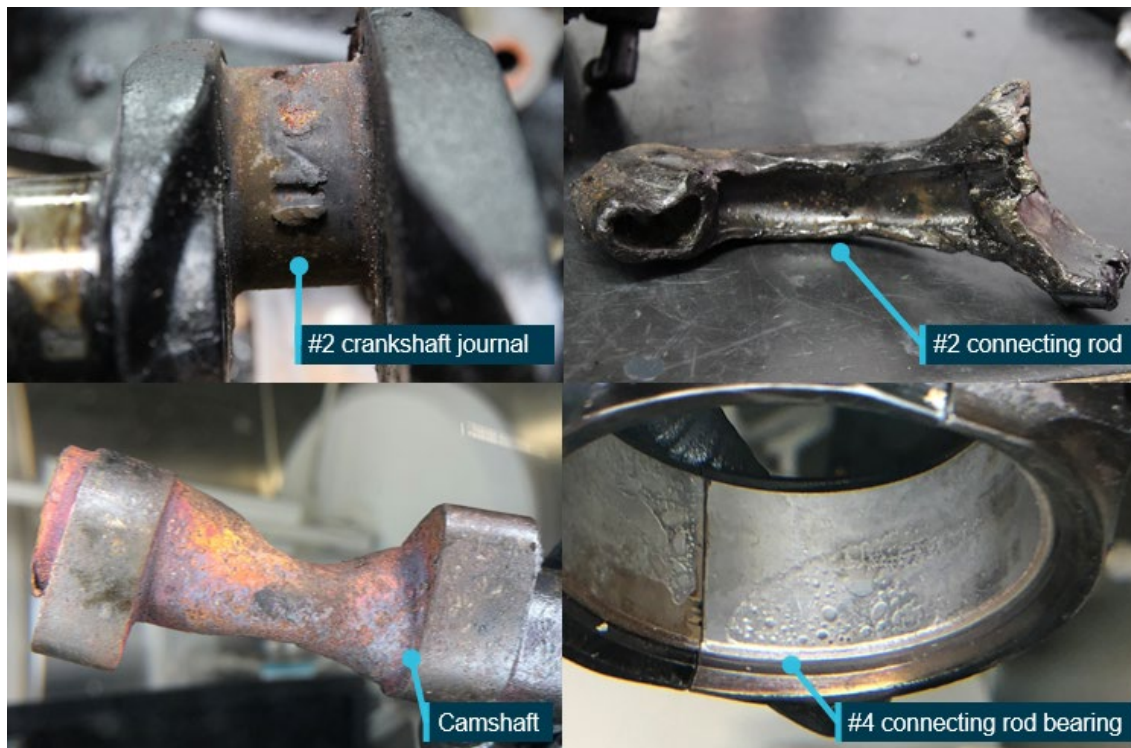
**Figure 6: Damaged engine components removed from VH-UQI**

The engine was disassembled and inspected under the supervision of the ATSB. The examination revealed that all components were heat affected from the post-impact fire. The crankcase had large holes either side of the number 2 cylinder and a series of adjacent impact marks on the internal surface. The number 2 connecting rod was fractured and separated from the crankshaft journal and piston. The connecting rod fracture surfaces were significantly damaged, which precluded any meaningful materials failure analysis.

The piston pin boss had fractured due to overstress; however, the piston pin showed no damage. The crankshaft showed significant impact damage and wear of the number 2 journal. The other journals were also discoloured but were otherwise undamaged. The number 2 journal bearing was destroyed, such that only small fragments remained. The number 1, 3 and 4 journal bearings did not exhibit any cracking, damage, or severe wear. Discrete areas of the bearing surface had a

‘cratered’ appearance, which was likely the result of localised melting of the thin bearing layer adjacent to the crankshaft journal. The absence of any significant operational wear associated with these areas, indicated that the melting was most likely due to the post-impact fire.

It was also found that the crankshaft oil supply galleries to the internal components were unobstructed. The damage to the number 2 conrod and bearing journals were consistent with the engine failure initiating due to breakdown of the number 2 bearing (Figure 6).

The connecting rod journal bearings fitted to the engine for VH-UQI were part number LW-13521 and marked with a manufacture date of 12-95. These were premodification bearings composed of an aluminium-tin alloy on a steel backing, which had been superseded in September 2004 by [Lycoming Service Instruction No. 1512](#). The LW-13521 bearings were required to be replaced with the upgraded bearings whenever new bearings were to be installed (such as at engine overhaul).

The ATSB determined that the initiating factor of the engine failure was likely the breakdown of the number 2 connecting rod journal bearings. This would have resulted in excessive clearance between the connecting rod and crankshaft journal. Therefore, this allowed increased flexure of the big end bearing housing under continued loading cycles, and ultimately fatigue failure of the connecting rod and damage to the surrounding components.

- The engine sustained a mechanical failure, most likely as a result of material degradation and impulse loading of the number 2 connecting rod journal bearing.
- After experiencing an inflight engine failure, the pilot conducted a downwind forced landing into a paddock while experiencing reduced visibility from smoke and oil over the windscreen. The landing roll could not be arrested before over-running the paddock and impacting trees.

- The aircraft had limited usage for an extended period, possibly with no specific engine preservation done while in storage.
- Had the engine been overhauled at the manufacturer's recommended calendar time, the connecting rod journal bearings would have been replaced with post-modification bearings as part of the overhaul process.
